Aleppo حبل

Aleppo Governorate

FIGURE 1. Cultural heritage damage assessment in Ancient City of Aleppo overlaid general infrastructure damage density analysis by UNOSAT.

This report provides a detailed analysis of the significant changes made to the cultural heritage of this site resulting from the ongoing conflict in Syria. World View 1 and 2 satellite imagery acquired on 21 November 2010, 22 October 2014 and 06 November 2014 were used for this report.

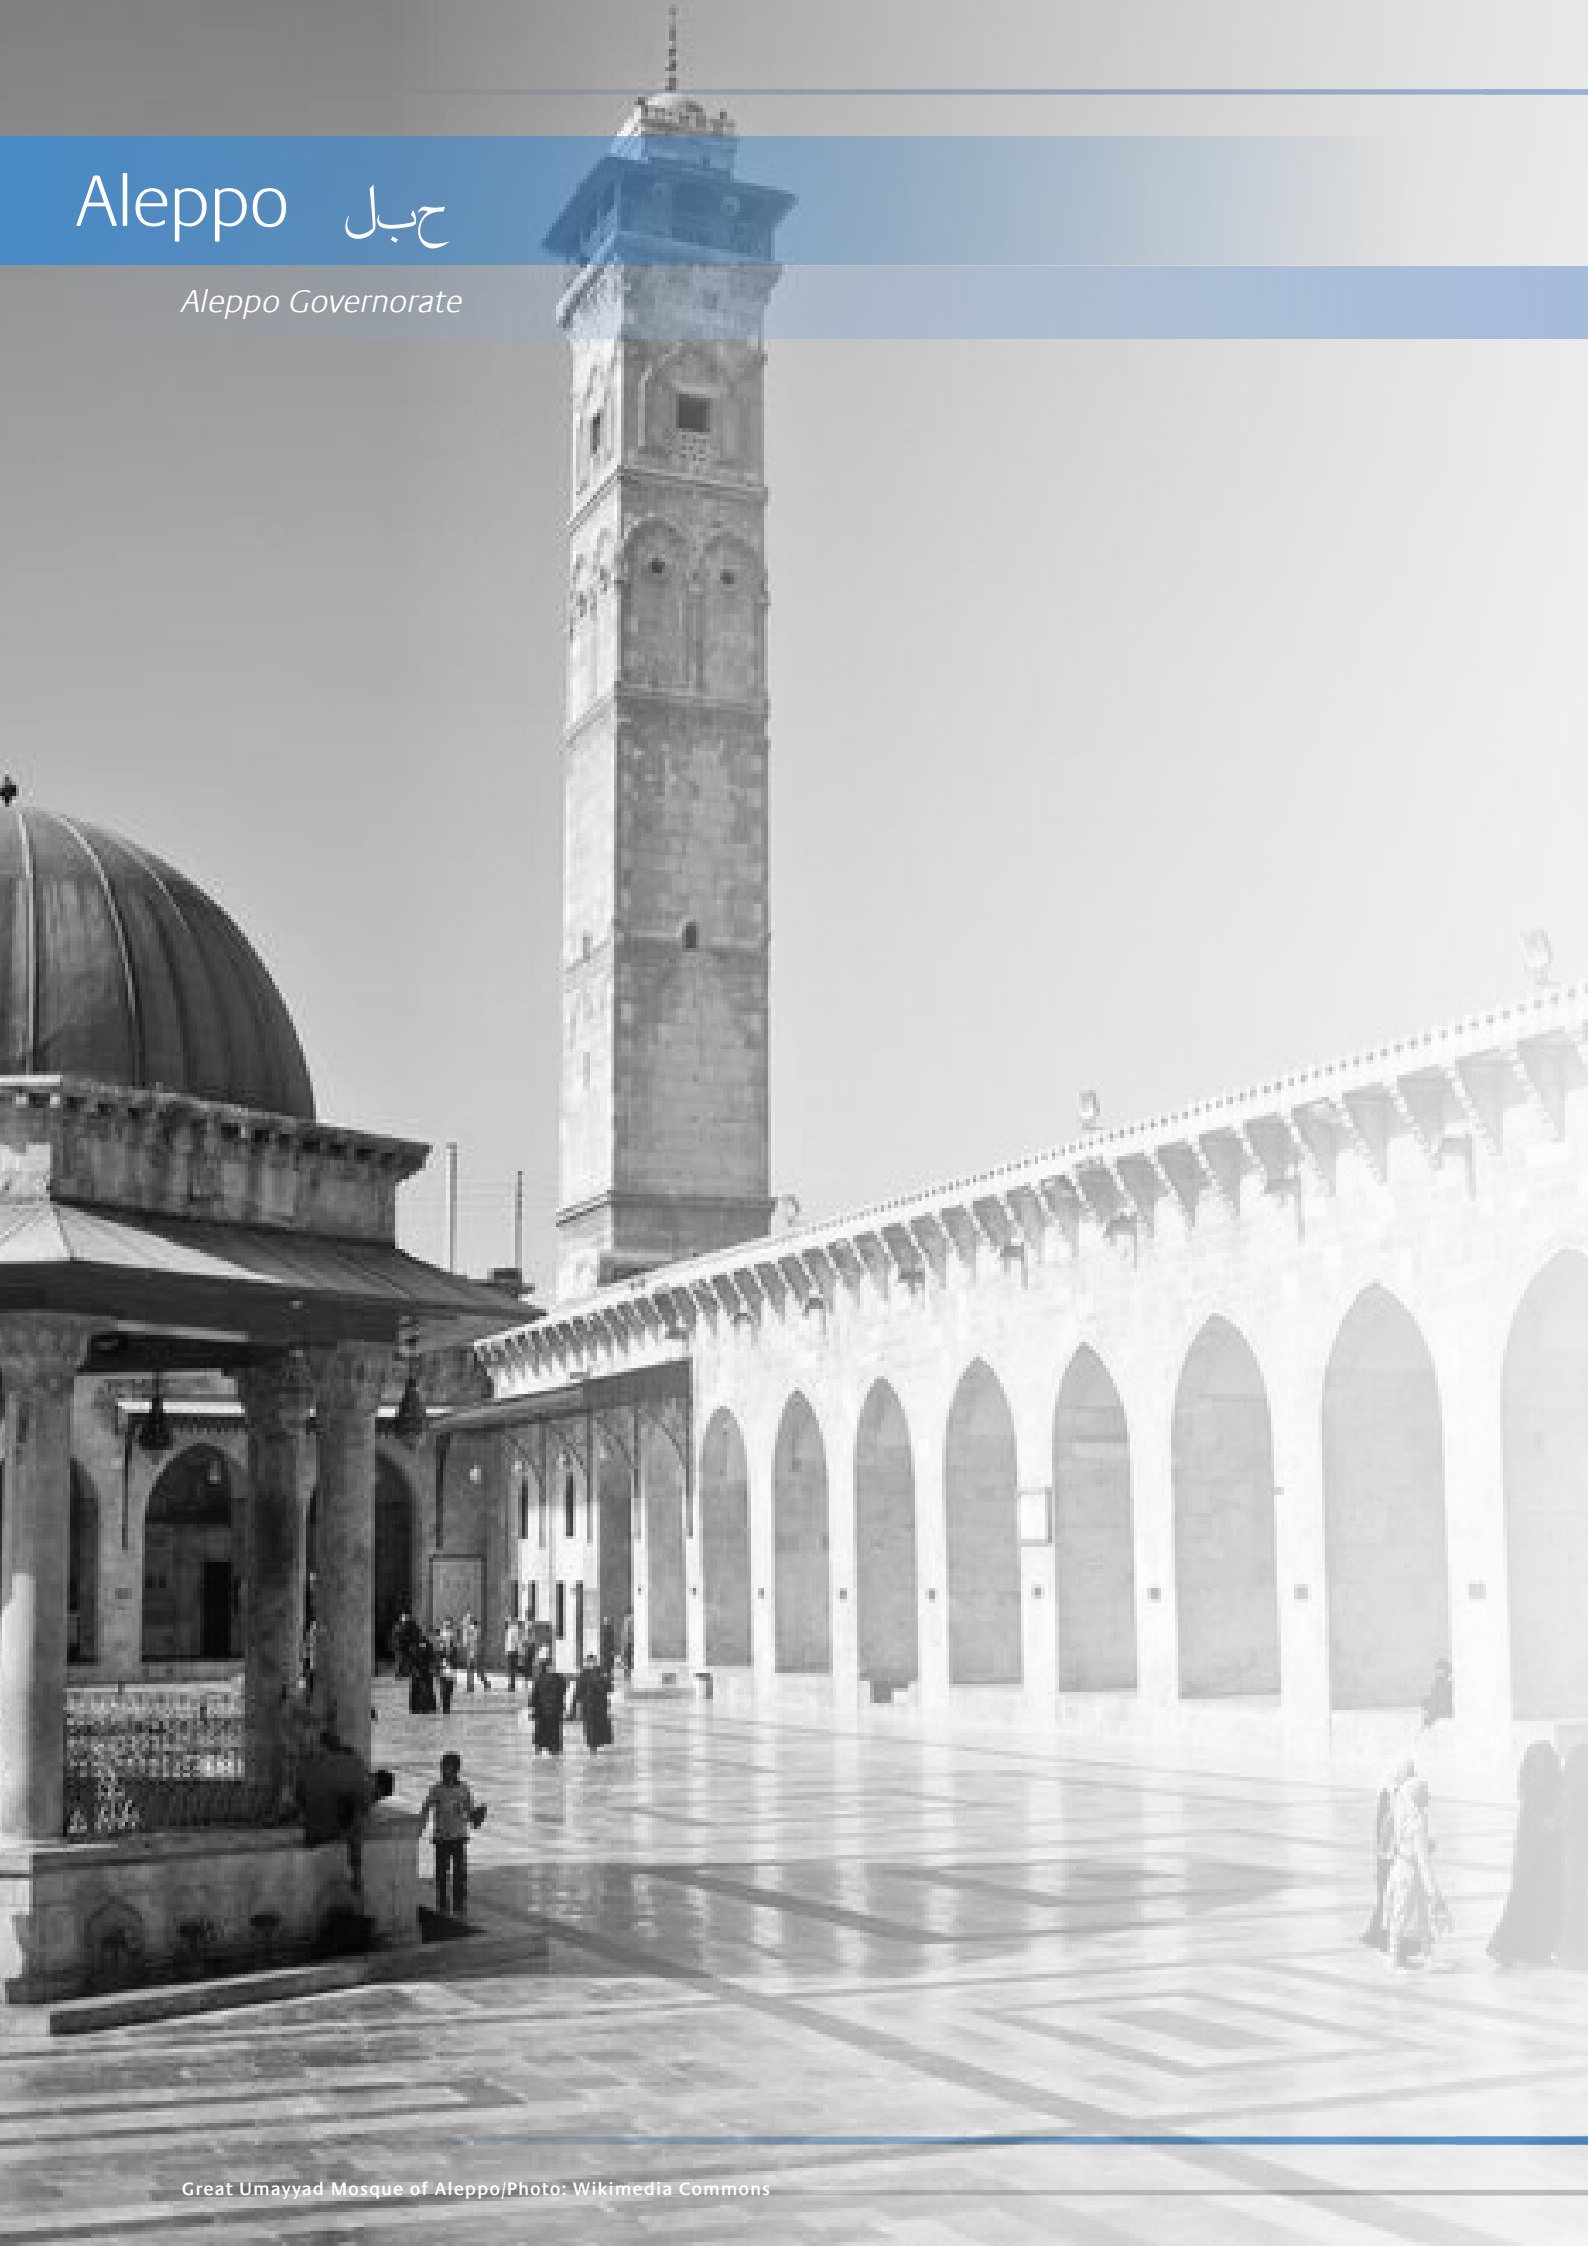
High to low damage

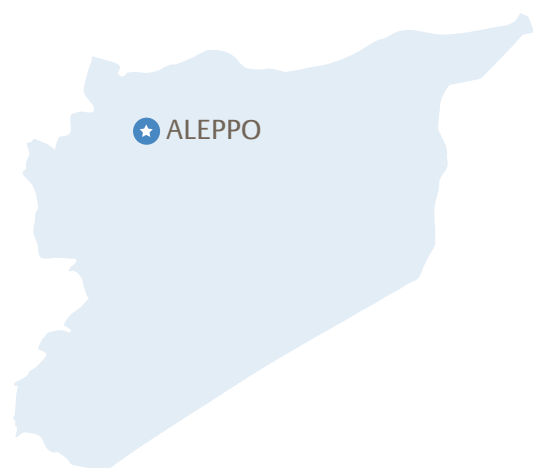
Aleppo Damage Level (Number of Heritage Locations)

FIGURE 2. Overview of Aleppo and damage to cultural heritage locations.

Using satellite imagery, this study examined 210 key structures and locations within the World Heritage Property. These include the citadel, city walls and gates, 73 historic buildings, 83 religious buildings (mosques, madrassas, mausoleums, shrines, churches and a synagogue), the National Museum, and the souqs/markets (comprising 45 sections). It is not possible to discuss every site, so the area has been summarised and mention will only be given to key sites. Sites examined are listed in Annex 2.

Of the locations examined, 104 have sustained damage, while roughly a fifth of the sites are completely destroyed. Inspection of the imagery suggests that within the World Heritage Site, the area to the east and southeast of the citadel towards Bab Antakya is the most affected, particularly between the citadel and the Umayyad Mosque; large parts of this area are no longer present (as seen in figures 1, 2 and 3). Throughout the area, there is visible evidence of severe structural damage from shelling impacts and from fire. One building has been completely destroyed, as have some of the surrounding structures due to a targeted explosion.⁽ⁱⁱ⁾ In addition to the examination of the selected structures, a large number of other buildings within the World Heritage Site were clearly damaged and, in some cases, have collapsed. Visible rubble in the streets indicates a number of other buildings may be affected.

Satellite imagery confirms the building was completely destroyed—not even the foundations remain (see figure 2). This was caused by explosives that were placed in a tunnel underneath it in May 2014.^(iv)

Many of the souqs were badly damaged in a fire in 2012.^(v) Imagery verified visible damage to 34 of the 45 souqs examined; a 35th souq was reported to have been damaged by the fire, but damage could not be confirmed. Additionally, 20 of these 35 souqs contained 1,121 shops supporting the official estimate that 1,500 of the 1,600 shops were damaged or destroyed.^(vi) Of the 20 souqs which sustained damages, 4 souqs sustained a minimum of moderate damage (and at least one is suspected to have severe damage inside); 19 sustained severe damage; and 11 have been completely destroyed (see figure 2).

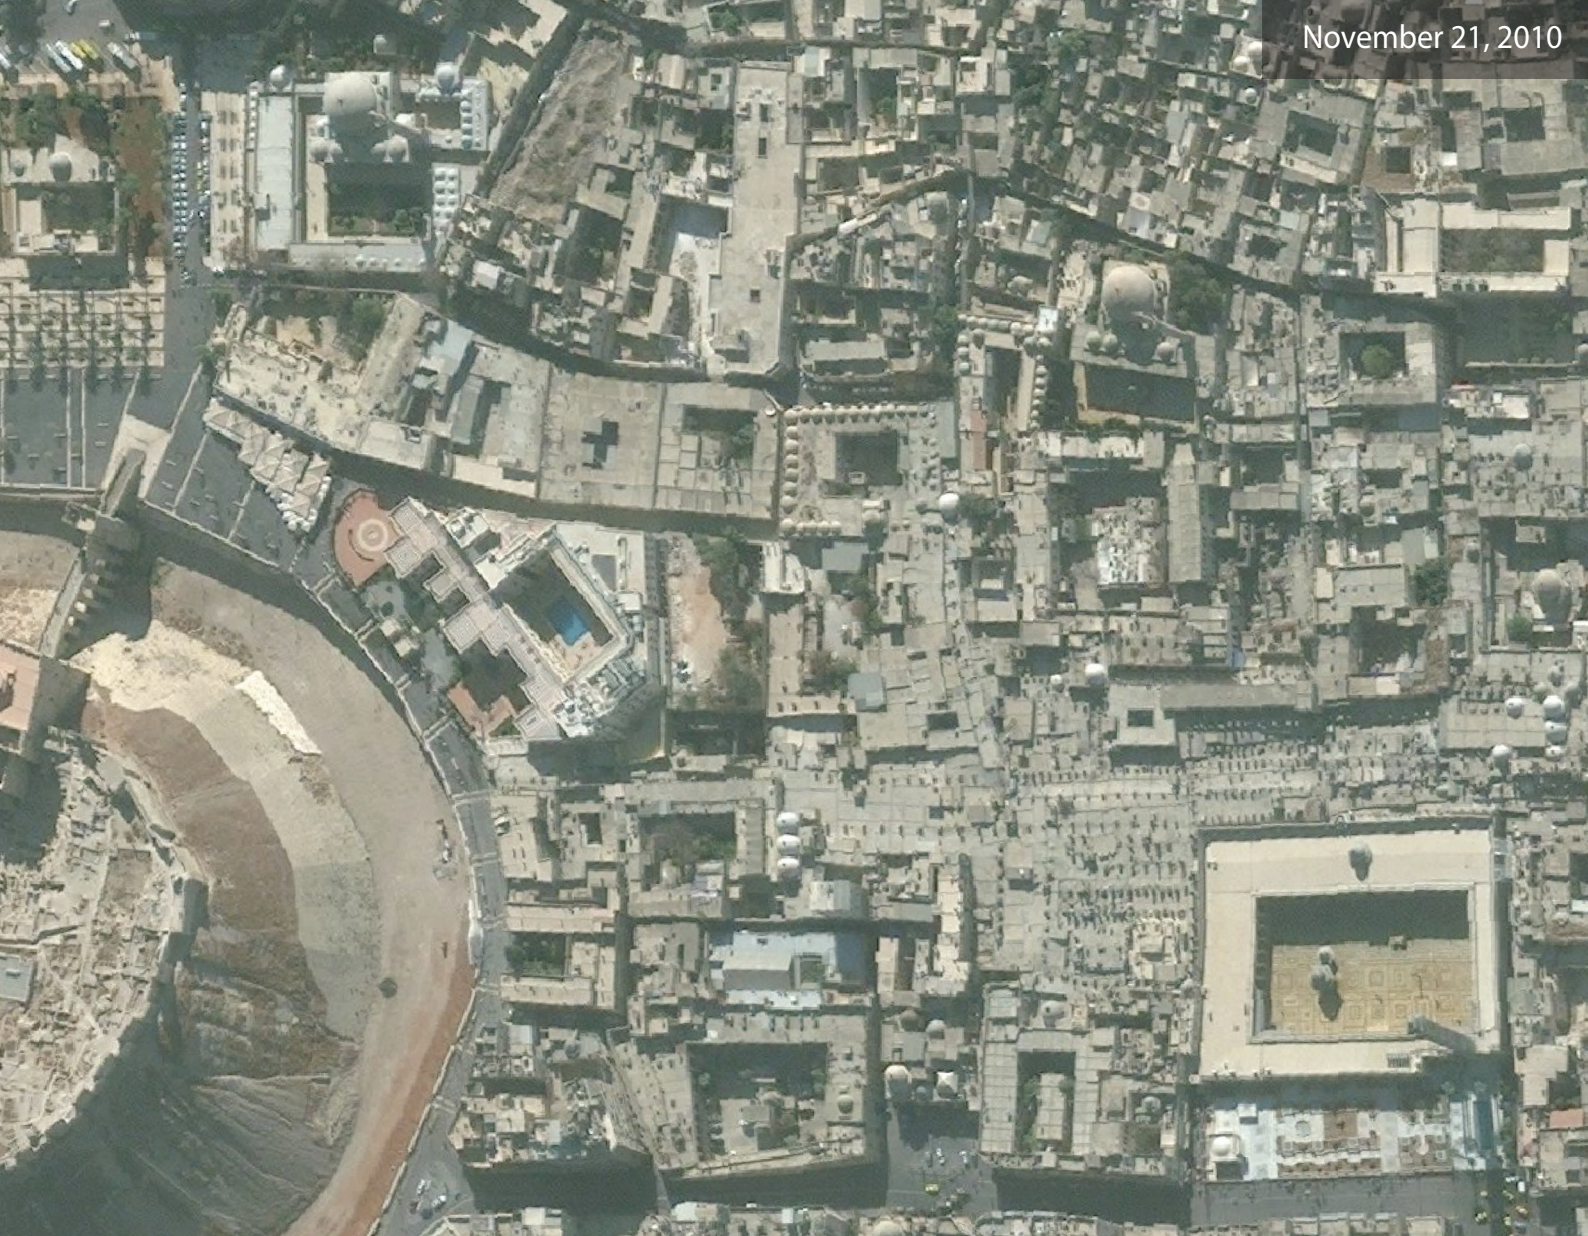
FIGURE 3. Overview of Aleppo and damage to cultural heritage locations.

Additionally, 35 structures were reported to have sustained damage from internal fires or damage which is too light to confirm.⁽ⁱⁱⁱ⁾ Damage is likely, given the state of the surrounding buildings, but these cannot be verified via imagery. Also given the significant damage observed in surrounding areas, a large amount of structural damage can be expected to the nearby buildings, even if they appear undamaged from an aerial perspective.

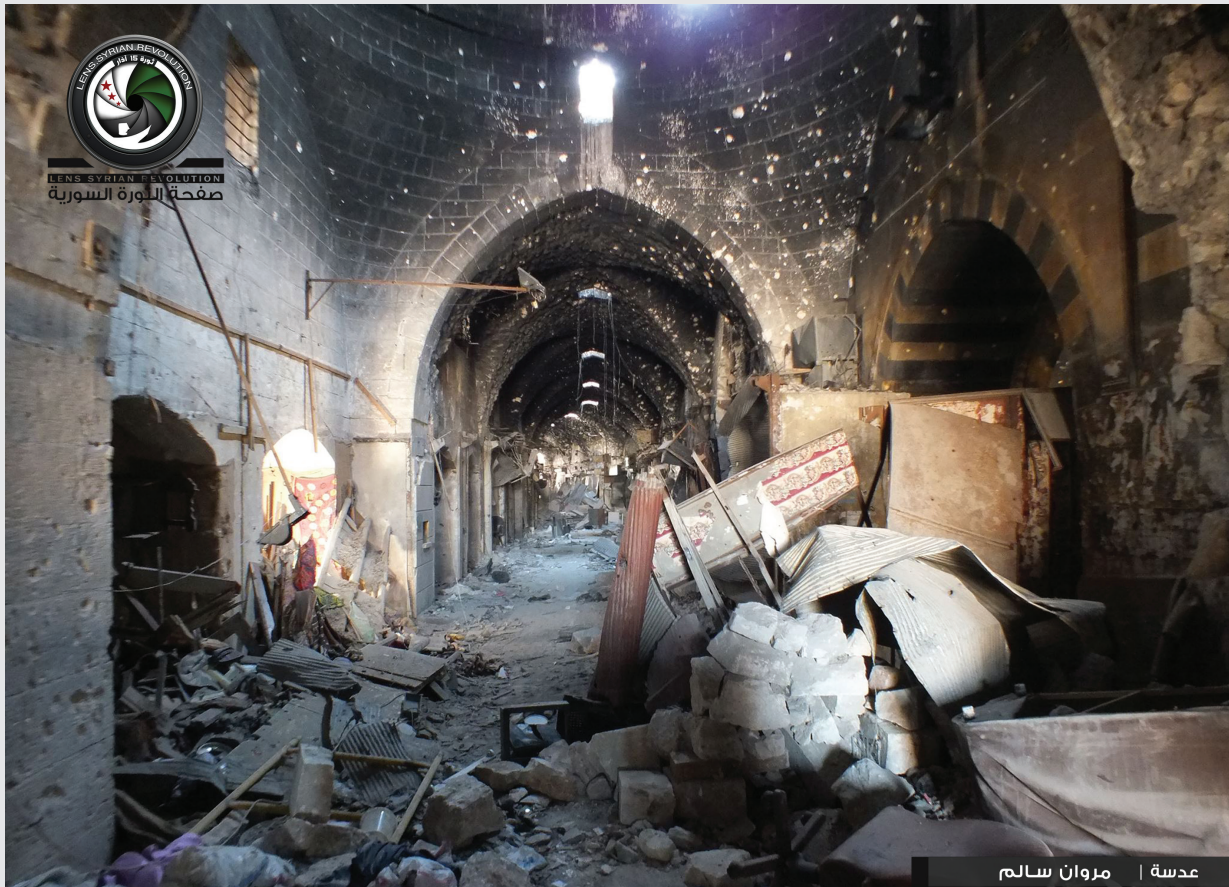
Damages to one of Aleppo's Souq/Photo: Lens Syrian Revolution.

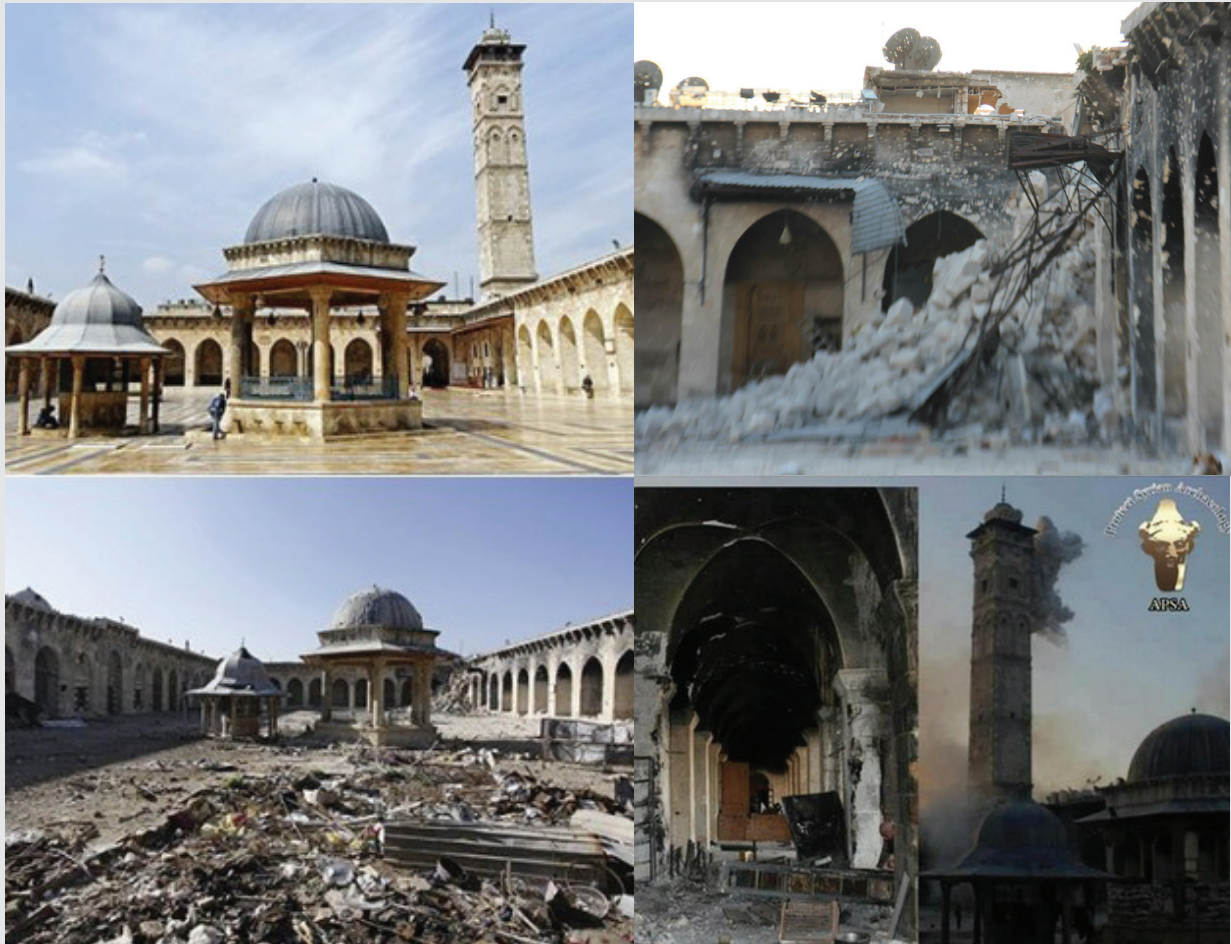
Damages to the Great Umayyad Mosque. Images shown the Gerat Umayyad Mosque Minaret destroyed/Photos: Aleppo Lens/Lens Young Halabi, Lens Syrien Revolution (Sami), al-Fanar Media, and APSA (The Association for the Protection of Syrian Archaeology).

The Umayyad Mosque is perhaps the worst affected of Aleppo's monuments. The minaret was destroyed during fighting in 2013—its rubble is clearly visible in the imagery.^(viii) There appears to be severe damage to the eastern outer wall, the southern part of the eastern gallery, and the northeast corner of the northern gallery. It was destroyed by the same fire which ravaged the rest of the gallery and destroyed the library in 2013.^(ix) In addition, the marble-tiled courtyard has been partially destroyed. Lastly, the garden is severely damaged as is the entrance to the souq from the eastern gallery.

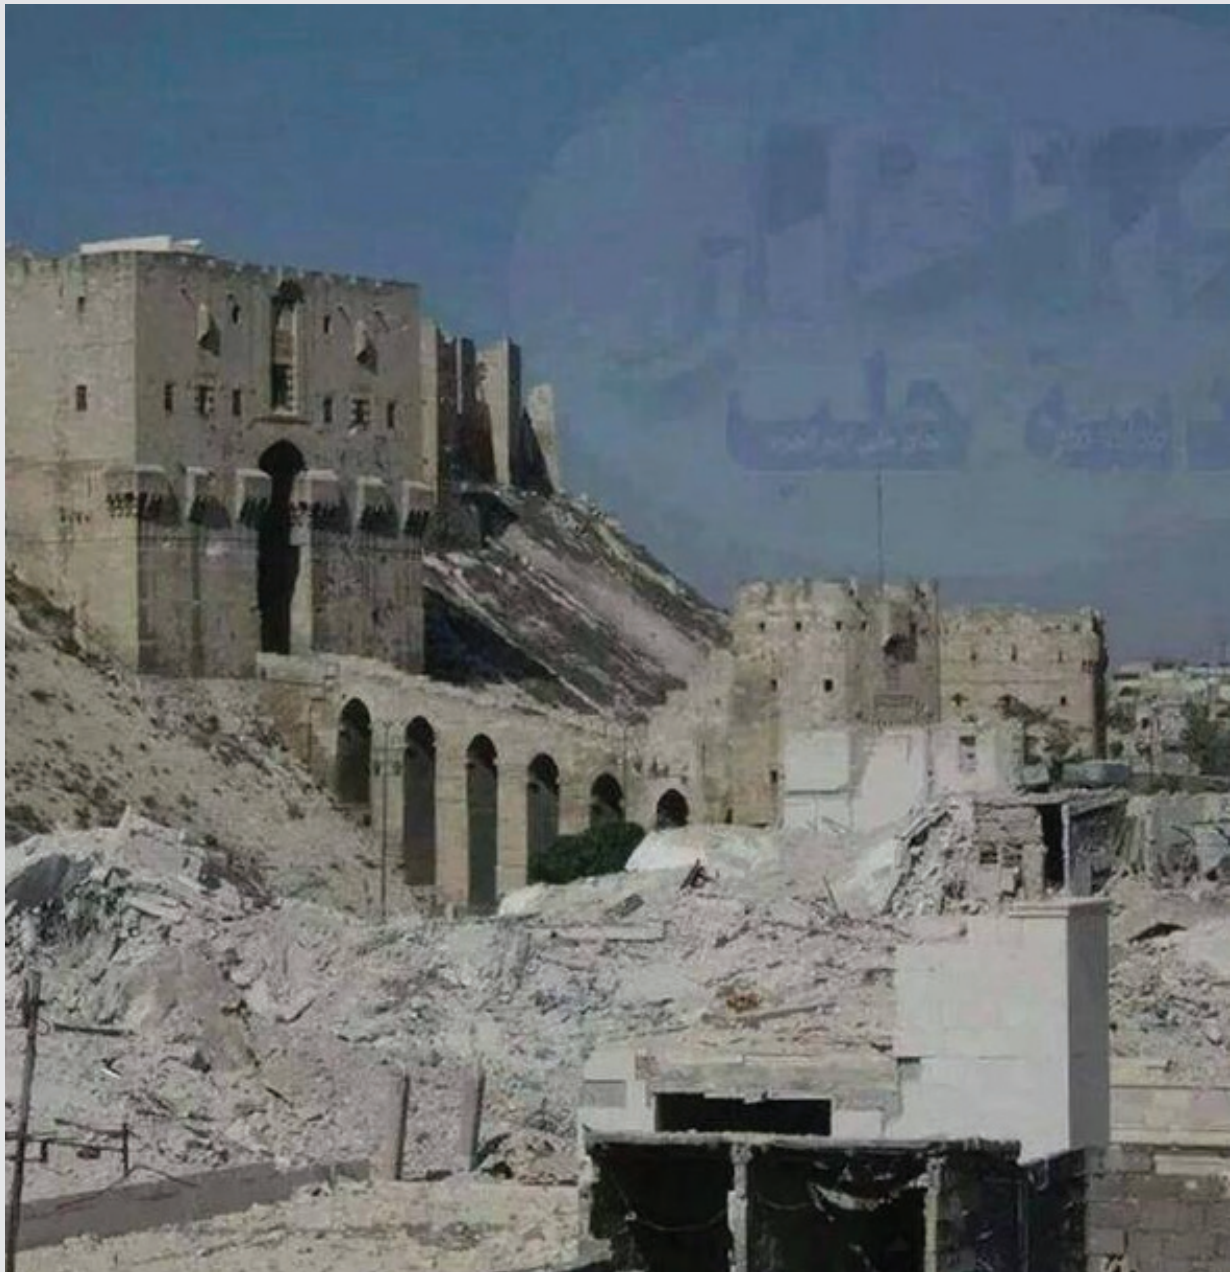
Impact damage visible on Aleppo's Citadel structure/Photo: Facebook.

Impact damage is visible on the stone cladding of the glacis (the damage largely dates back to 2012⁽⁴⁾). Minor structural damage is visible on some of the other structures, including some of the towers on the wall. The worst damage was done to the Temple to the Storm God. A roof was constructed in 2005 to protect the excavated area; this is no longer present. The state of the excavation underneath is unclear in the imagery, but appears as if it may have been disturbed. Although the Gatehouse is known to have sustained minor to moderate damage from an attack in 2012,⁽⁴⁾ damage cannot be verified with the imagery.

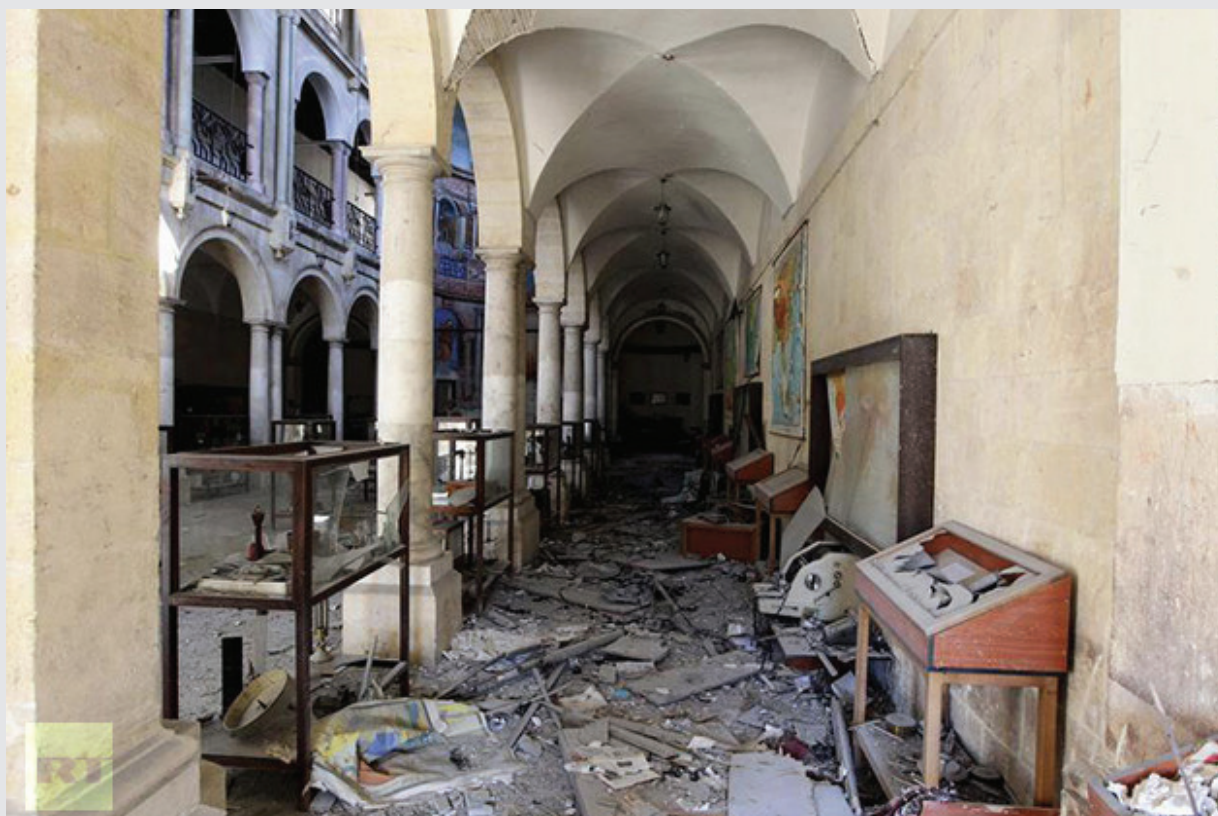
Debris lies on the ground of the damaged Museum of Science in the old city of Aleppo/Photo: REUTERS/Muzaffar Salman.
