Apamea افاميا

Lattakia Governorate

FIGURE 4. Overview of Apamea and damage of cultural heritage locations.

This report provides a detailed analysis of significant changes to the cultural heritage of this site resulting from the ongoing conflict in Syria. World View 1 and 2 satellite imagery acquired on 02 June 2008, 28 November 2013 and 06 March 2014 was used for this report.

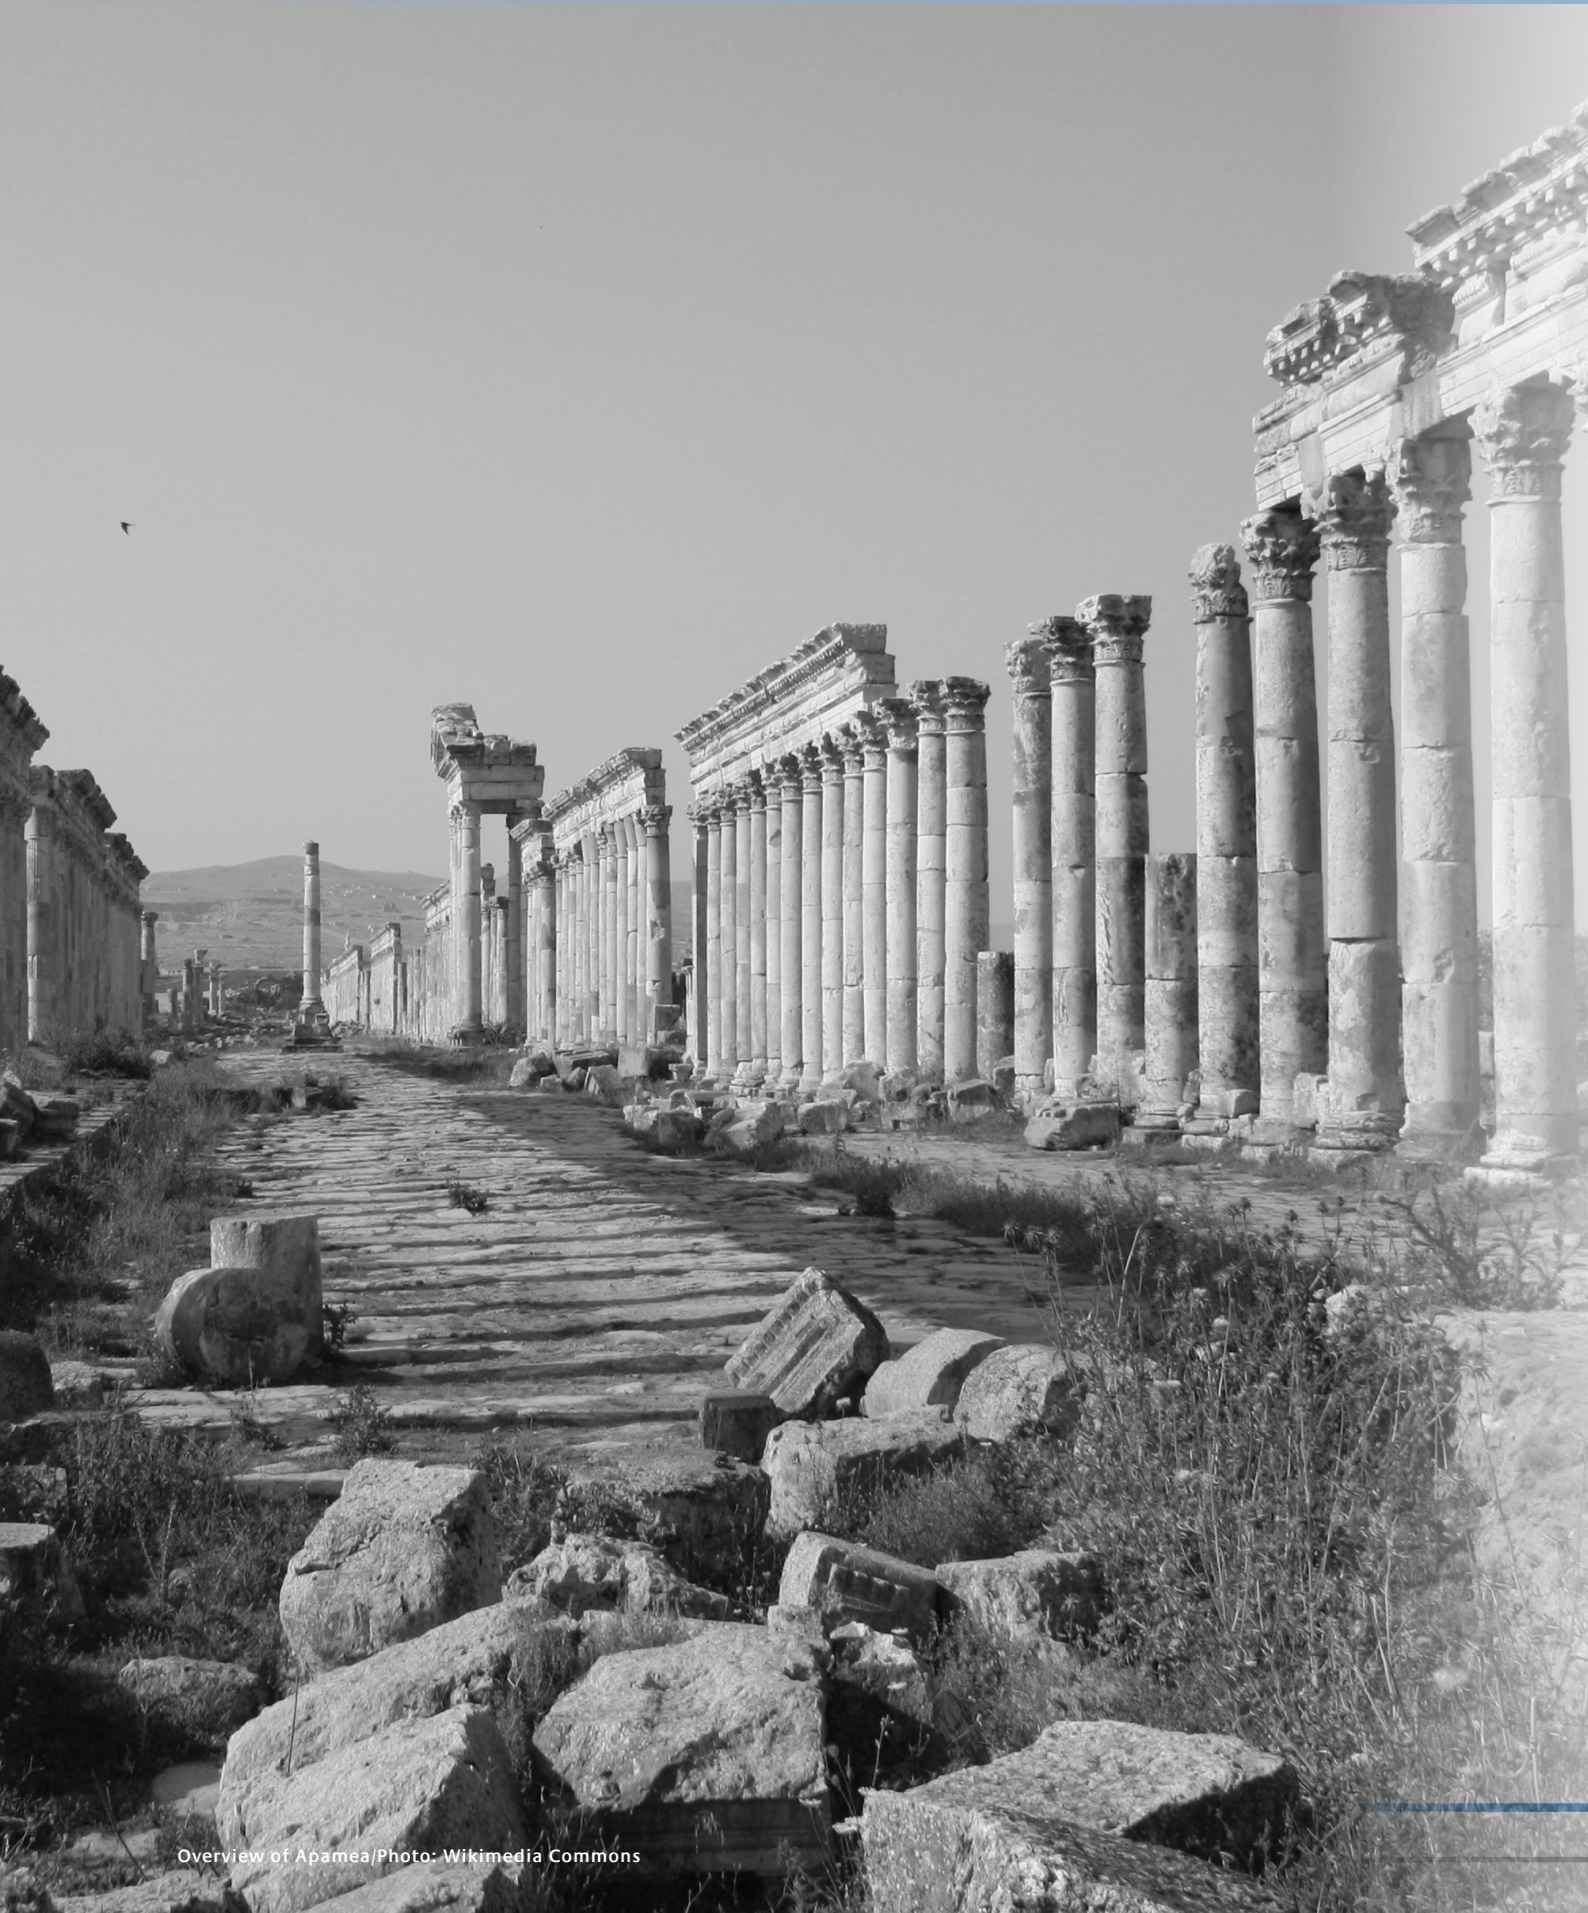
Researchers Casana and Panahipour also studied the site on satellite imagery from 2007, April 2012 and November 2012.⁽ⁱⁱⁱ⁾ Their results demonstrated that the vast majority of looting can be dated to the first phase of the conflict, having occurred by April 2012, although it continued into November 2012. They also found that in April 2012 only a few holes had been dug into the privately owned land, though there was a considerable amount of holes outside the walls.

By November 2012, looting holes were starting to encroach into the private areas, but looting outside the walls had largely ended. By November 2013, the road that separates the private- and state-owned parts of the site were no longer visible at the northern end, and the heavy looting covered the northern section of the private arable land. In April 2012, the main part of the looted site was 170 ha, with a further 3 ha of smaller looted areas, mostly outside the walls. A review of imagery from 2013 demonstrates that looting still continues; almost another 20 ha (20,000 m²) of archaeological soil has been looted (see figure 4).

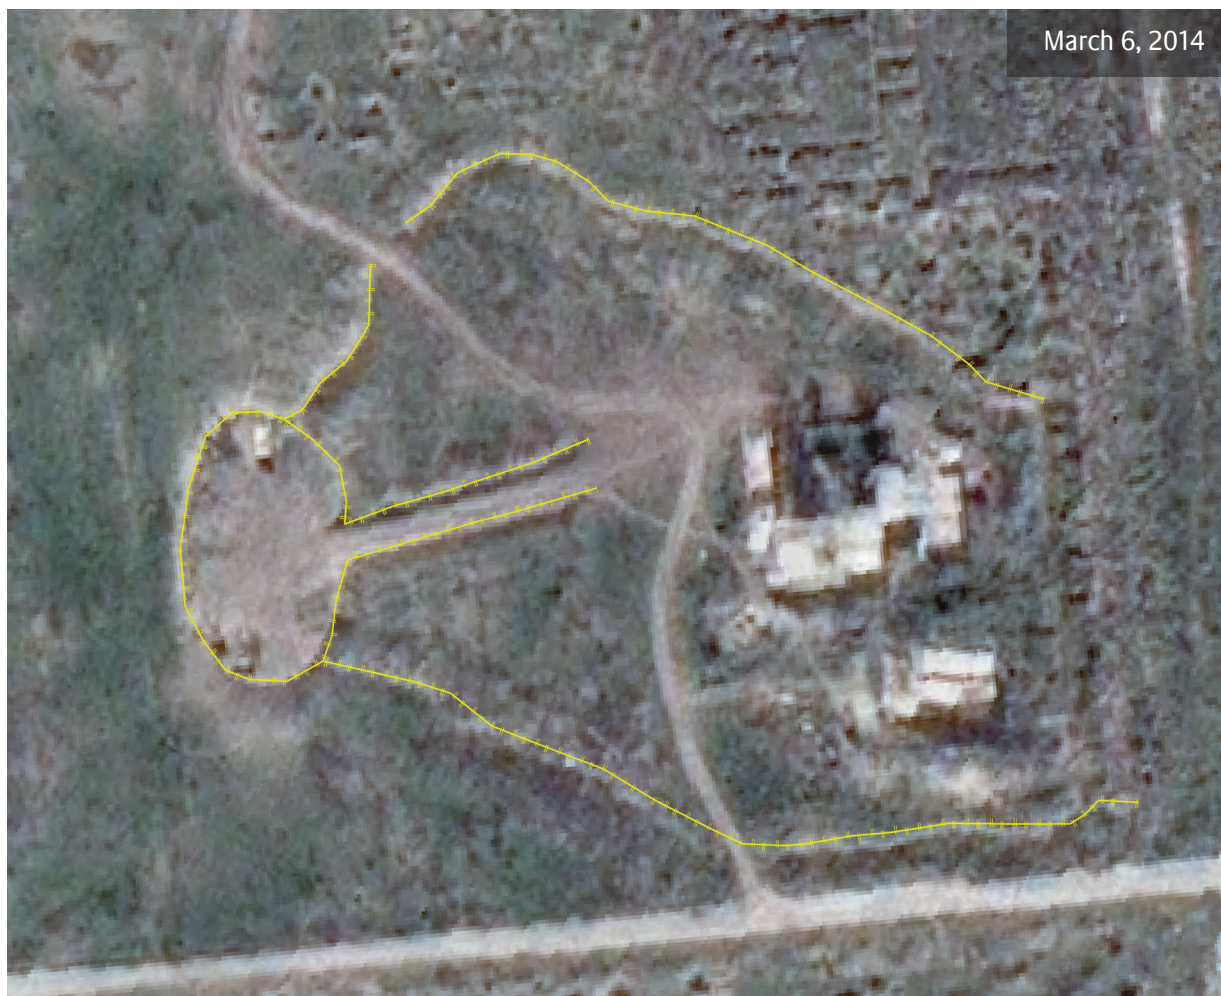
FIGURE 5. Evidence of military garrison around the former café in the centre of the site.

In addition, some areas have suffered significant structural damage from unknown causes. Parts of the colonnade have collapsed, and there is damage to a large section of the city wall. A military garrison is now located around the former café in the centre of the site. New buildings have been constructed around the café as well and the area has been surrounded by an earth emplacement, which covers 2 ha, and was constructed with heavy machinery from the archaeological area around it (see figures 5 and 6).

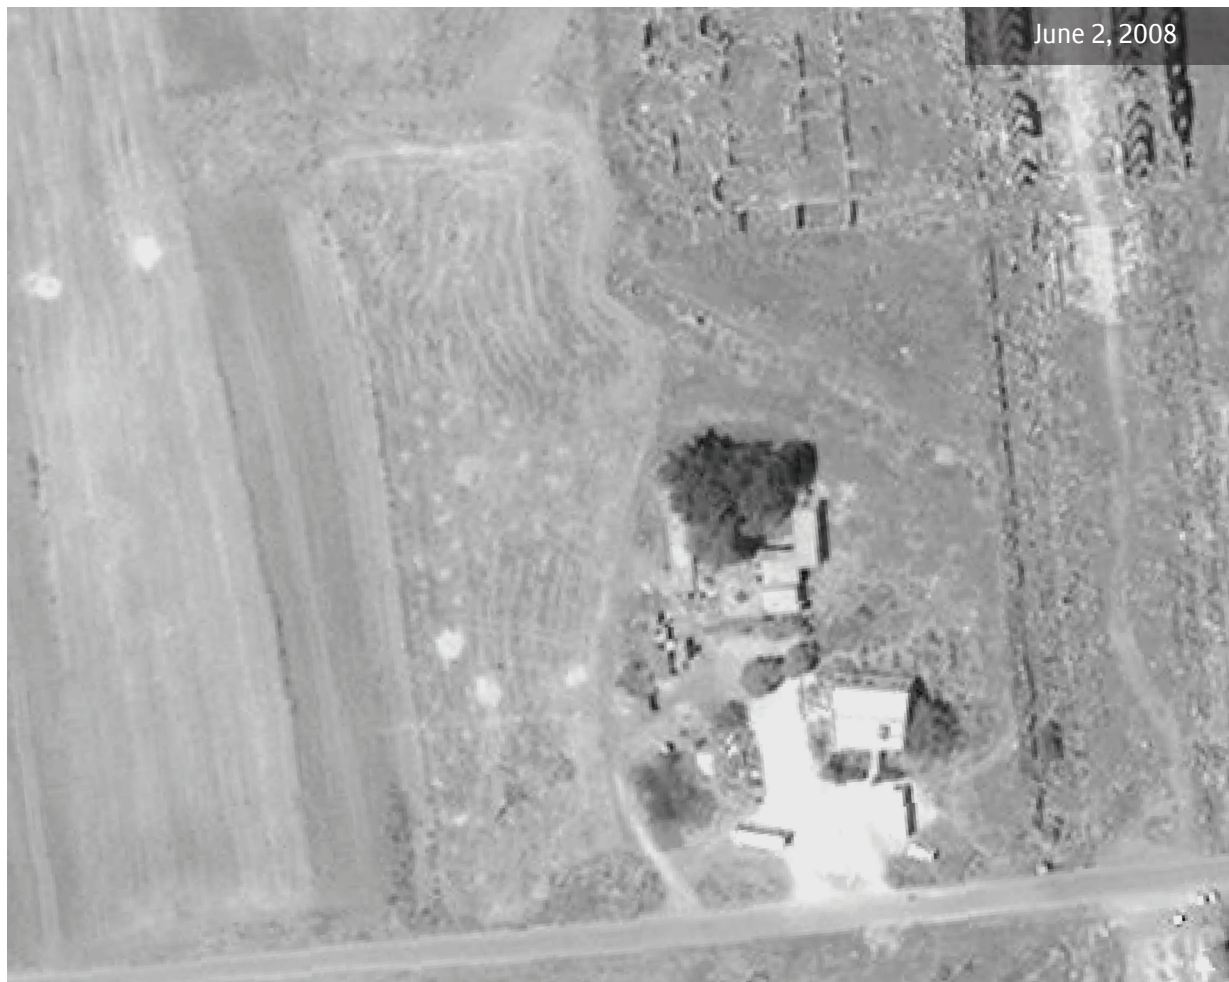
FIGURE 6. Former café in the centre of the site.

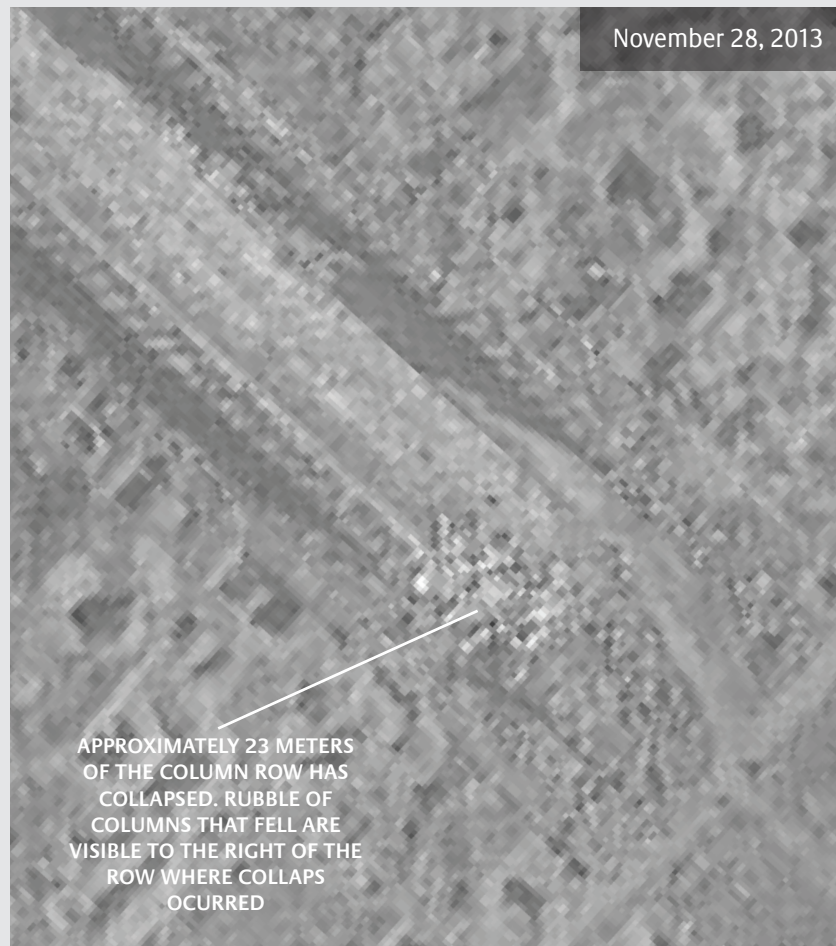
FIGURE 7. Cardo Maximus in Apamea. c.23m of colonnade has collapsed. The rubble is visible to the right of the row where the collapse occurred.

A section of columns, approximately 23 m long, have collapsed (see figures 7 and 8). The remains of the collapsed columns are visible.

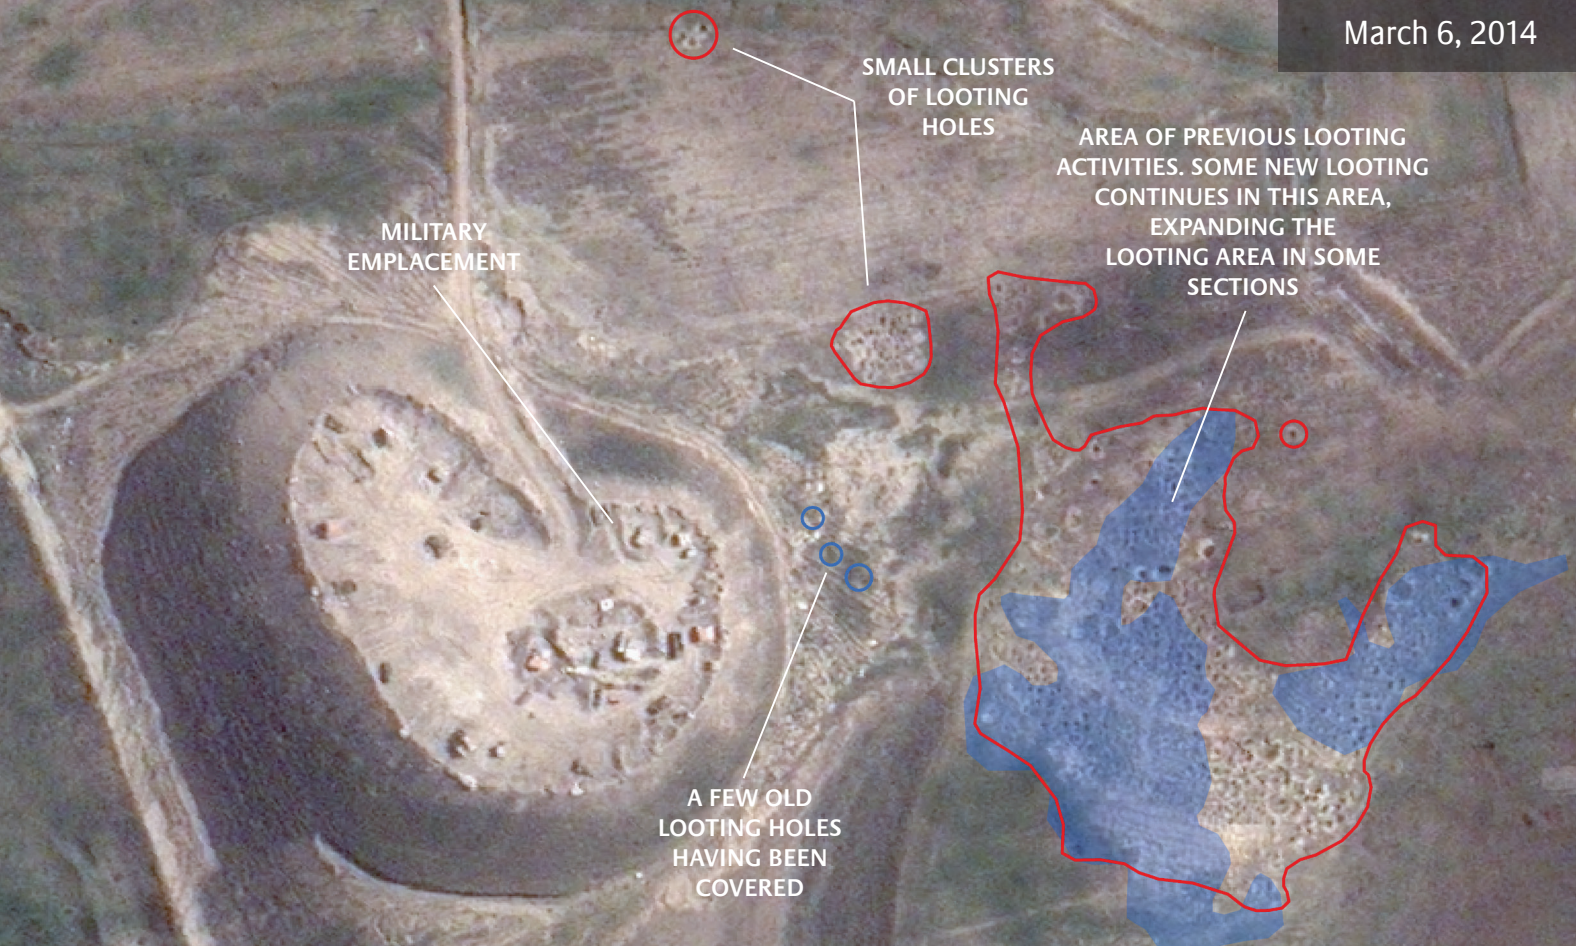
FIGURE 9. Tell Jifar – Military emplacement, new looting holes, smoothed over looting holes at the base of the tell, and earlier looting holes from 2008.

Looting in this area has clearly been a problem for some time. For instance, the 2008 image reveals the lower surrounding town was already looted previously. Holes are visible covering an area of approximately 2.5 ha. The looting also increased; by November 2013, the expanded looted area was approximately 3.1 ha, covering new areas, with some of the old looting holes no longer visible. However, the looting appears to have mostly stopped, as a few of the holes are still sharply defined, and most are smaller indicating many are not fresh. In addition, a military garrison has been built on top of the tell. The road to the summit has been widened, with a raised embankment excavated by heavy machinery along parts of it, together with a raised embankment around the edges of the summit, and a semi-circular emplacement within that on the southern end of the summit. These have been created from and are in archaeological soil. Furthermore, the vibrations caused by heavy traffic are likely to cause damage to the unexcavated remains (see figures 9 and 10).

By November 2013, the imagery demonstrated that the track was no longer present. Furthermore, many of the looted areas, several of which were around the base of the tell, have been filled in using heavy machinery and all military presence is concentrated on the tell summit. The smaller military emplacement/enclosure has been smoothed over and a new one created, damaging the site further.
