Bara (al-Bara) البارة

Idlib Governorate

BARA DAMAGE ASSESSMENT SUMMARY

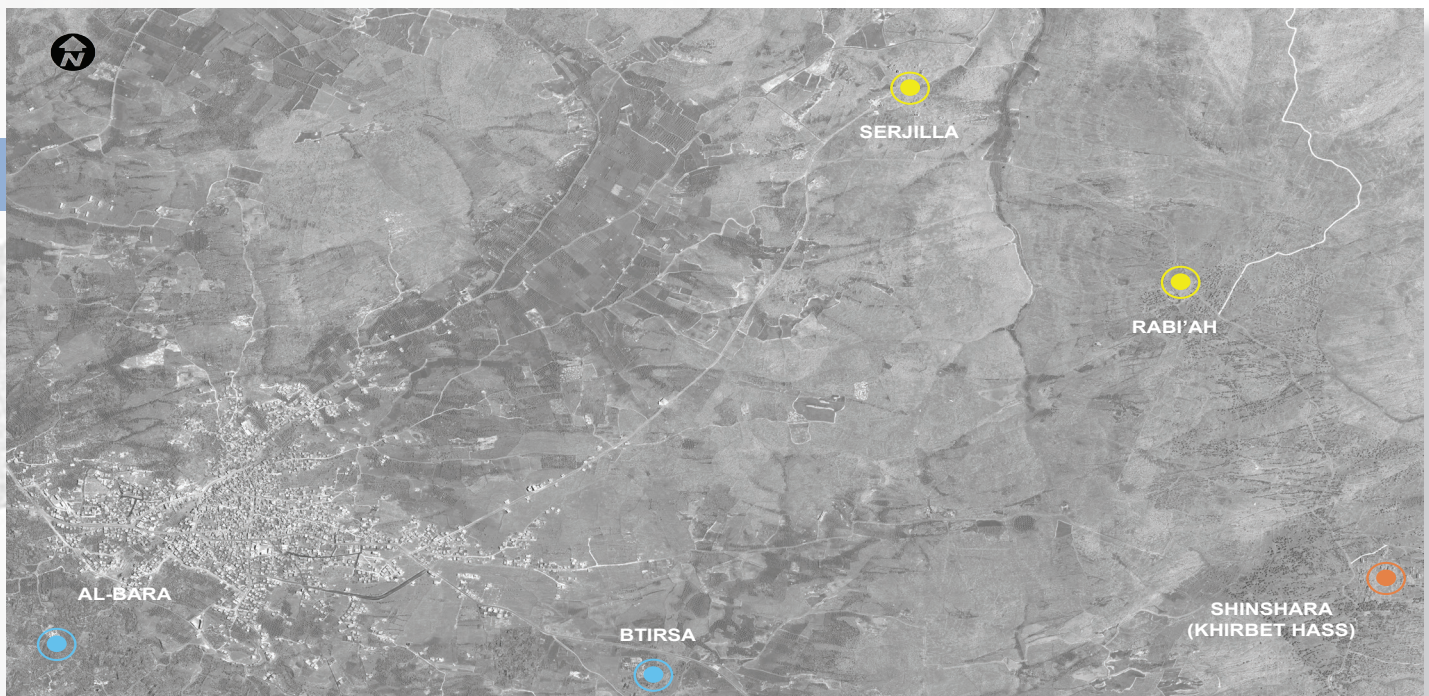
FIGURE 11. Overview of Bara and damage of cultural heritage locations.

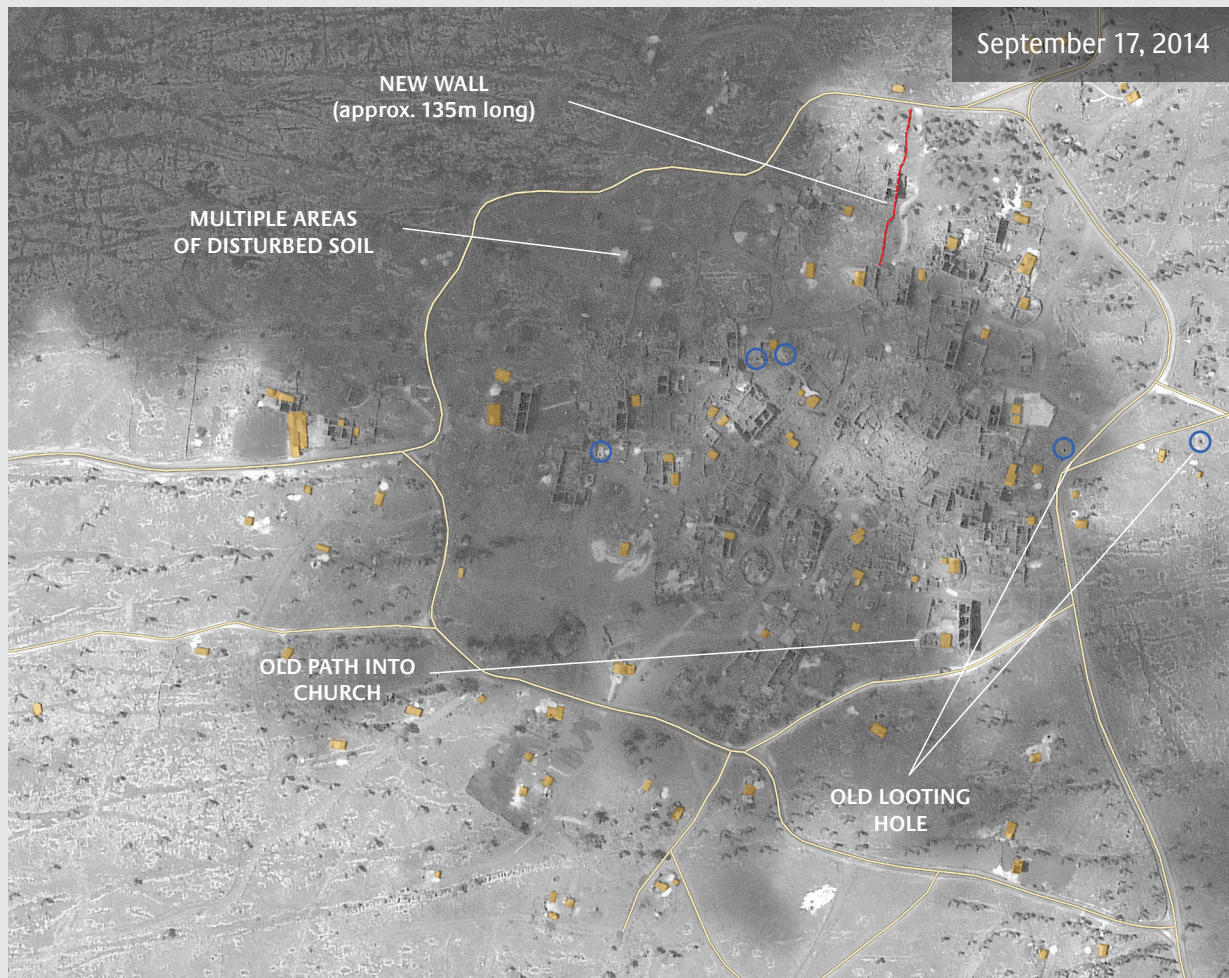
FIGURE 12. Shinshara Roman/Byzantine village showing signs of new structures and disturbed soil. New structures are marked in orange.

There is evidence of resettlement amongst the ruins of Shinshara,^(v) which has caused extensive damage. Approximately 80 new structures have been built amongst the ruins. In some places, the ruins have been cleared or disturbed to make space for the new structures. Stone robbing also seems likely; for example, in one area a wall has been built that is approximately 135 m long, potentially using material from the ruins. In some structures, such as the ruined church northeast of the village, the ground has been disturbed, suggesting either heavy use or possible looting. One small hole was visible north of the village on the 2008 imagery, indicating looting was already a problem, but at least three more possible small looting holes are also visible south of the village on the 2014 image (see figures 12 and 13). There are multiple areas of disturbance of the ground some of which may possibly be a result from shelling. Shelling was reported to have occurred from an airstrike on 02 May 2014, which destroyed an entire house and the wall of one of the churches.^(vi)

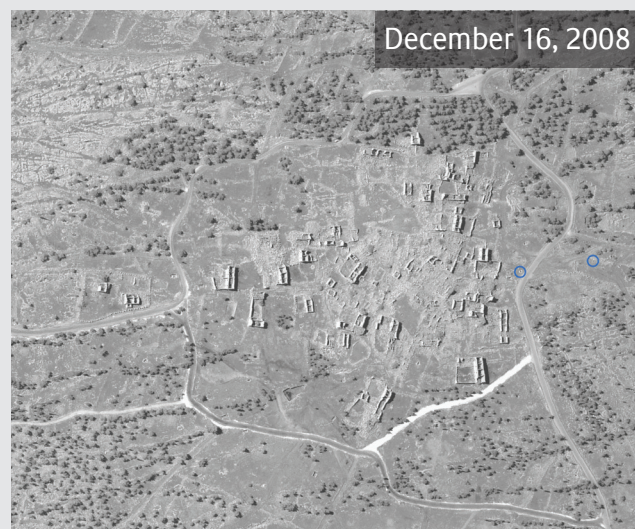
FIGURE 13. Shinshara.

Visible looting holes

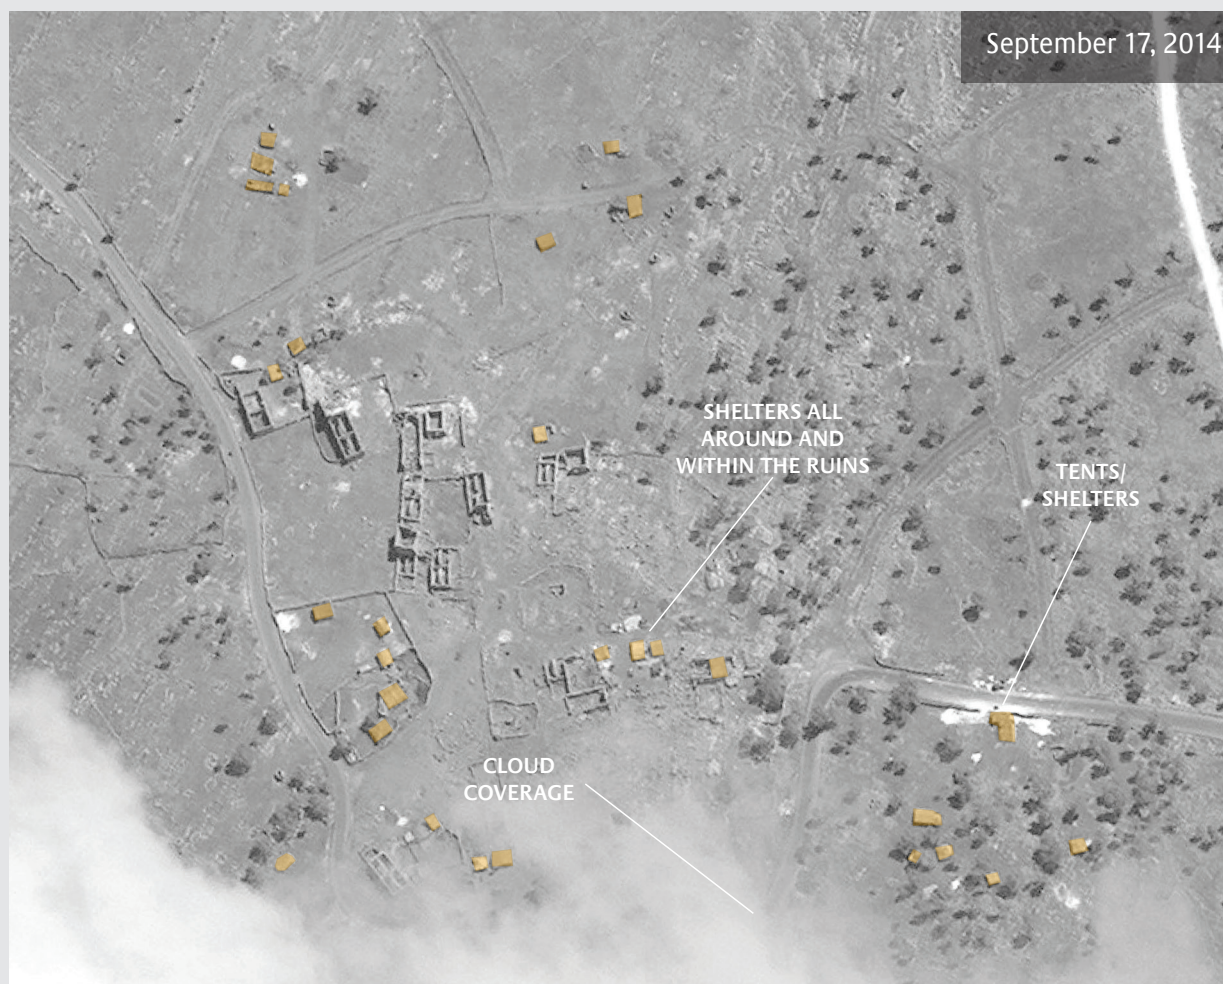
FIGURE 14. Rabi'ah Byzantine settlement showing shelters and tents within the ruins. New structures are marked in orange.

The ruined settlement was apparently resettled at some point between January 2013 and September 2014. Approximately 29 shelters have been placed in and around the ruins as of 17 September 2014 (see figures 14 and 15). A report released by the The Association for the Protection of Syrian Archaeology shows that the settlements were well established by July 2014.^(vii) The extent of the damage to the site cannot be determined at this time. However, it is likely the activity has affected the ruins and the archaeological levels. No looting was visible in the imagery.

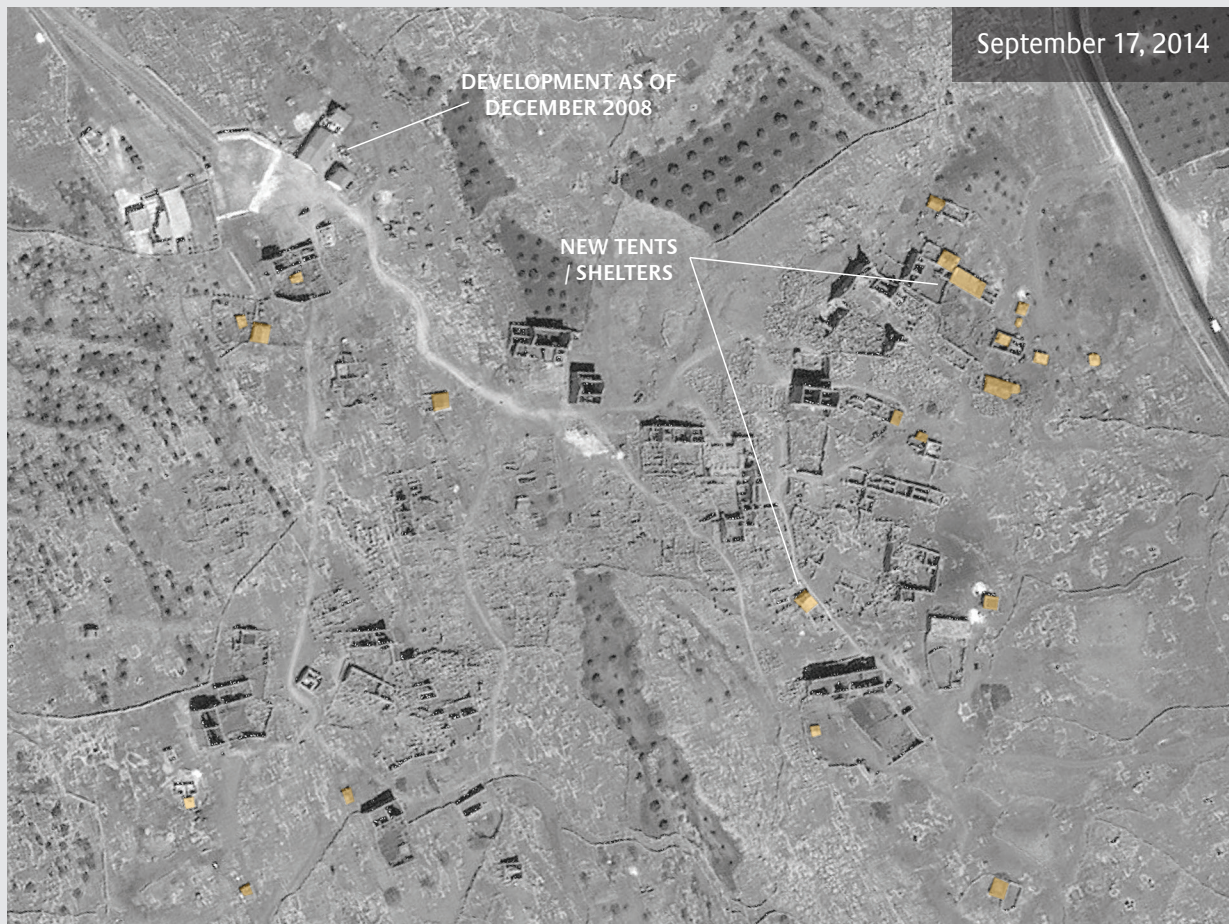
FIGURE 16. Serjilla Byzantine settlement showing new structures, tents and shelters. New structures are marked in orange.

Approximately 22 shelters and one new structure had been placed in and around the ruins as of 17 September 2014 (see figures 16 and 17). Most of these structures were placed between January 2013 and September 2014. The level of damage to the site cannot be determined at this time. However, it is likely the activity has affected the ruins and archaeological levels.^(ix) No looting was visible in the imagery.^(x)
