Deir Semaan (Telanissos) دير سمعان

Aleppo Governorate

Status Overview

NOTE
This report provides a detailed analysis of significant changes to the cultural heritage of this site resulting from the ongoing conflict in Syria. World View 1 and 2 satellite imagery acquired on 19 November 2013 and 08 October 2014 was used for this report.

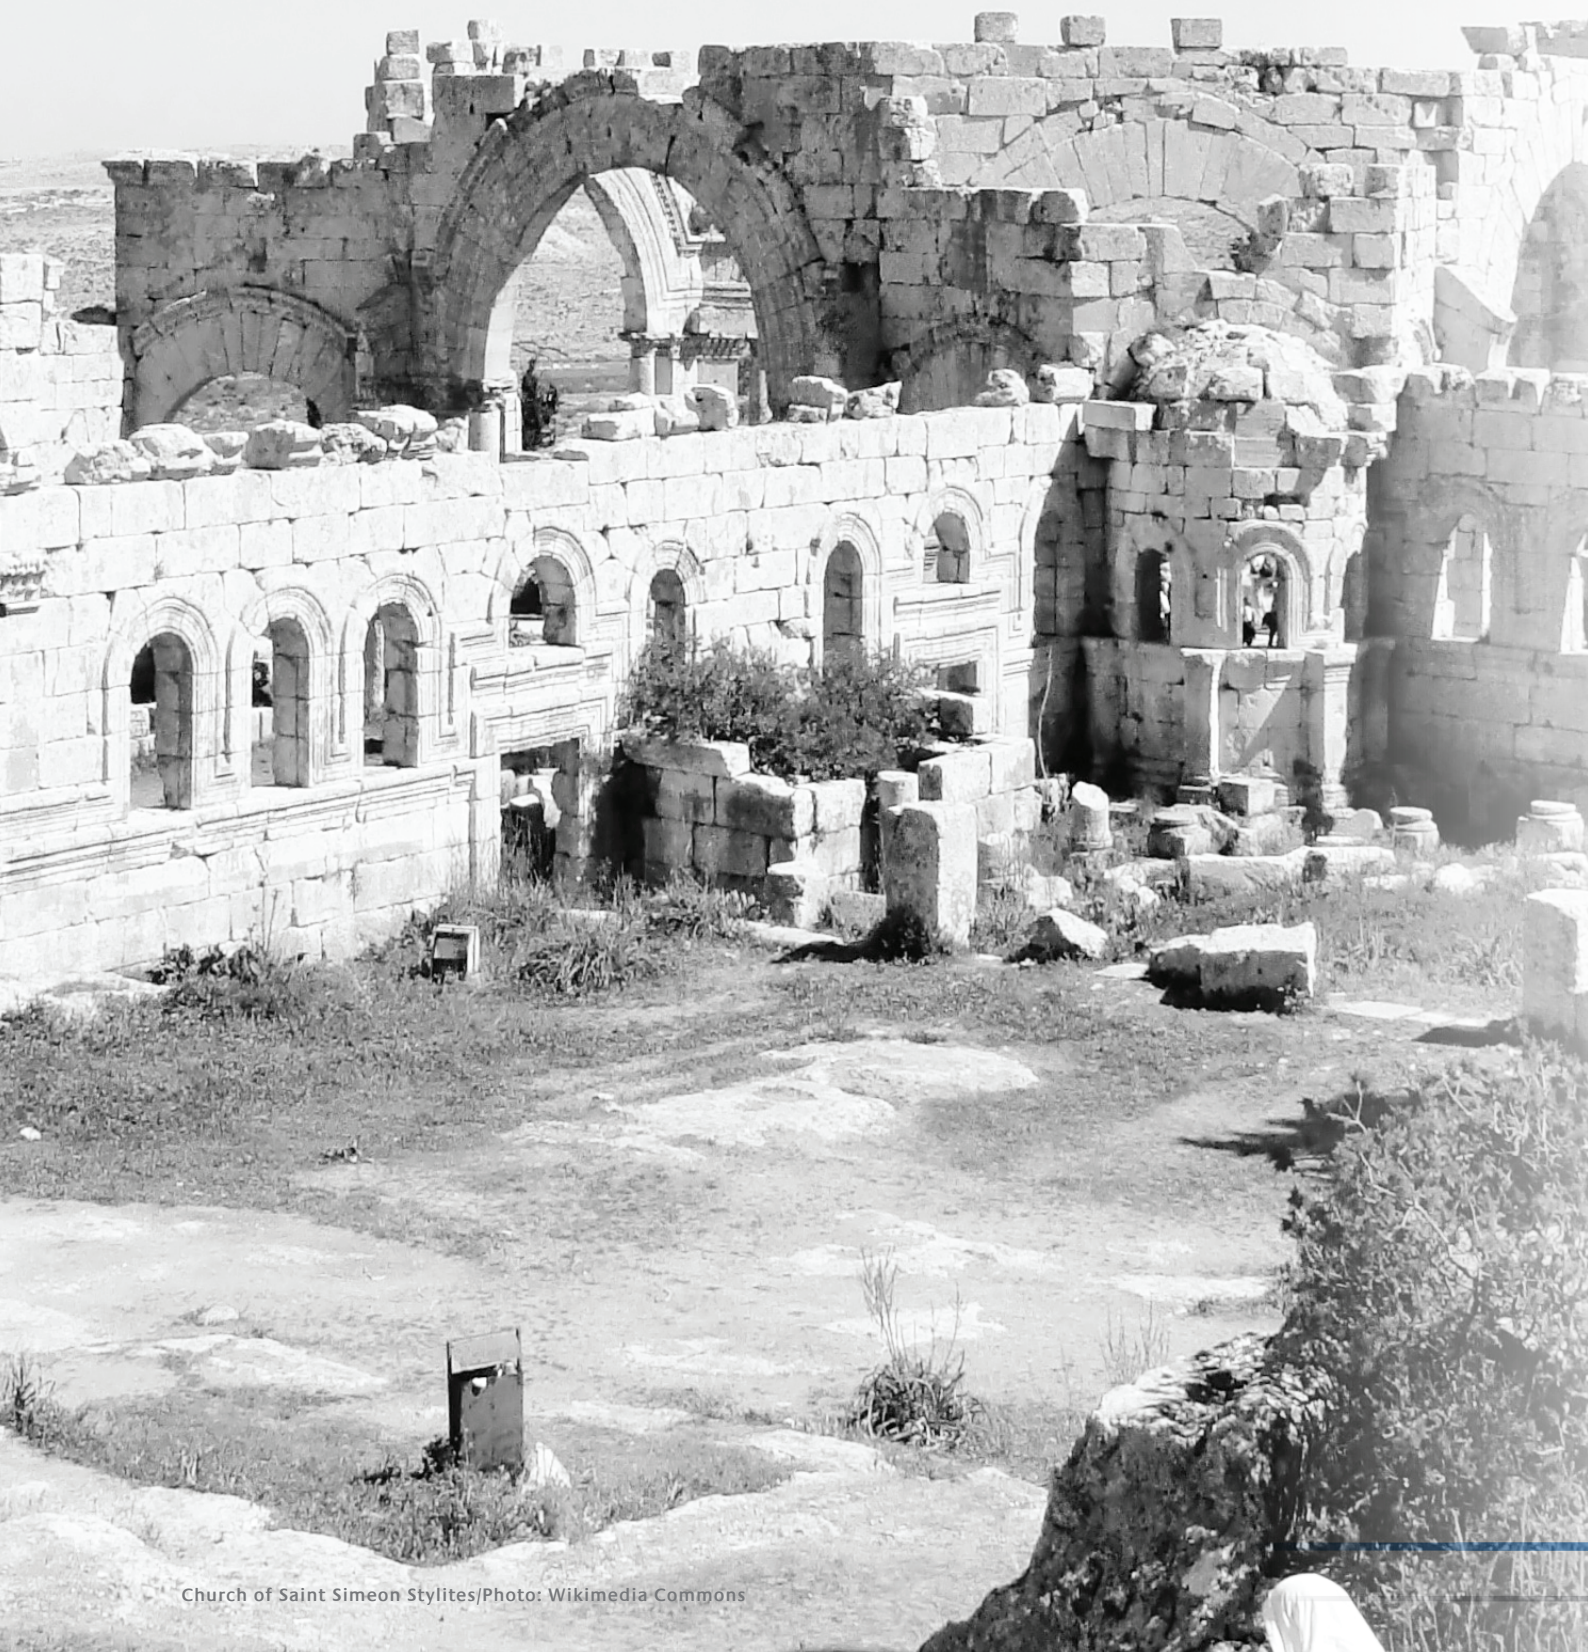
FIGURE 37. Overview of Deir Semaan and locations where damage has occurred and is visible.

A review of the satellite imagery indicates that Saint Simeon’s Basilica experienced looting by 2013. A number of distinct small holes (no more than a couple of metres wide) are visible in four locations across the site, with other potential holes visible in two more locations. No further damage is visible to the complex.

New construction and resettlement are evident or likely in all of the other Byzantine villages with the exception of Qatura, the ruins of which appear undamaged. These activities have damaged some of the ancient structures. Looting is also possible at several of the ancient villages, although it appears to be of limited extent. Stone robbing may be occurring at Sitt al-Rum, though this cannot be confirmed. These activities have also been reported in Refade,⁽ⁱⁱⁱ⁾ but it is either too limited to be visible or cannot be distinguished from the construction activities occurring (see figure 37).

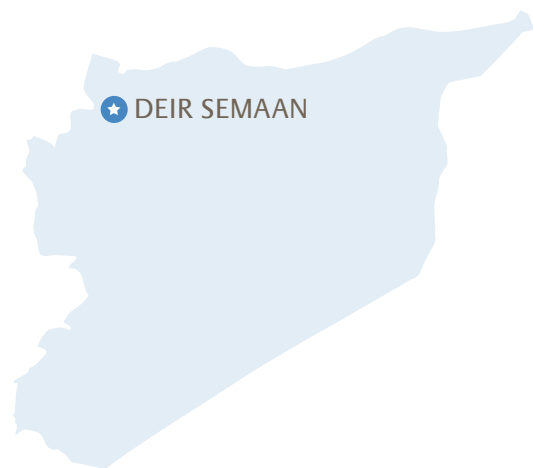
Deir Semaan Damage Level

(Number of Heritage Locations)

DEIR SEMAAN DAMAGE ASSESSMENT SUMMARY	
LOCATION NAME	DAMAGE LEVEL
Large Pandocheion	Possible damage
Pandocheion and Bazaar	Possible damage
Refade	Possible damage
St. Simeon’s Basilica & Baptistery	Moderate damage
Sheikh Suleiman	Moderate damage
Sinhar	Possible damage
Sitt al-Rum	Possible damage
Southwest Monastery	Possible damage

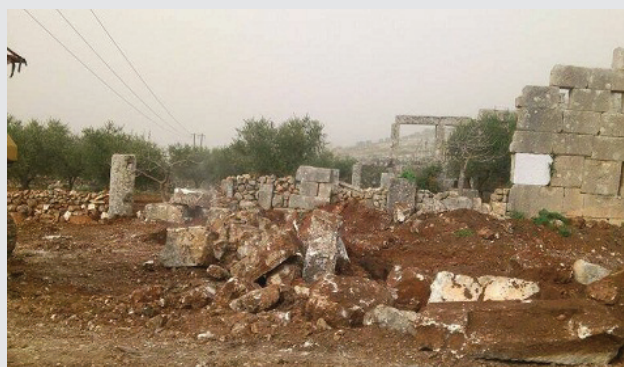
Damage to St Simeon Stylites/Photo: Directorate General of Antiquities and Museums DGAM, 2014.

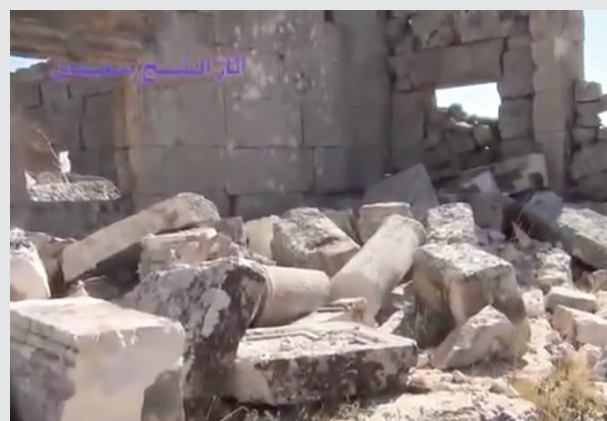
Artillery damage at Shiekh Suliman village ruins/Photo: Flash News Network.

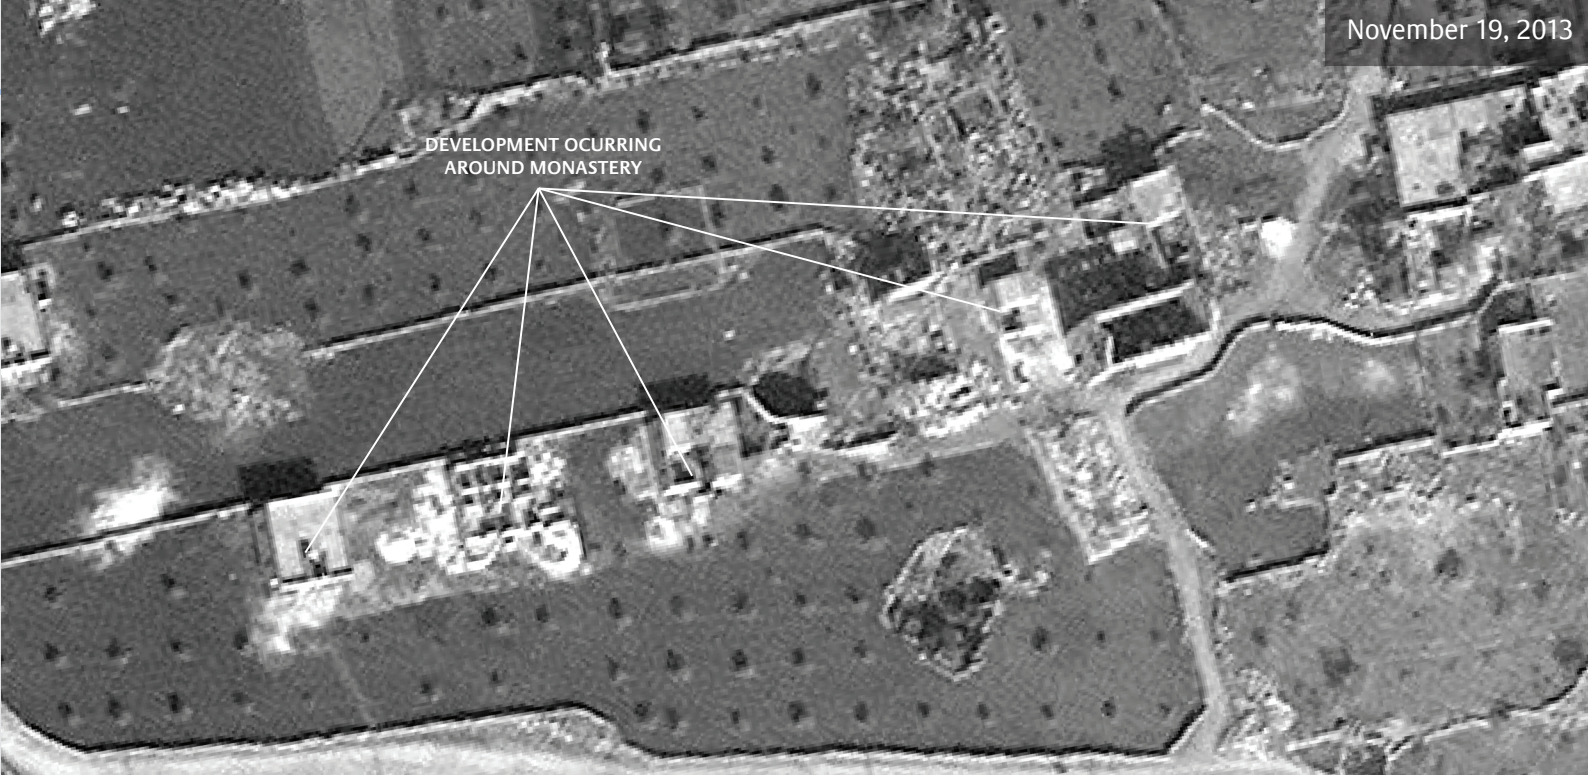
FIGURE 41. Deir Semaan (Southwest Monastery).

The 2013 satellite image appears to show damage to the southern building, the monks' accommodation. The walls are no longer clearly defined, suggesting they have sustained damage (see figure 41).
