Dura Europos (Tell al-Salilhiye) دورا أسوبورو

Deir Ez-Zor Governorate

Site Description

Status Overview

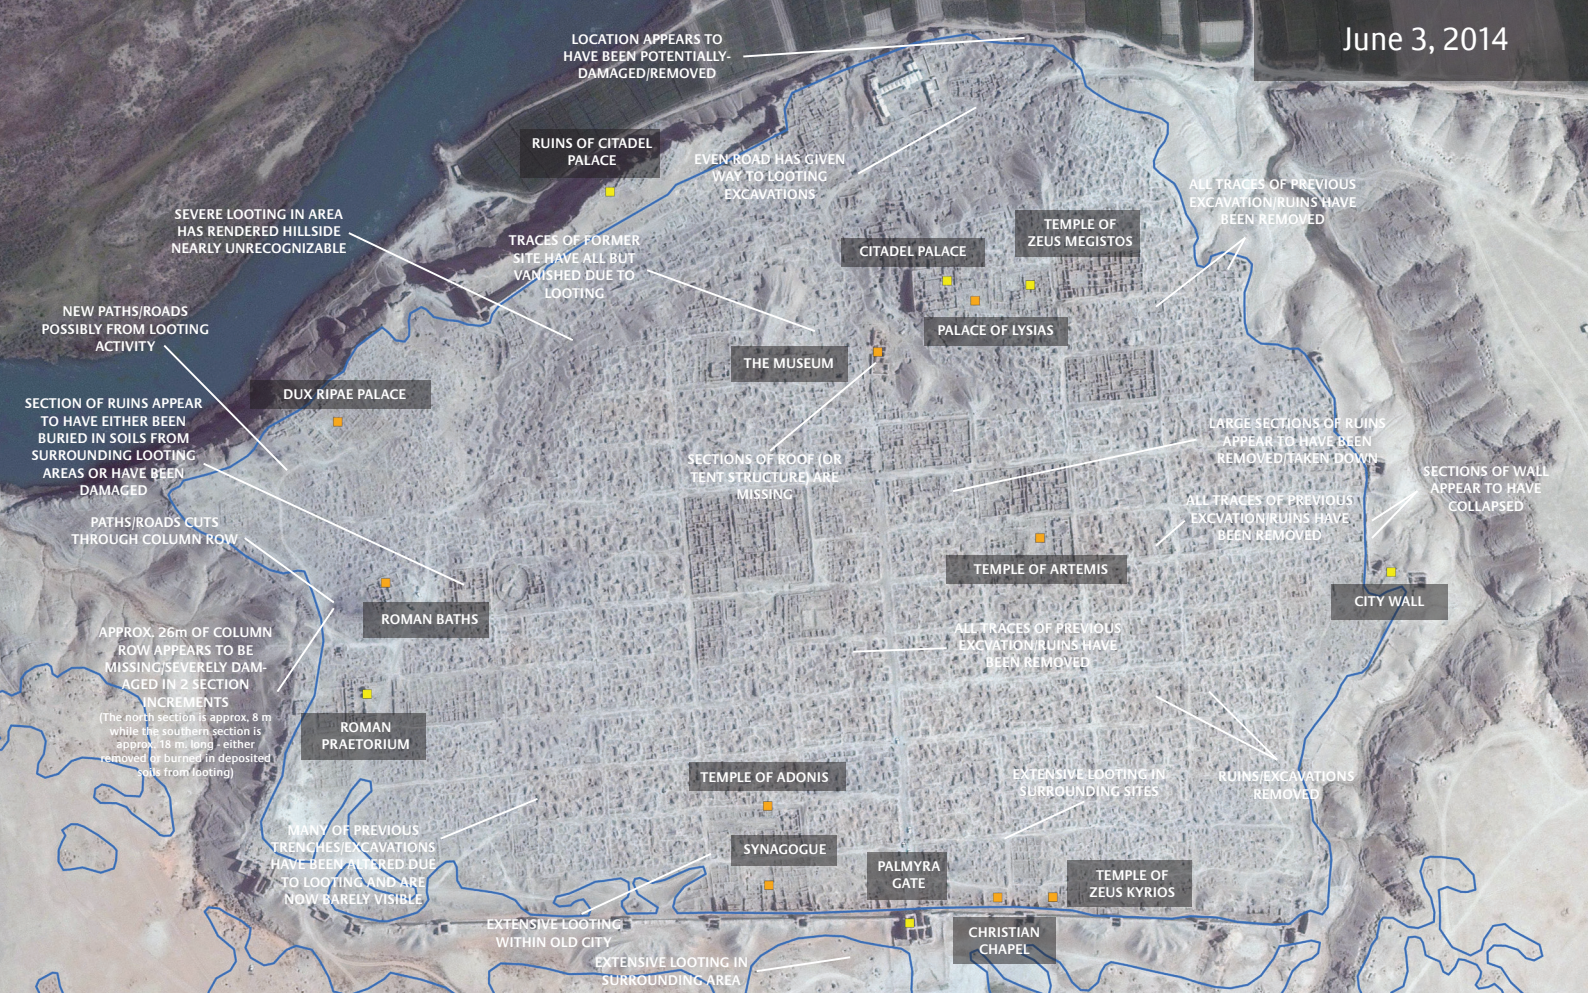
FIGURE 43. This image shows the damage in the area of the Palace of the Strategion/Old Citadel. Some ruins are completely removed and there are many looting holes around and inside the buildings. The looting holes have even removed the track. There is evidence of earth-moving machinery being used to excavate some areas (see Citadel Palace section). The damage to the museum is also visible (see The Museum section); one room has collapsed and most of the roof has been removed.

The building has been severely damaged; most of the roof has been removed with the possible exception of one room, and the walls of one room that joins the two sections of the building have collapsed.

Looting is still visible here, as indicated by numerous holes surrounding and within the site, but the walls appear to be intact. There are no signs of collapse at the northern end, despite the fact that the stabilisation (see description) has not been maintained.^(viii) However, the path leading up to the citadel is no longer visible and large sections of it have been removed. The extent of one area removed from the path (621 m²) suggests earth-moving machinery may have been used.

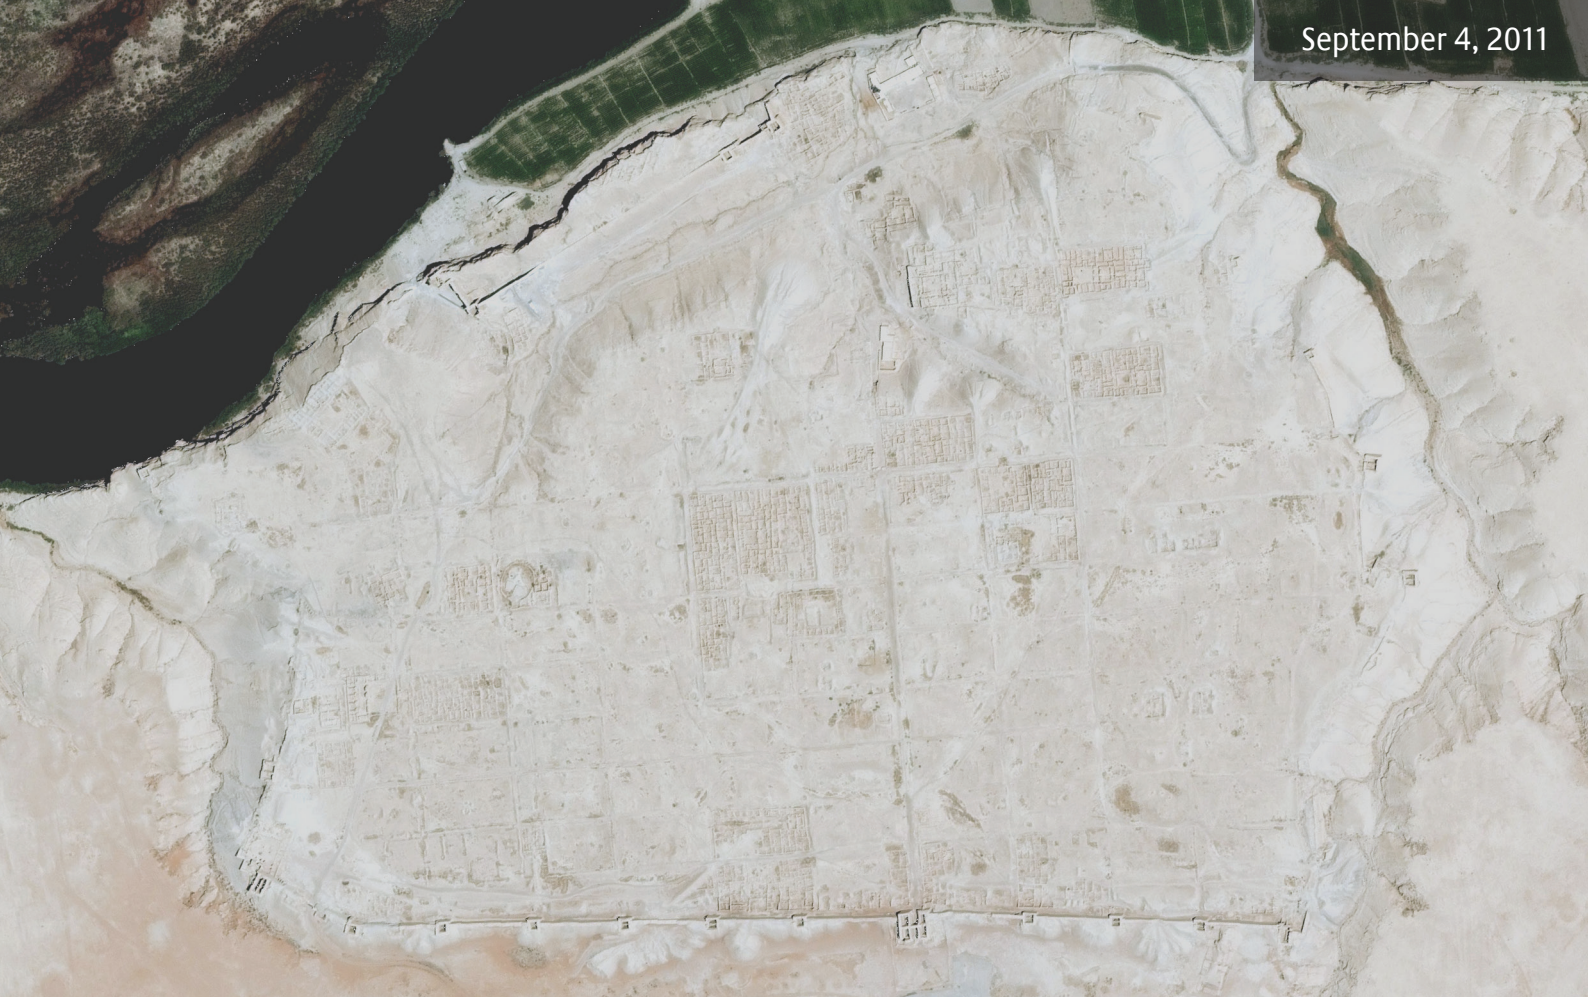
FIGURE 44. This image shows the area of the Palace of the Strategos/Old Citadel and the museum before extensive damage occurred.

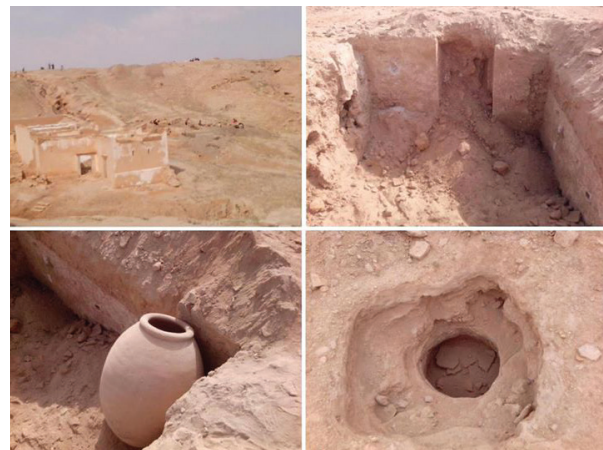
This image shows illegal excavations at Dura Europos/
Photo: Endangered Antiquities of Syria.

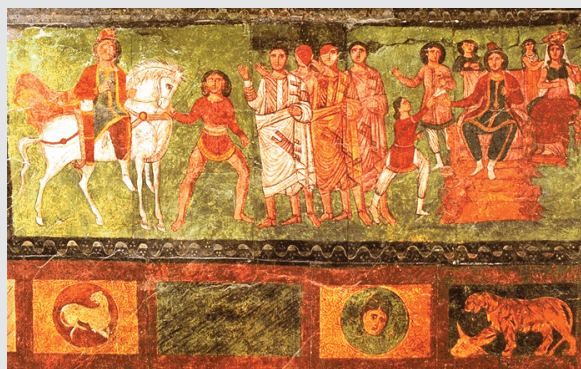
SYNAGOGUE

Part of the fresco at the Dura-Europos synagogue. This image illustrates a scene from the Book of Esther/
Photo: Wikimedia Commons.

A large number of looting holes are visible on the imagery, both around and within the building, and are causing severe damage to it. However, the walls are still visible, so the synagogue has not been completely destroyed.

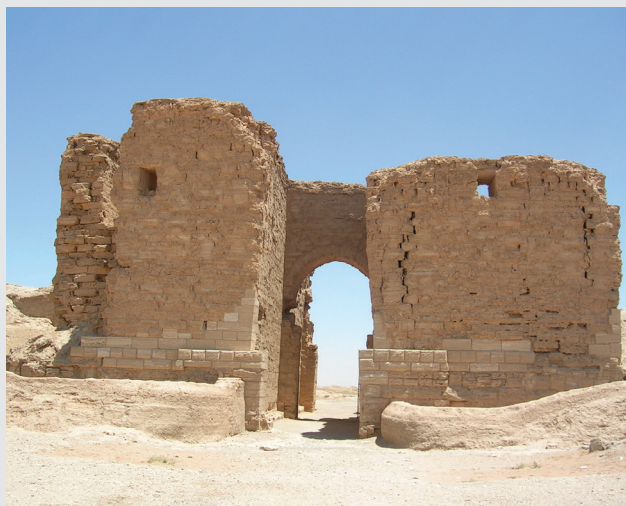
Imagery indicates that, while the structure of the main bastion is clear, the small reconstructed walls at the front are no longer present or are heavily disturbed, as are the outer walls around the gate. The presence of vehicles inside the site, just beyond the gate, suggests that it is being used as a vehicular entrance, which may have caused further damage.

Image of the Palmyra Gate/Photo: Emma Cunliffe.
