Ebla (Tell Mardikh) إيبلا

Idlib Governorate

This report provides a detailed analysis of significant changes to the cultural heritage of this site resulting from the ongoing conflict in Syria. World View 1 and 2 satellite imagery acquired on 16 December 2008 and 04 August 2014 was used for this report.

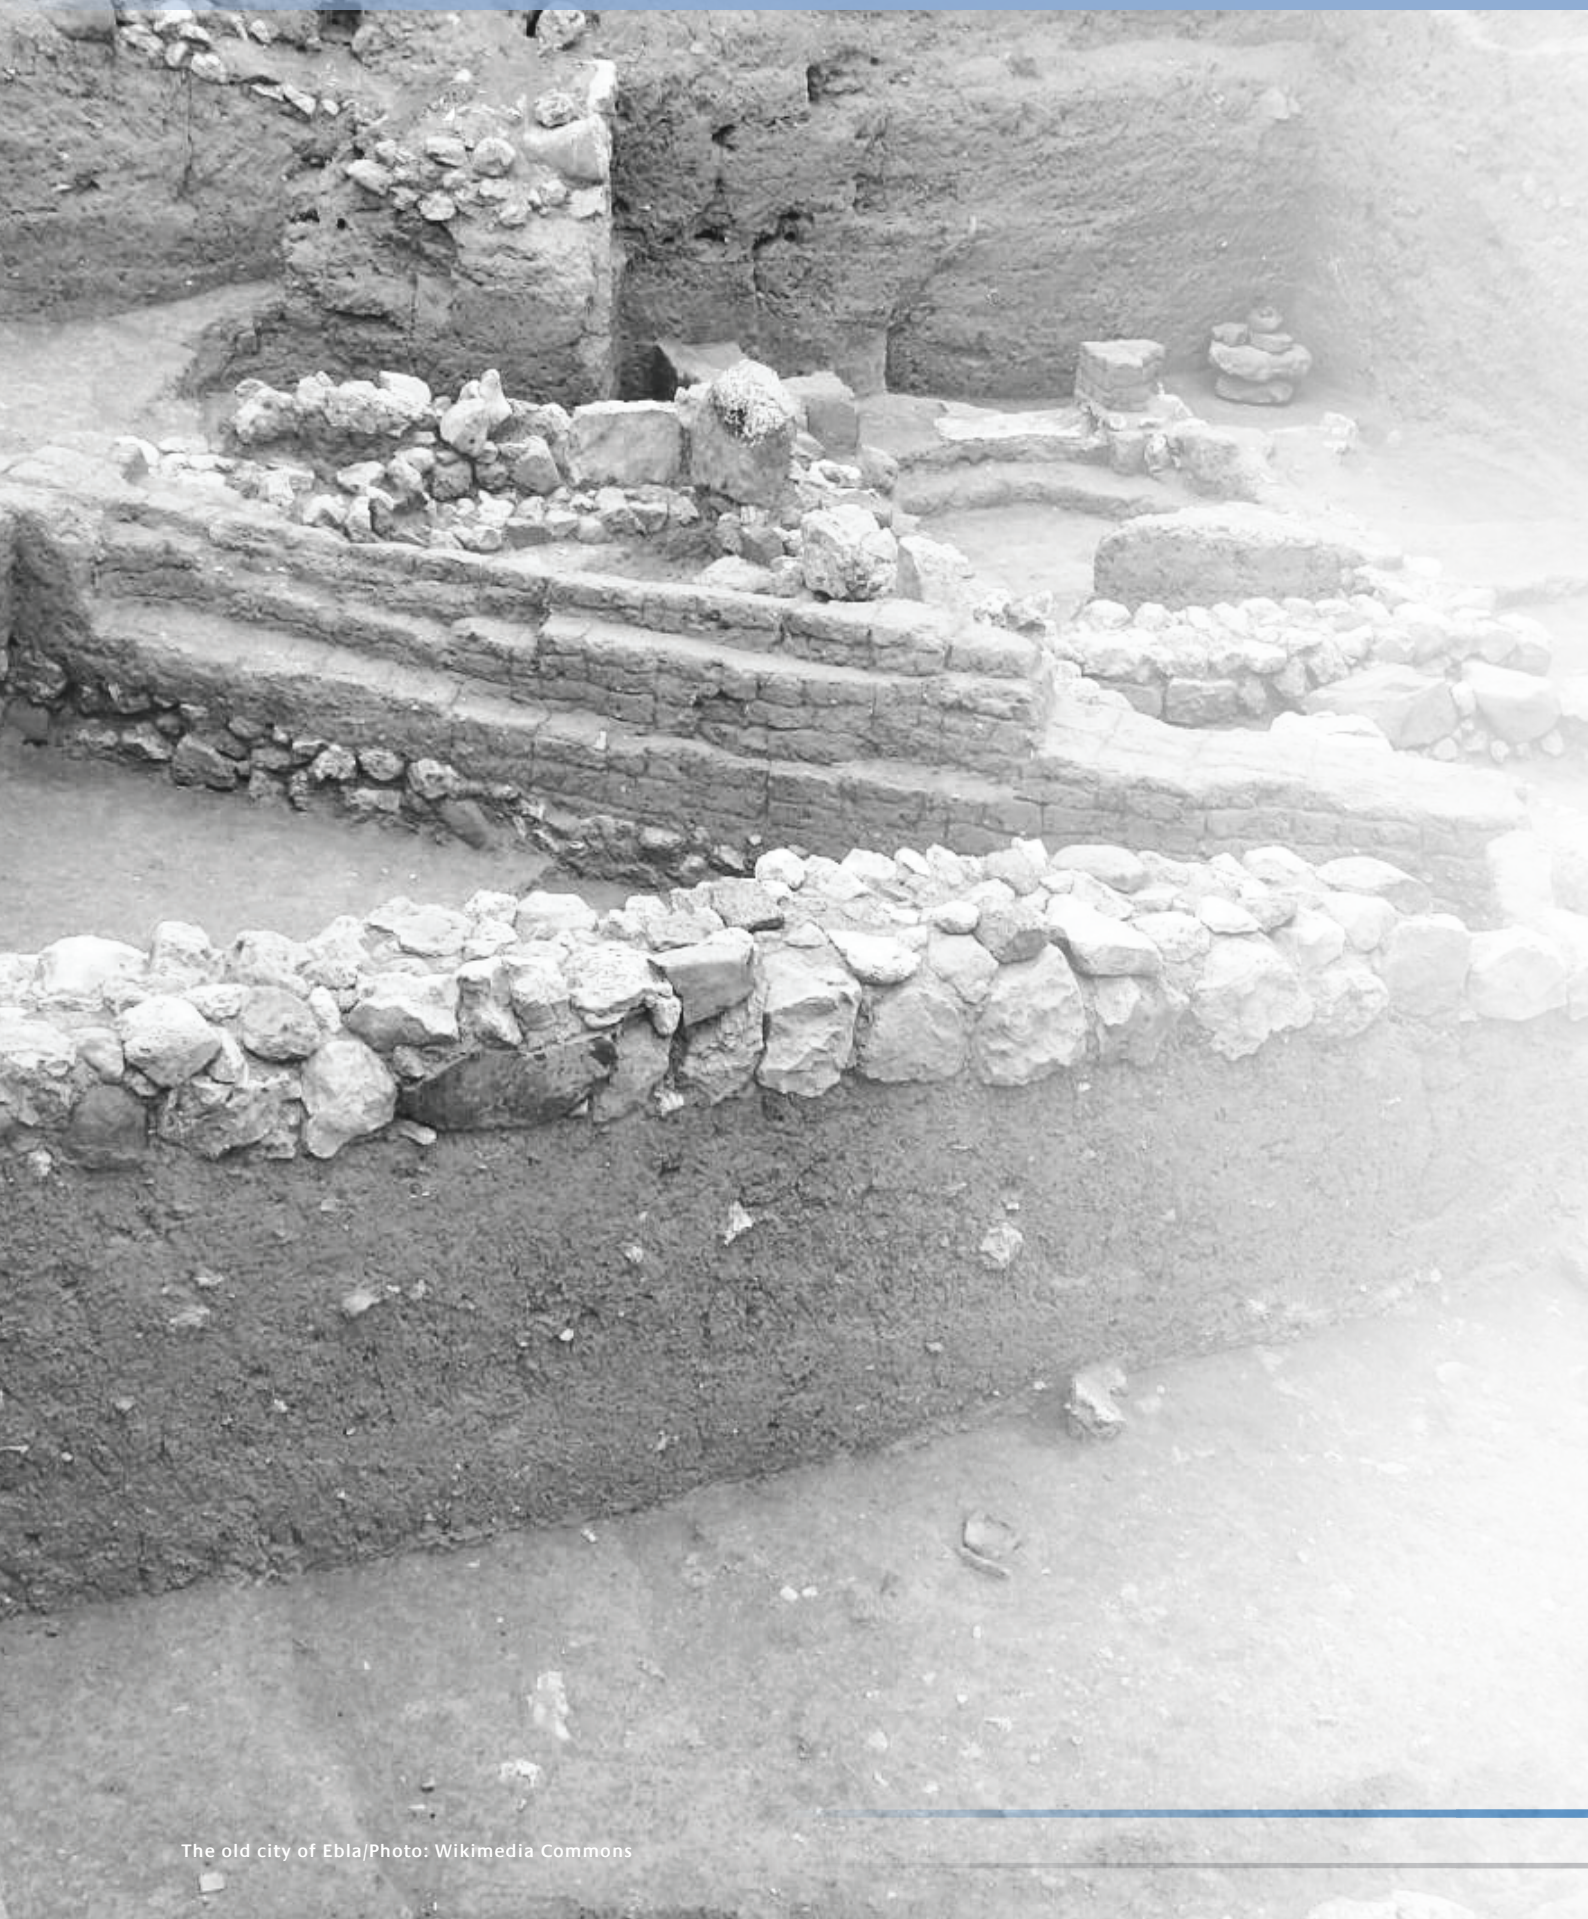
FIGURE 45. The Acropolis: The clarity of many of the excavated structures has significantly degraded, indicating heavy damage. Area F appears to have been removed and looting holes are visible in some structures. Areas R and CC have been infilled. Note the irregular edge of all the excavated structures within the acropolis; the excavated area has been illegally extended, causing heavy damage.

All of the legitimately excavated areas are heavily disturbed.^(iv) Most of the excavations have been extended, possibly with heavy, earth-moving machinery, and the clarity of many of the excavated buildings has significantly degraded between the acquisition of the two images (December 2008 and August 2014). This suggests they have been severely damaged or destroyed, or have been covered, perhaps with spoil from the illegitimate excavations. While in some cases, spoil seems likely, in many cases the level of soil disturbance suggests the walls have been destroyed. One report^(v) indicated that looters were digging under the walls in the Acropolis in order to reach unexplored levels, which would cause extensive damage to the walls as seen on the August 2014 imagery. In addition, a number of small looting holes are visible across the site, both within and outside excavated structures.

According to a report,^(vi) the looters search for artefacts they can sell by tunnelling into the site, but also come to the site to haul away carloads of dirt from inside the tunnels as it is ideal for making the ceramic liner for bread-baking ovens. If true, this could explain why so little spoil is visible in the excavations. Those occupying the mound “...say they also try to protect Ebla from full-on looting by thieves who want to sort through the place with earth-moving equipment” (Chivers, April 2013), suggesting heavy machinery had not been used on the site at this point. Unfortunately, later reports^(vii) recorded its use on the site—use of heavy machinery causes significantly more damage than other forms of digging. A large number of the expanded illegal excavations visible on the August 2014 imagery, particularly around the Acropolis, are substantial enough that the use of heavy machinery is a distinct possibility (see figures 45 and 46).

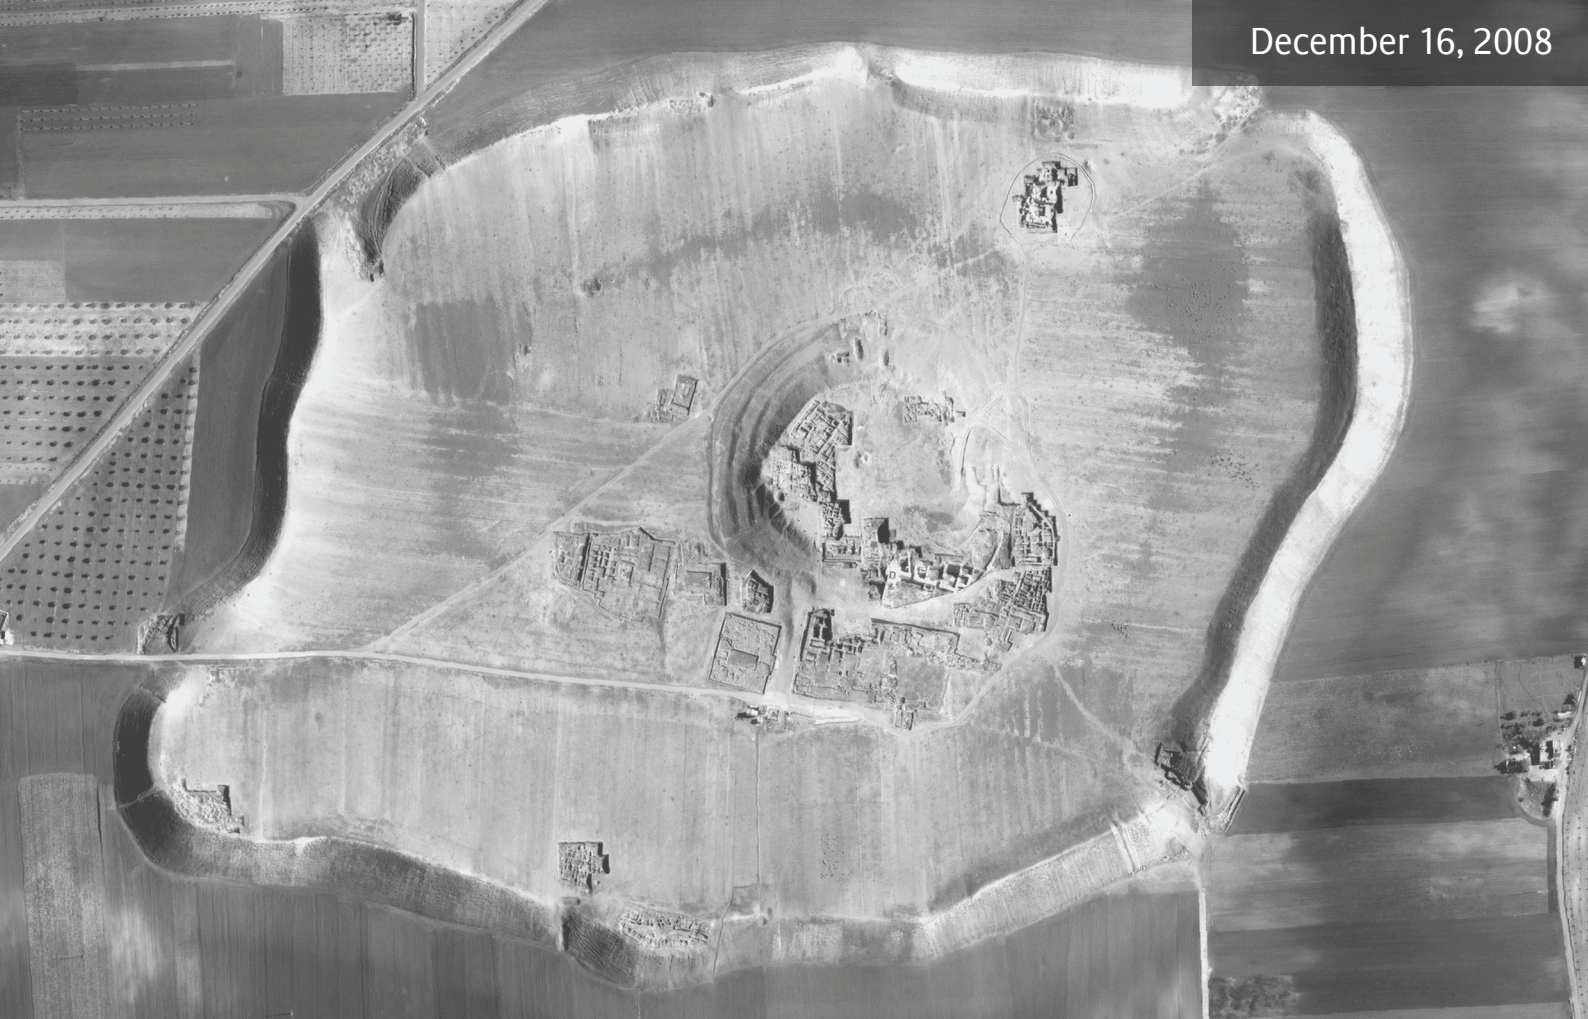
FIGURE 46. The Acropolis before damage.

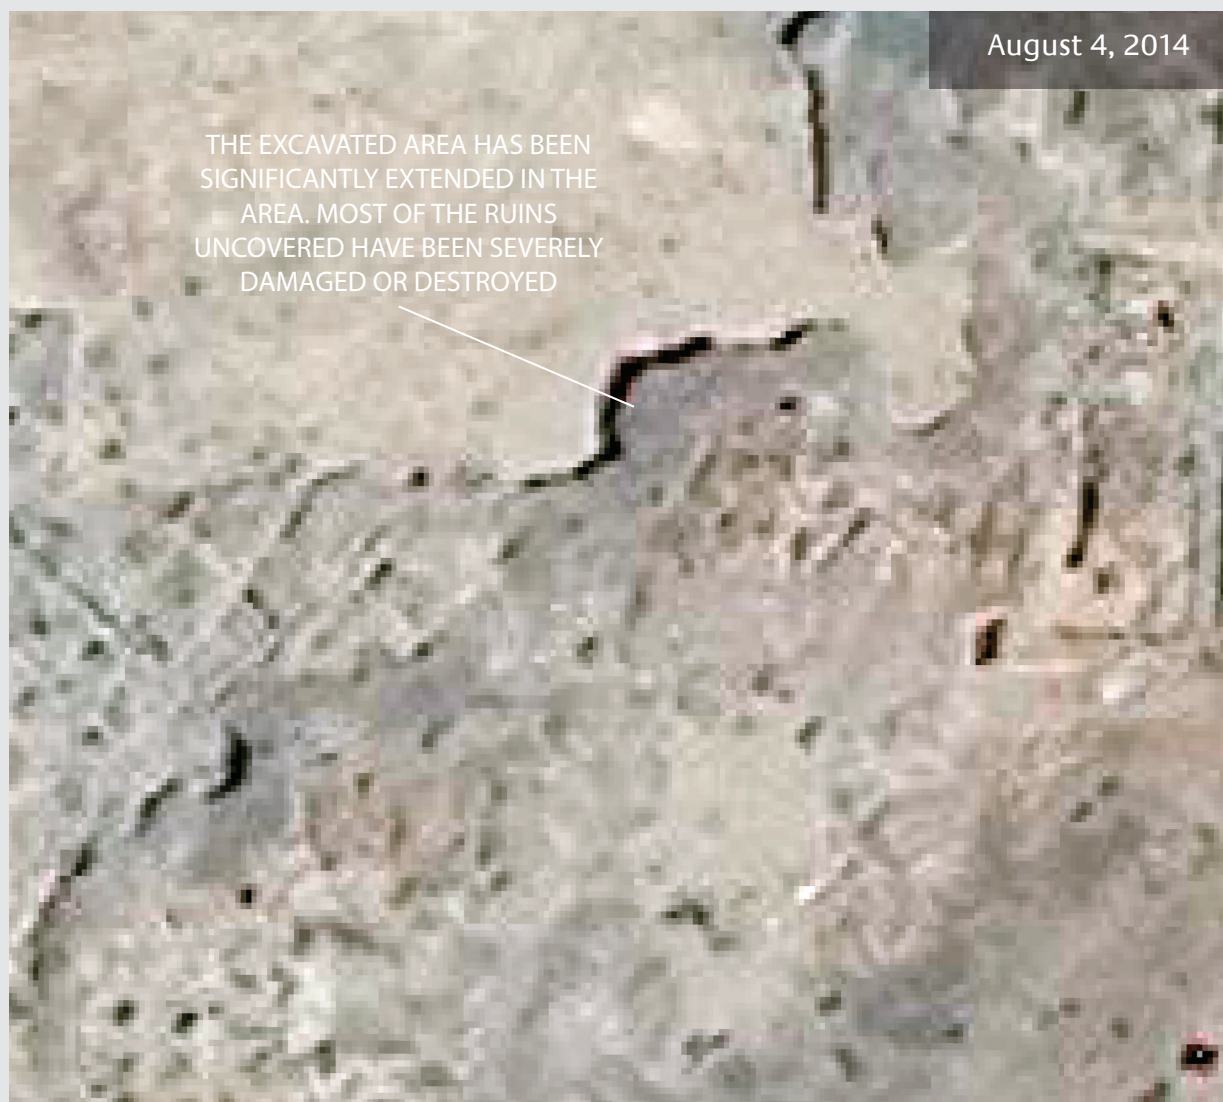
FIGURE 47. The excavated area has been significantly extended. Most of the uncovered ruins have been severely damaged or destroyed.

This area of Ebla has been heavily damaged. A comparison of the satellite imagery from December 2008 and August 2014 indicates that only the faintest traces remain of legitimately excavated features in this area. Furthermore, substantial parts of the acropolis around this area and extending south have been dug up, most likely with heavy machinery (see figures 47 and 48).

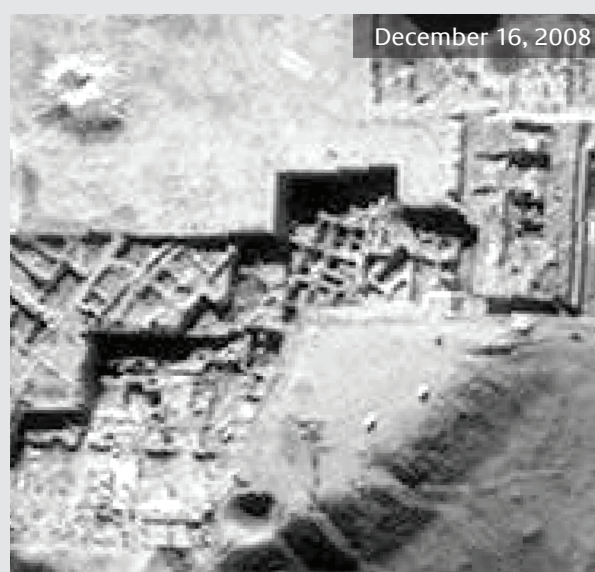
FIGURE 48. Area F before damage.
