Kirkbizeh رقبی قزه

Idlib Governorate

FIGURE 49. Overview of Kirkbizeh and locations where damage has occurred and is visible.

KIRKBIZEH OVERVIEW MAP

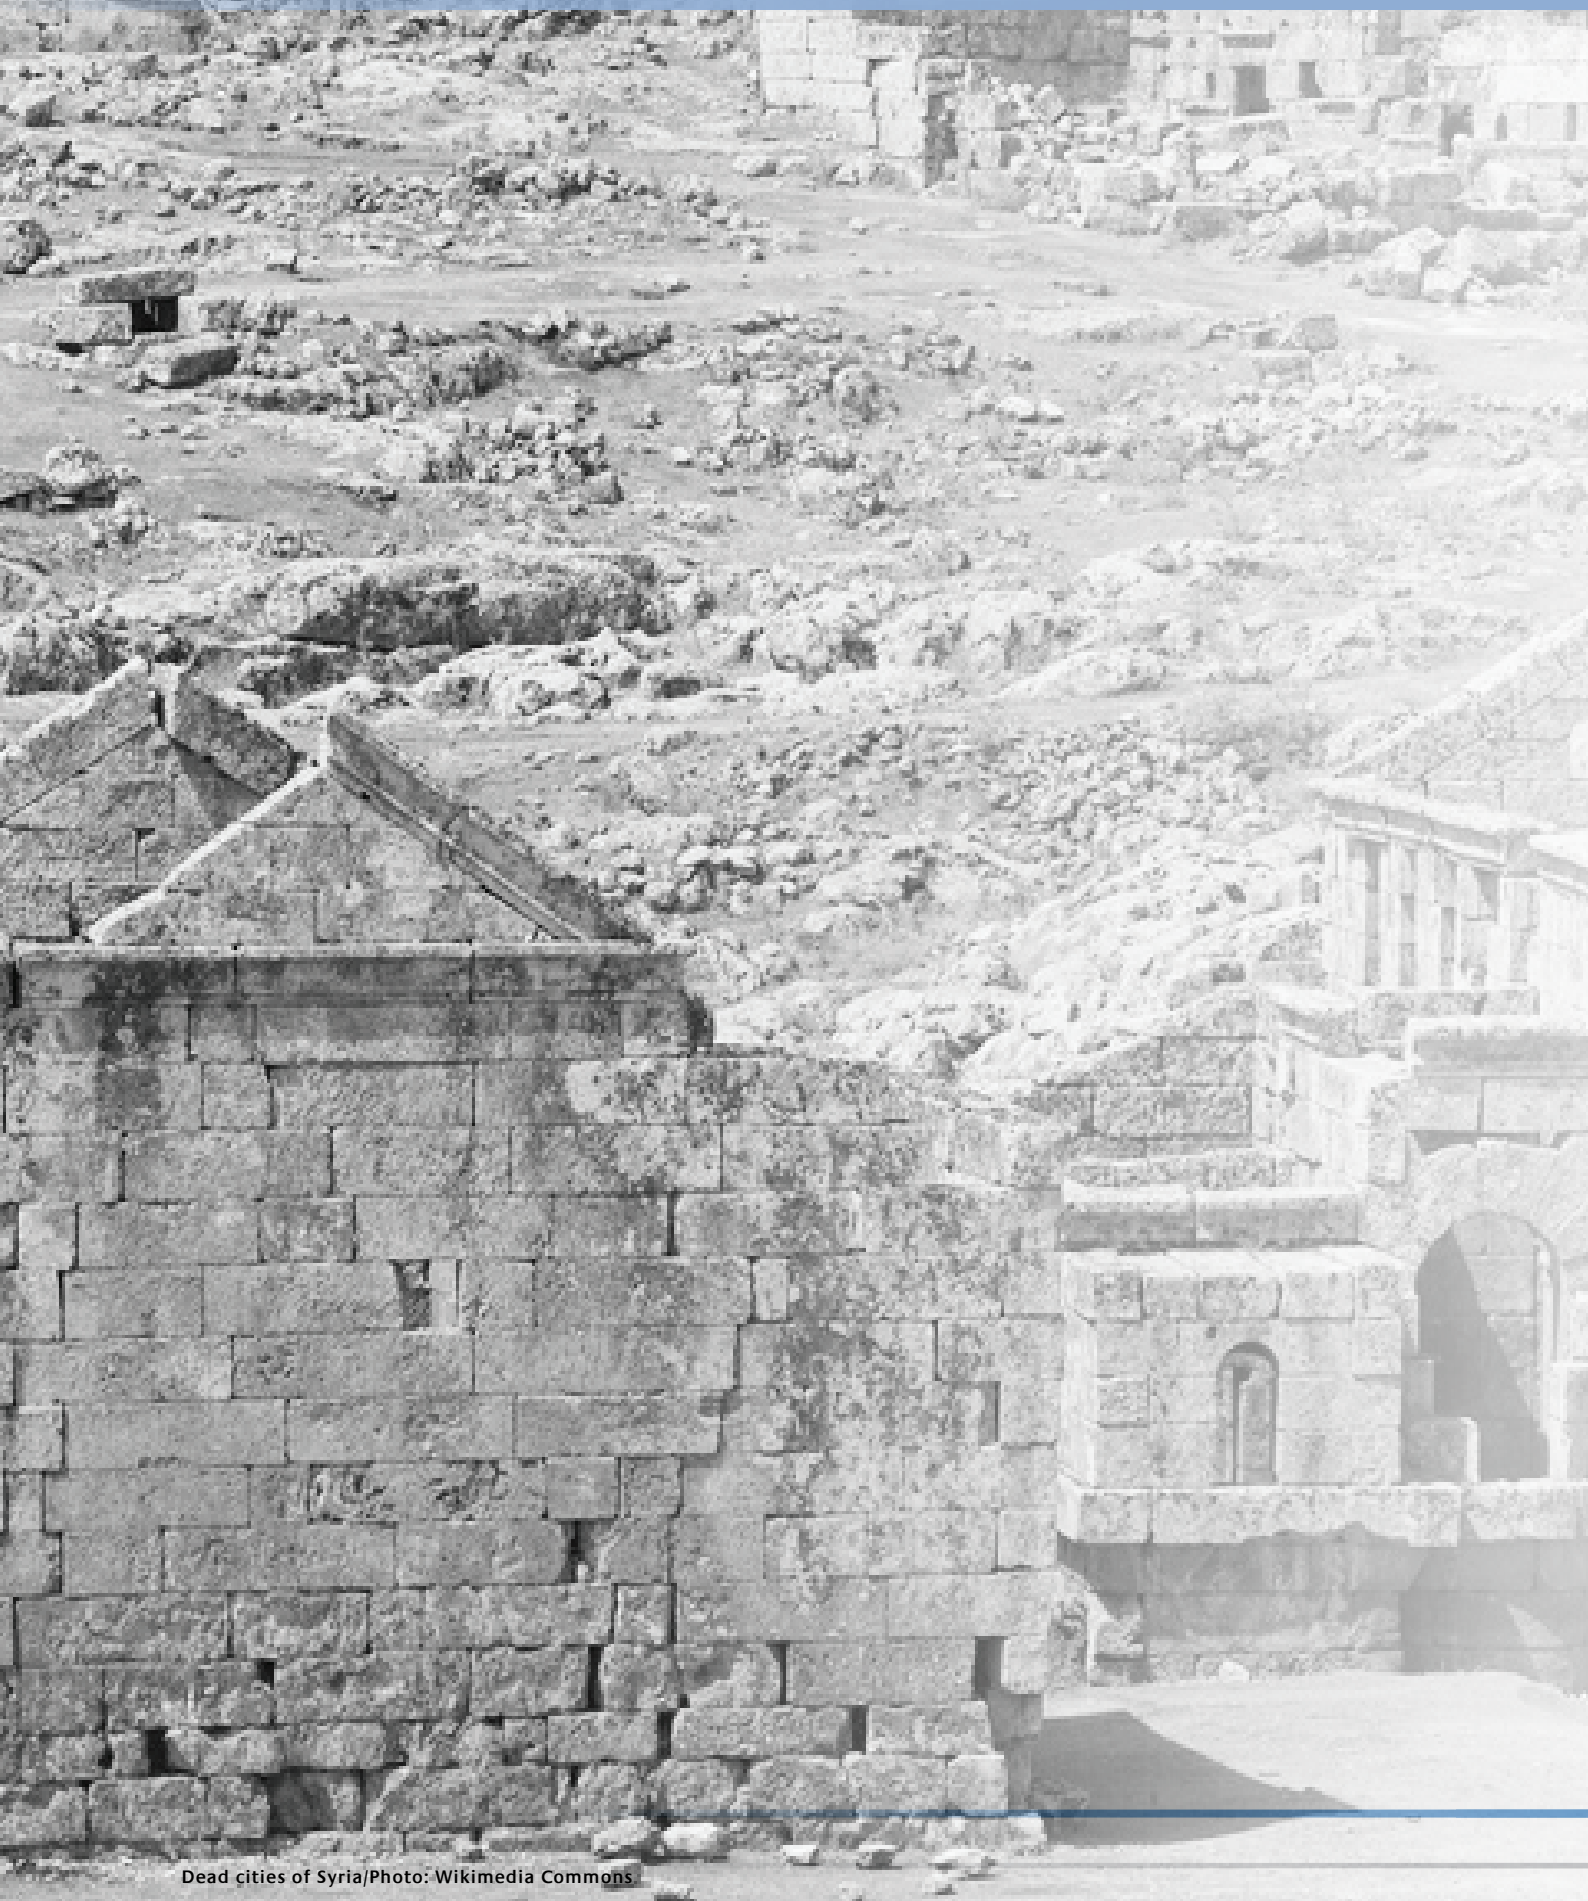
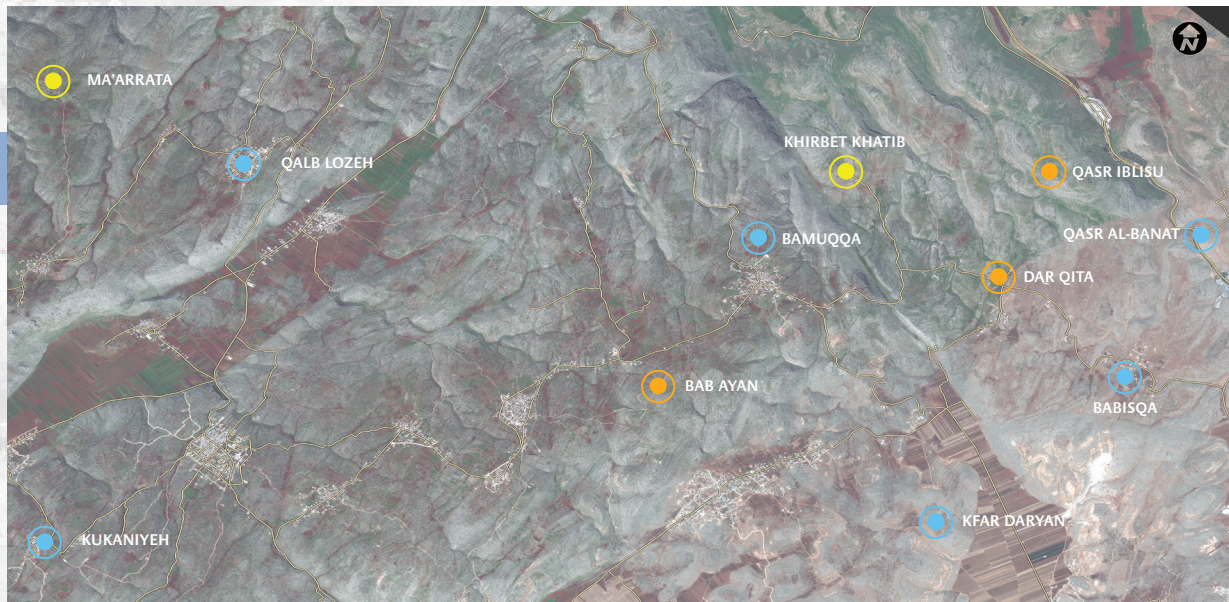
The Dead Cities/Ancient Villages examined on satellite imagery (see figure 49) are at severe risk of damage from construction. Of the 31 sites examined, there are new constructions (buildings and roads) on or around eight of them. While some of the construction appears to be avoiding the obvious features of the site, there are two cases where sites have been severely damaged. One has been moderately damaged as large areas of the ruins have been cleared. In addition, the ruins are more than a thousand years old and considerably fragile—the vibrations caused by heavy construction equipment can be extremely damaging, and the chemicals used in construction can be extremely damaging to archaeological soils. No evidence of looting was visible at the sites, but possible stone robbing/stone clearance was noted at one site.

The overview map (figure 47) show the damage level of the different heritage sites analysed in the vicinity of Kirkbizeh. Analysis with satellite imagery found three severely damaged sites, two moderately damaged and six with possible damage.

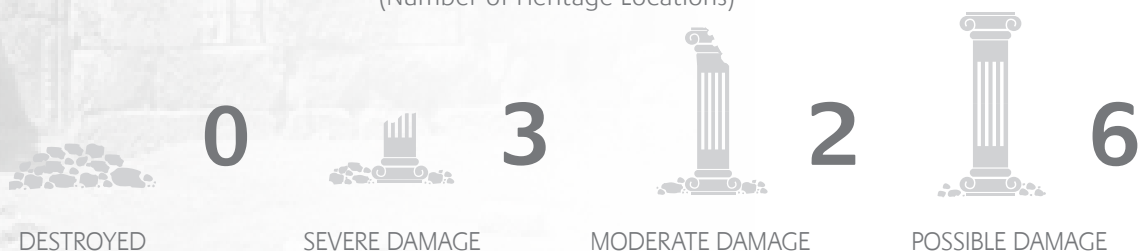
Kirkbizeh Damage Level

(Number of Heritage Locations)

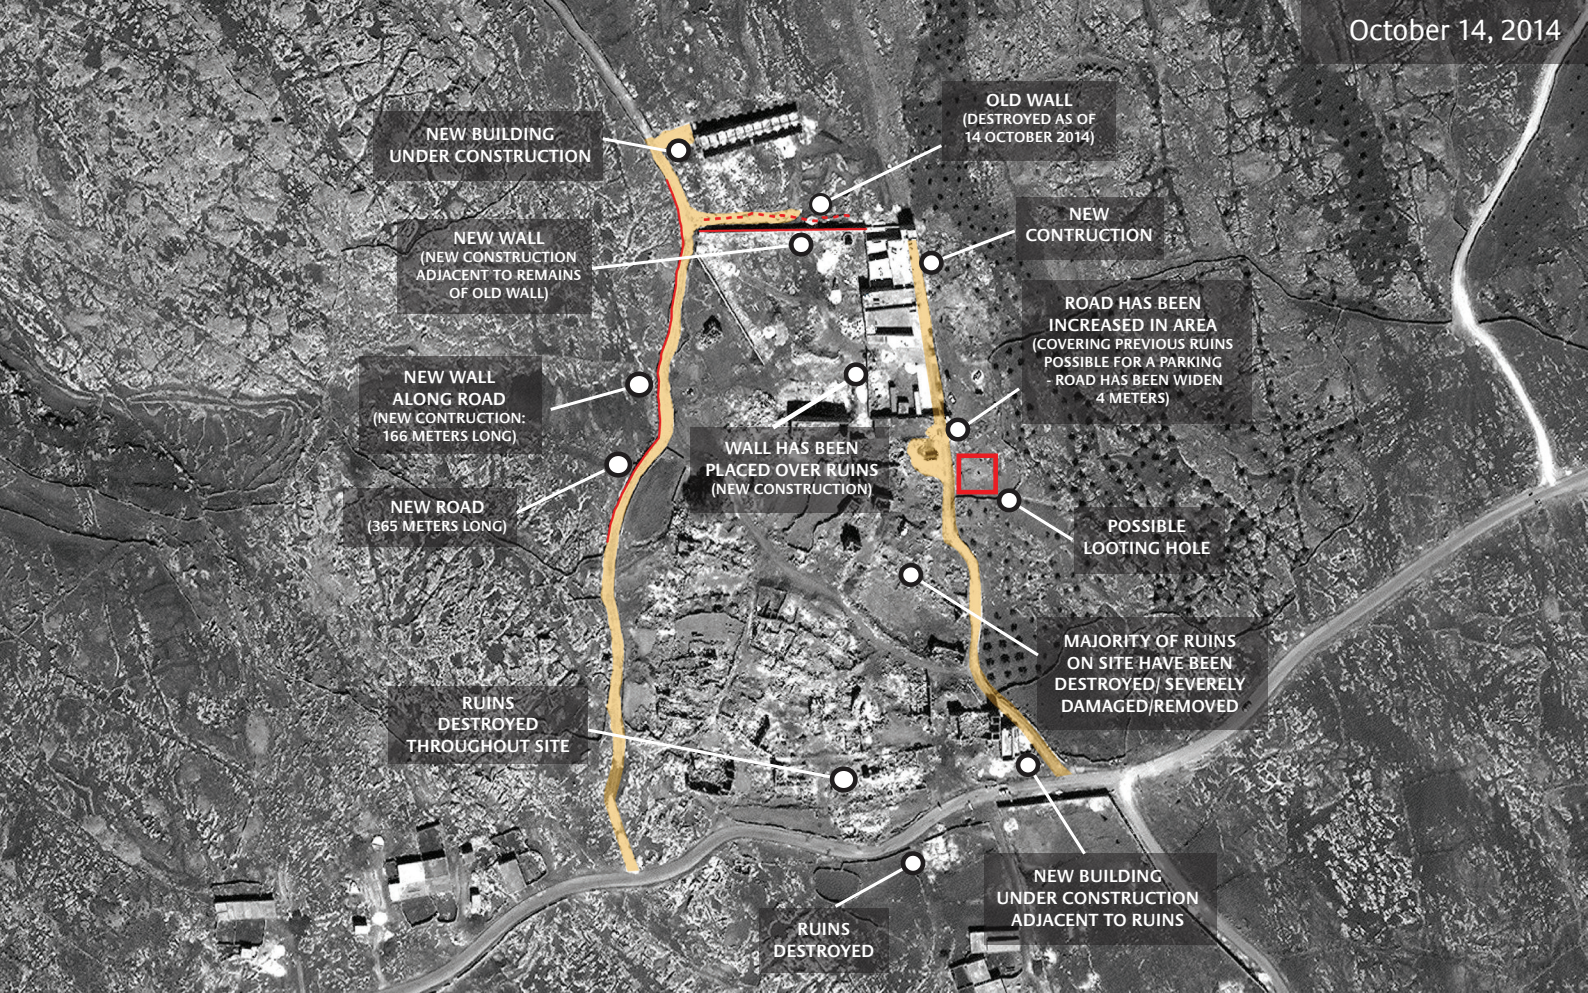
FIGURE 50. Extensive damage to Dar Qita, including road widening, new buildings, the building of stone or concrete walls and earth walls over the ruins, as well as the removal of much of the site.

A review of imagery confirms that most of the ruins on the site have been destroyed or severely damaged (see figures 50 and 51). The development in the northeast corner of the site has been rebuilt and substantially increased in size, destroying some original walls and potentially disturbing archaeological levels. The eastern road to the building has been widened by approximately 4 m, covering some ruins. The southern-most ruins (an area of approximately 3,000 m²) have been cleared to increase farmland, and the farm next to them has also been enlarged. No cause of damage can be identified for the rest. In addition, a wall had been added to the western road, which has also been lengthened. There is no evidence of looting, though it has been reported.⁽ⁱ⁾

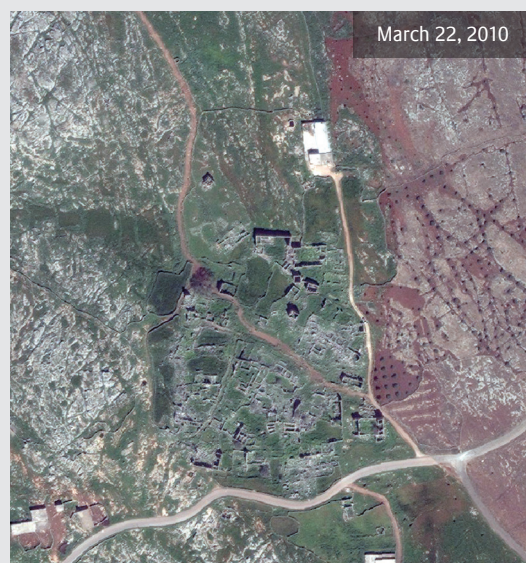
FIGURE 51. Image of Dar Qita before damage.

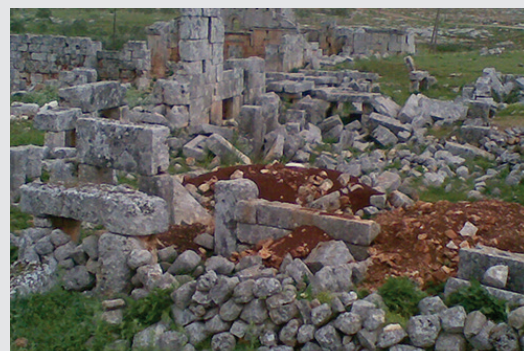
Excavation at Dar Qita/Photo: DGAM, 2013.

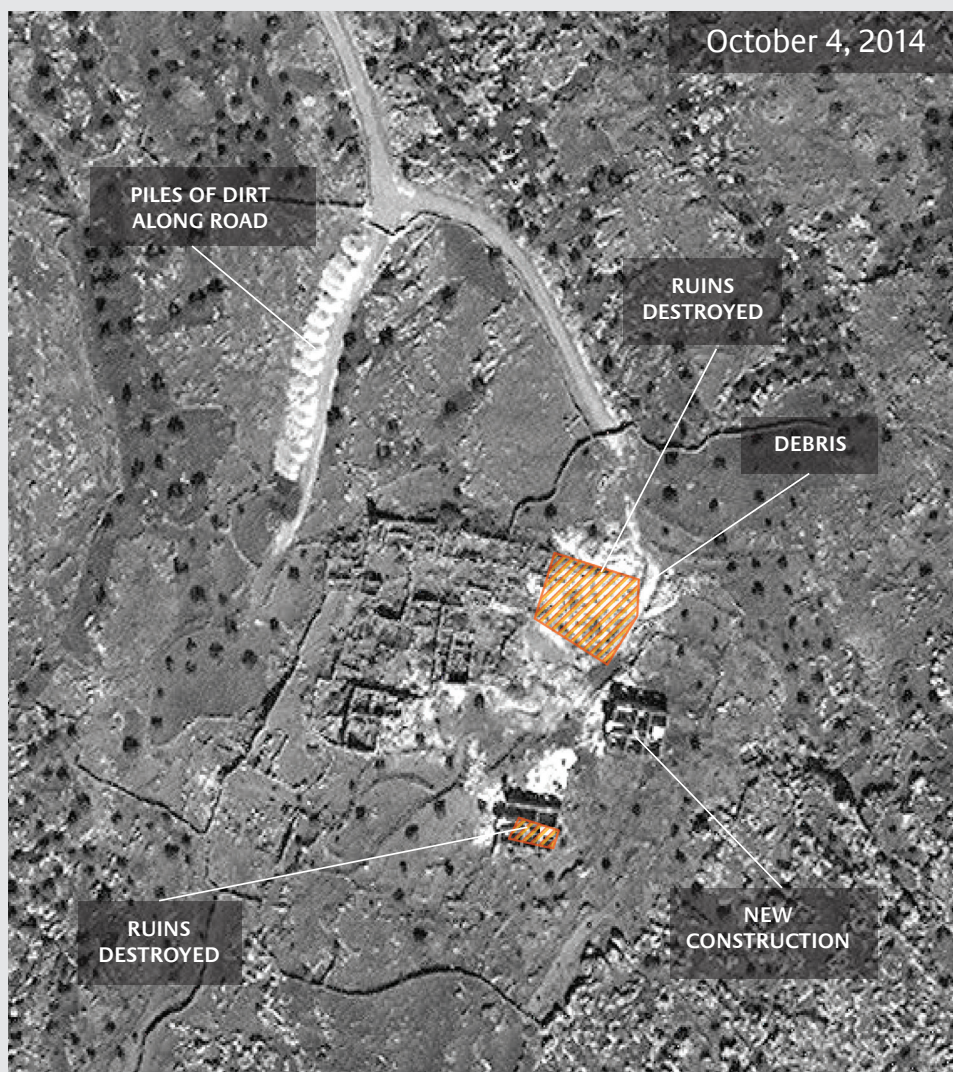
FIGURE 52. Bab Aynan.

There are two new constructions to the south and east of the village, in addition to a number of new constructions on the road leading to the site. An area (approximately 2,000 m²) of the eastern ruins has been cleared, destroying them. Soil has also been piled up along the western branch of the road that leads to the site (see figures 52 and 53).

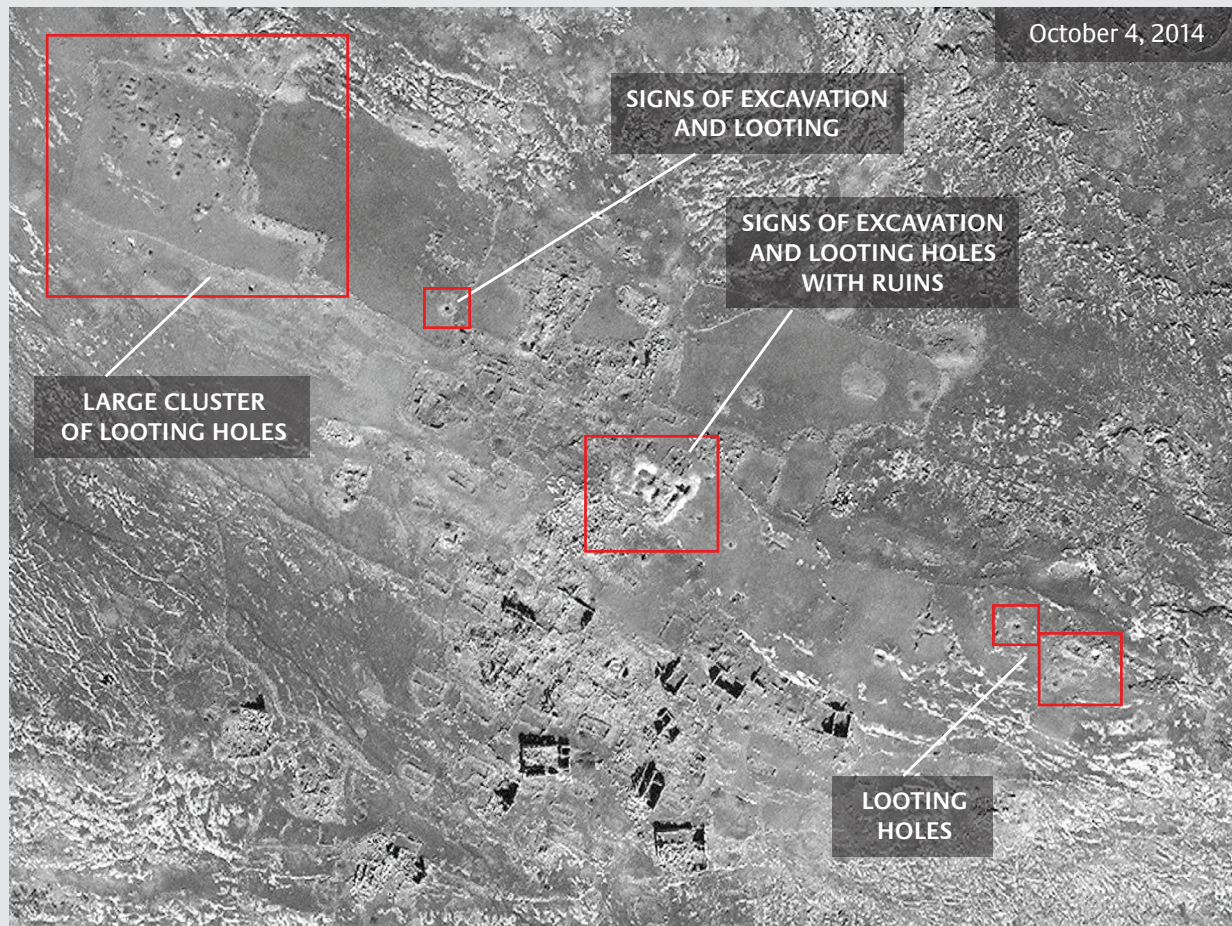
FIGURE 54. Qasr Iblisu.

A review of the imagery shows extensive looting within and around the ruins. Imagery also indicates a heavy concentration of looting occurring to the northwest section of the ruins (approximately 1,000 m²). There are also signs of illegal excavations within the ruins which may likely be related to looting activities. An additional smaller number of looting holes are apparent to the northeast section of the ruins (see figures 54 and 55).

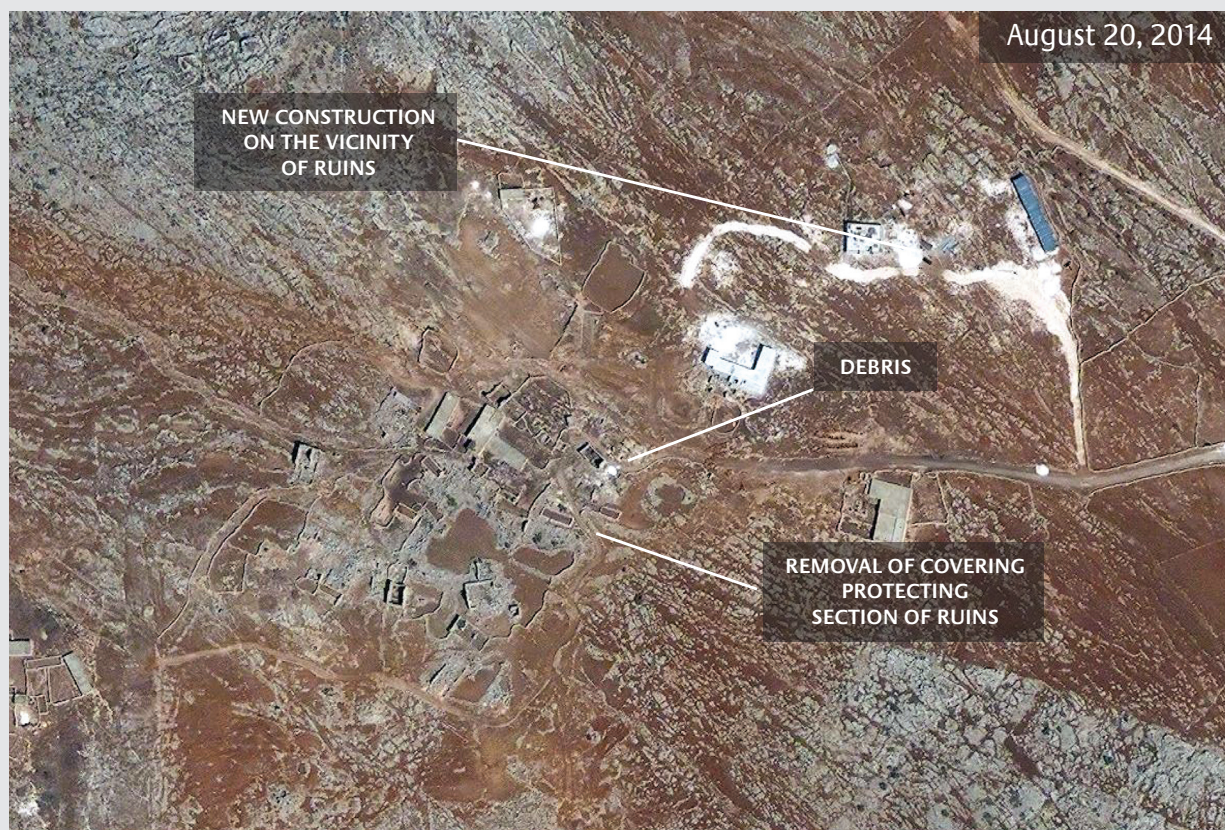
FIGURE 56. Khirbet al-Khatib.

A review of the imagery indicates not only increased construction near the site, but also on it. At least one of the farms at the site has expanded; the roof over one structure, possibly historic, is gone; another has been roofed suggesting it has been re-inhabited. There are a small number of new rectangular enclosures on the site; stone clearing/robbing appears to be occurring (see figures 56 and 57).

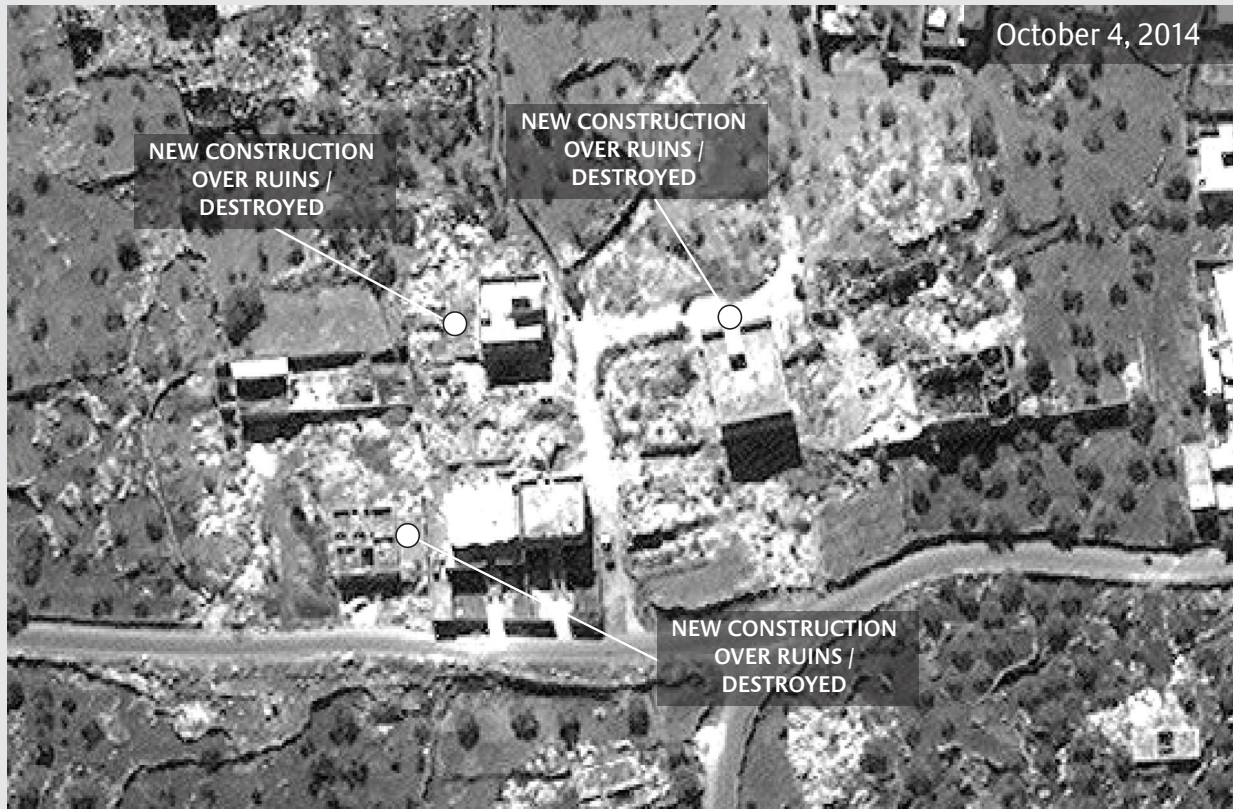
FIGURE 58. Kukaniyed.

Multiple new structures have been erected over the ruins with signs of more being constructed (see figures 58 and 59). The construction activities may have damaged or destroyed the ruins in this area, however such damage cannot be confirmed on the imagery.

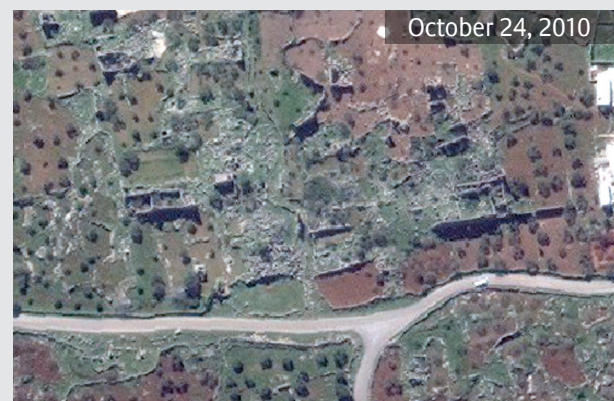
FIGURE 59. Kukaniyed.

Multiple new structures have been erected over the ruins with signs of more being constructed. The construction activities may have damaged or destroyed the ruins in the area; however, such damage cannot be confirmed on the imagery.

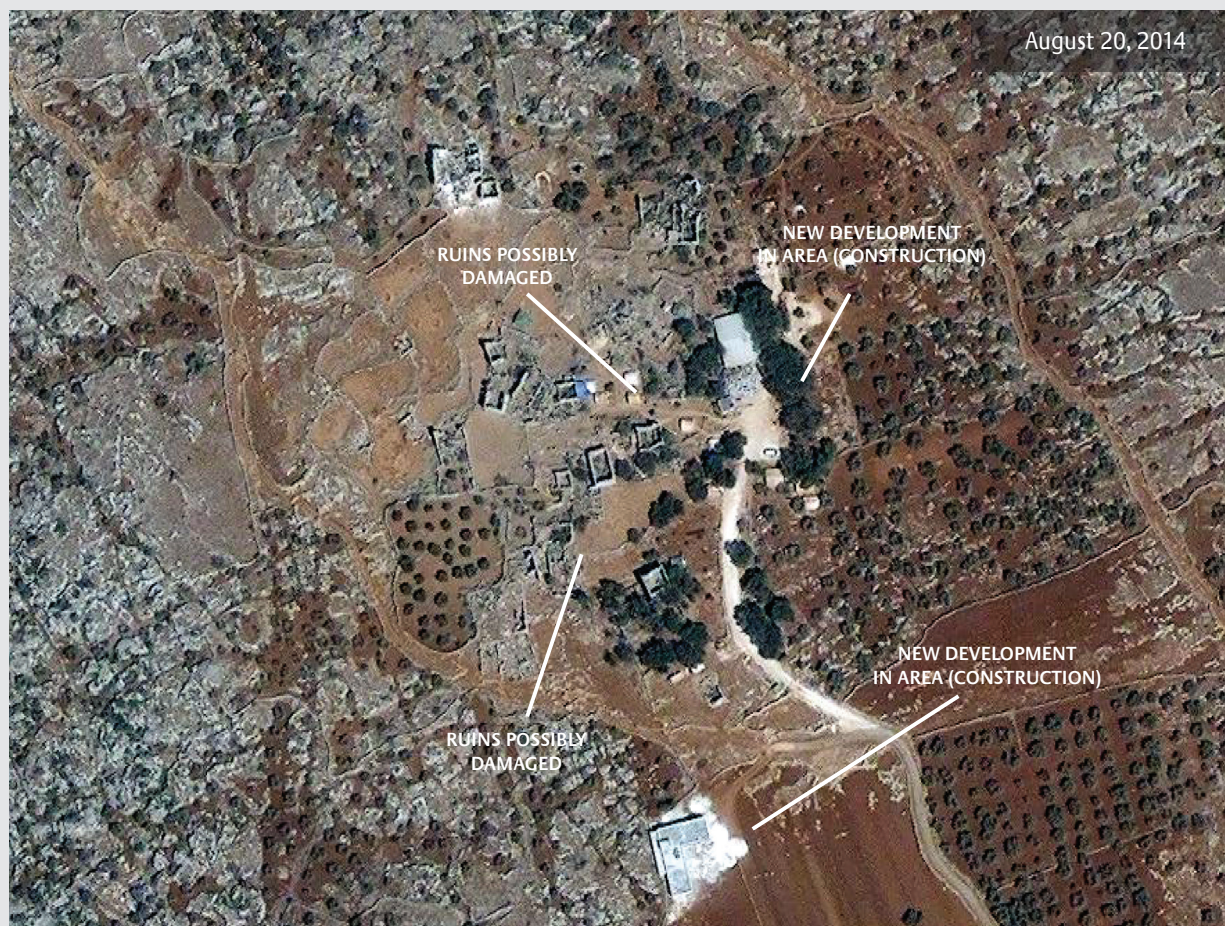
FIGURE 60. Bamuqqa.

The car park was redeveloped and covered by 2014, and a number of large vehicles (possibly trucks) are visible on the site. Four small structures (approximately 6 x 6 m) have been built in the clearings among the ruins, as well as a large number around them (see figures 60 and 61). However, none of the visible ruins seem to have been disturbed.

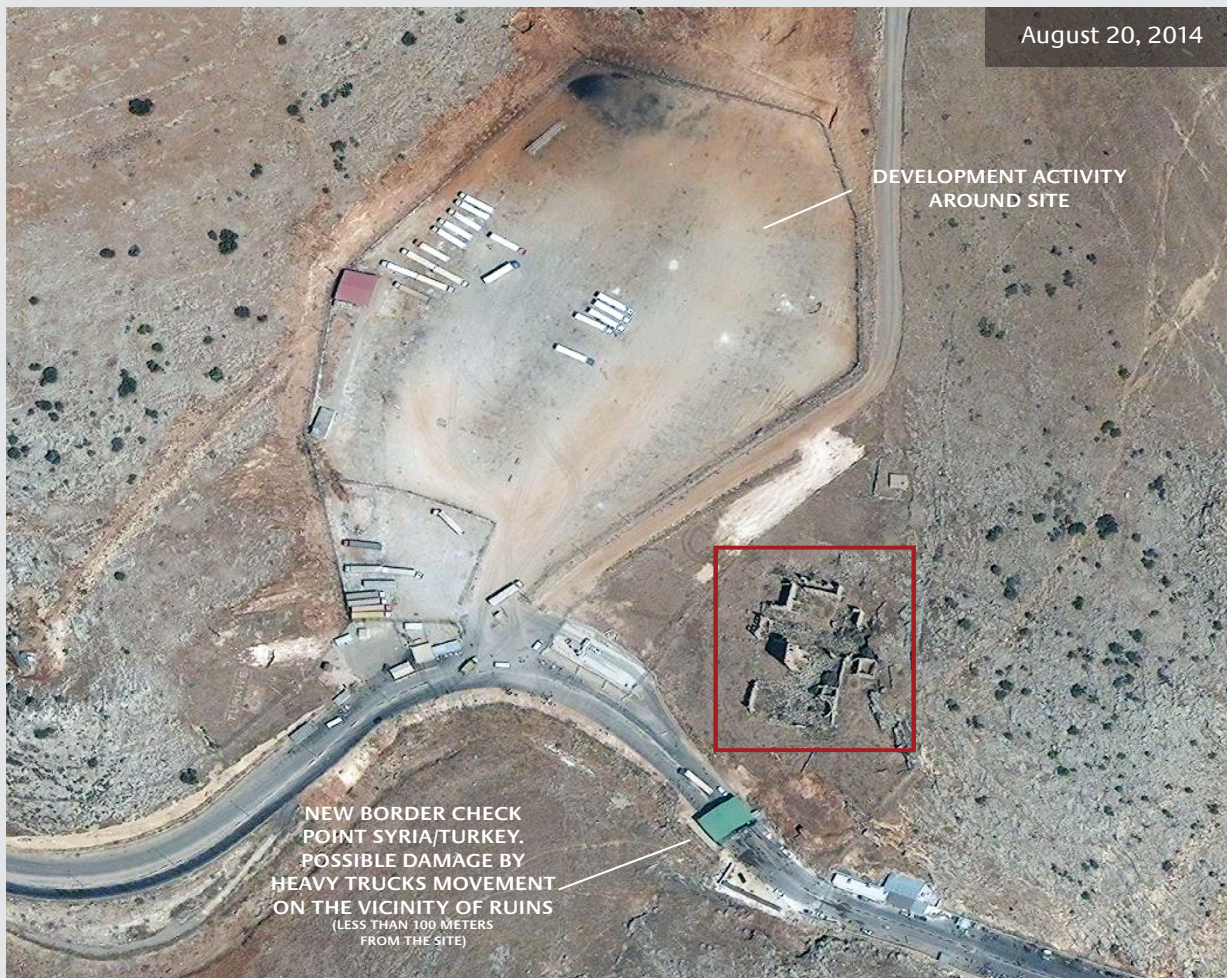
FIGURE 62. Qasr al-Banat.

Damage Assessment - A review of the imagery shows extensive new construction and development around the site, which is extremely close to the border crossing with Turkey. Although it appears undisturbed, the possibility remains that the site has been damaged from development activities (see figures 62 and 63).
