# Palmyra (Tadmor) بالميّرا

*Homs Governorate*

## Status Overview

*This report provides a detailed analysis of significant changes to the cultural heritage of this site resulting from the ongoing conflict in Syria. Satellite imagery acquired on 10 October 2009, 01 September 2012, 14 November 2013, 08 March 2014 and 26 October 2014 were used for this report.*

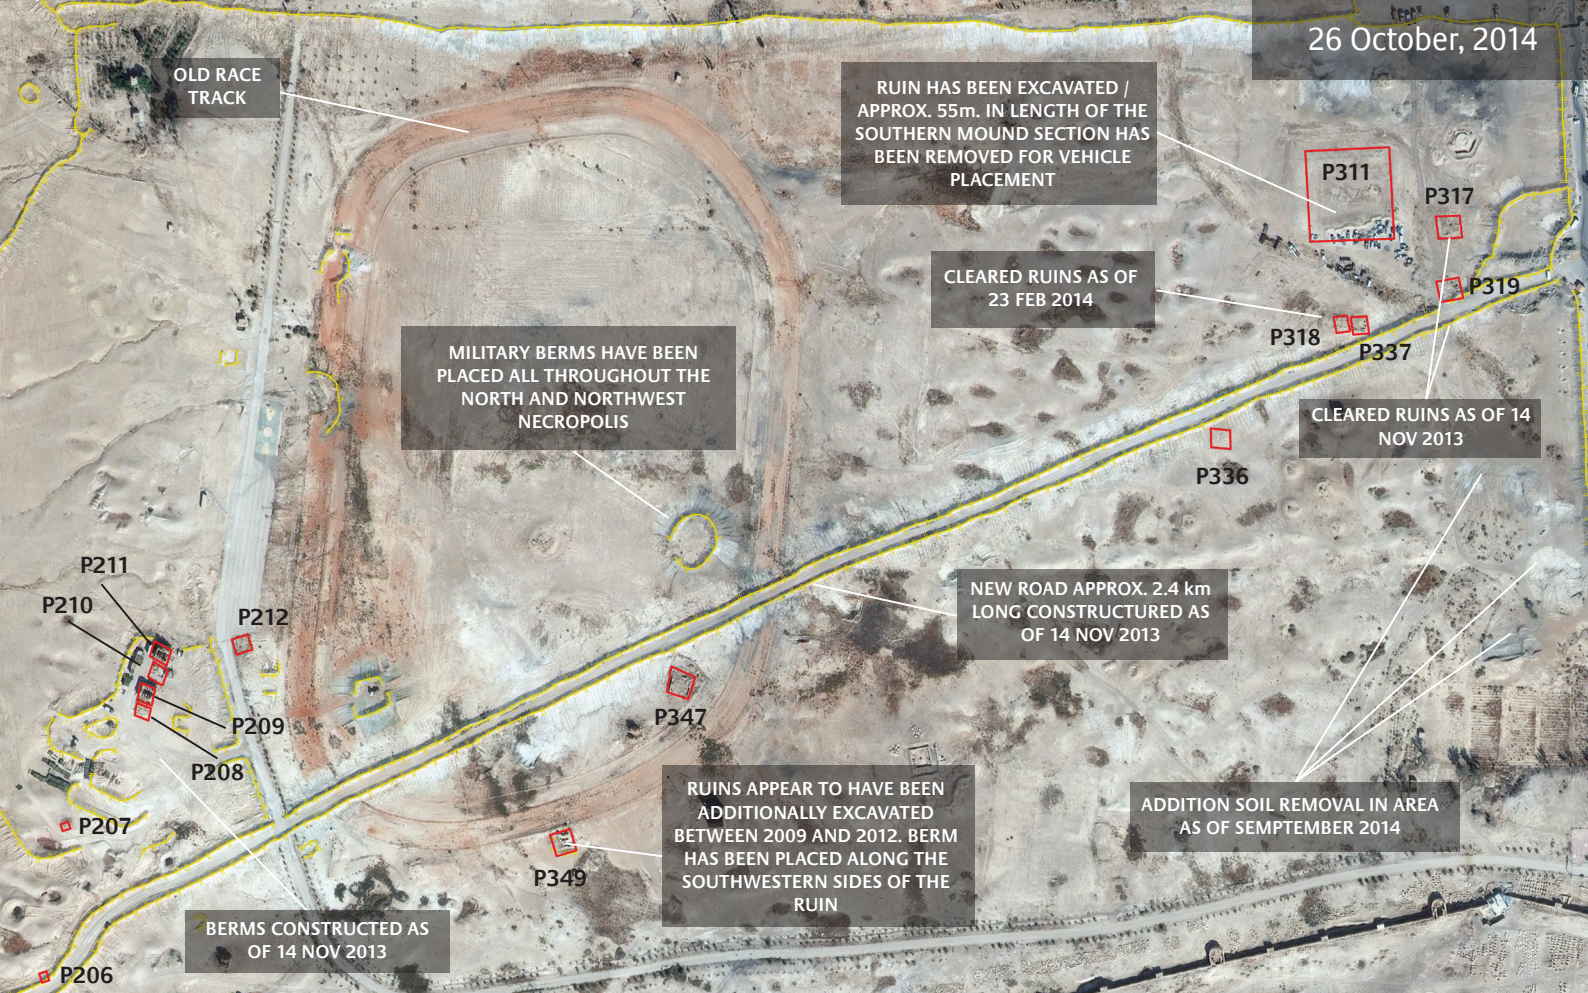
FIGURE 72. Northwest Necropolis.

The new road is clearly visible on the imagery. It was built between 01 September 2012 and 14 November 2013 and remains in use as of 26 October 2014 (see figure 72). Coming directly down from where the original road to the citadel branches to the communications/radio mast, the new road cuts through the northwest and northern necropolises to the tarmac road on the eastern edge of the modern town of Tadmur. This new road is approximately 2.4 km long. A secondary section, 579 m long, branches off from the main road in the northwest necropolis. It cuts through it to the rise at the eastern-most point of the walls. Here a small clearing has been excavated against and through the walls; an area of wall approximately 44 m long has also been removed (see figures 72 and 73). Soil from the surrounding areas, including the archaeological areas, has been piled up all along the road to provide a walled embankment.<sup>(vii)</sup> This embankment also disturbs the line of the Hellenistic wall running to the Bel Hammon Temple. The road is dirt, rather than tarmac, which will cause far less damage as it does not require such deep foundations, and no chemicals were used which would leach into the archaeological soils. However, it still requires the flattening of archaeological features, and the vibrations of heavy traffic will damage the archaeological remains. In addition, the tarmac road to the communications tower has been widened and resurfaced.

During the same period, a new dirt road was created along, and partially over, the remains of the mud-brick wall on the far north-eastern side of the site that marked the western end of the necropolis. The original wall runs from tower tomb Q287 on the rise heading east from the Valley of the Tombs across the small valley there. The buried part of this wall, within the valley, is now partially covered by a road, 274 m long and 5 m wide, with a roadblock/barrier at the northern end; it does not reach tomb Q287.

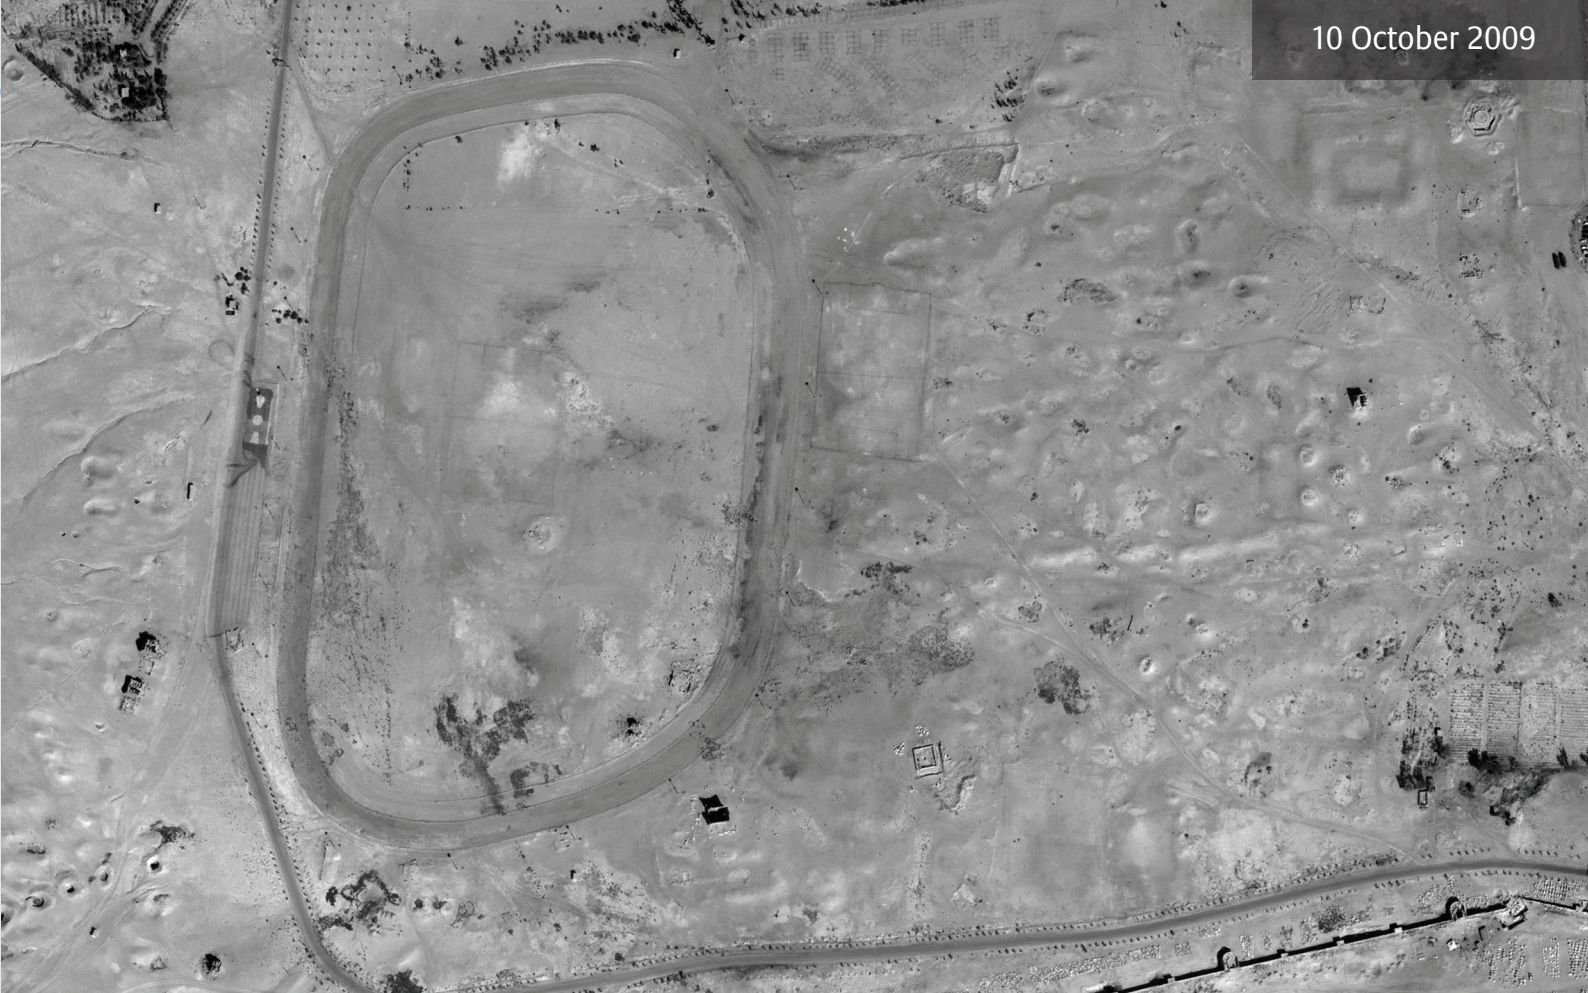
FIGURE 73. Northwest necropolis.

In addition to the banked road running through this area, which has passed over or through several tombs, the ground of the necropolis has been heavily disturbed. A set of small embankments protecting tanks and buildings/tents were constructed between 2012 and November 2013<sup>(ix)</sup> over several underground tombs, and incorporated the row of tower tombs to the southeast of the racetrack (tombs P206 - P211<sup>(x)</sup>). Collectively, the embankments measure 200 m x 150 m. Six more separate placements, banked with earth, were created concurrently on or inside the (modern) racecourse, one incorporating tomb P212, the largest of which is just under 50 m in diameter. Two sets of ruins (most likely funerary temples P317 and P319) south of the hexagonal tomb appear to have been cleared or robbed for stone as their outlines were no longer visible as of 2013. A third outline to the west of these was no longer visible by February 2014. Next to these, an embankment was dug into structure P311 for military vehicles/armaments, which destroyed approximately 65 m of the 100-meter southern wall (see figures 72 and 73). The northern edge of this necropolis is restricted by the road that runs along the southern edge of the modern town of Tadmur; another embankment has also been built along this road. Where the town ends, the embankment runs up the slope to the citadel for approximately 500 m.

Tomb P349 appears to have been further excavated on the southern edge of the racecourse between 2009 and 2012. Its outline was visible on the imagery from 2009, however as of 2014 there is clear increased definition of the ruins, suggesting further excavation of the tomb. In addition, a berm has been placed along the south-western sides of the ruin. It is unknown if it was excavated legitimately. Soil heaps are visible over or next to a number of the underground tomb entrances, particularly those near the new road. It is also unknown if these are a result of looting or were placed there to assist the construction work. However, the excavators recorded these tombs as “collapsed in the unspecified past, never excavated,”<sup>(xi)</sup> so it is more likely the spoil heaps are related to construction work. Part of the large excavation spoil heap outside the city walls at the southern end of the necropolis was removed between 2009 and 2012, perhaps as part of the restoration work conducted by the Palmyra Museum on the wall.<sup>(xii)</sup> Occasional looting holes are also visible; for example, two holes are visible in Funerary temple P214, just outside the walls by the Camp of Diocletian. The first appears between 2009 and 2012, and the second by 2013—the larger of the two is approximately 3 m in diameter.

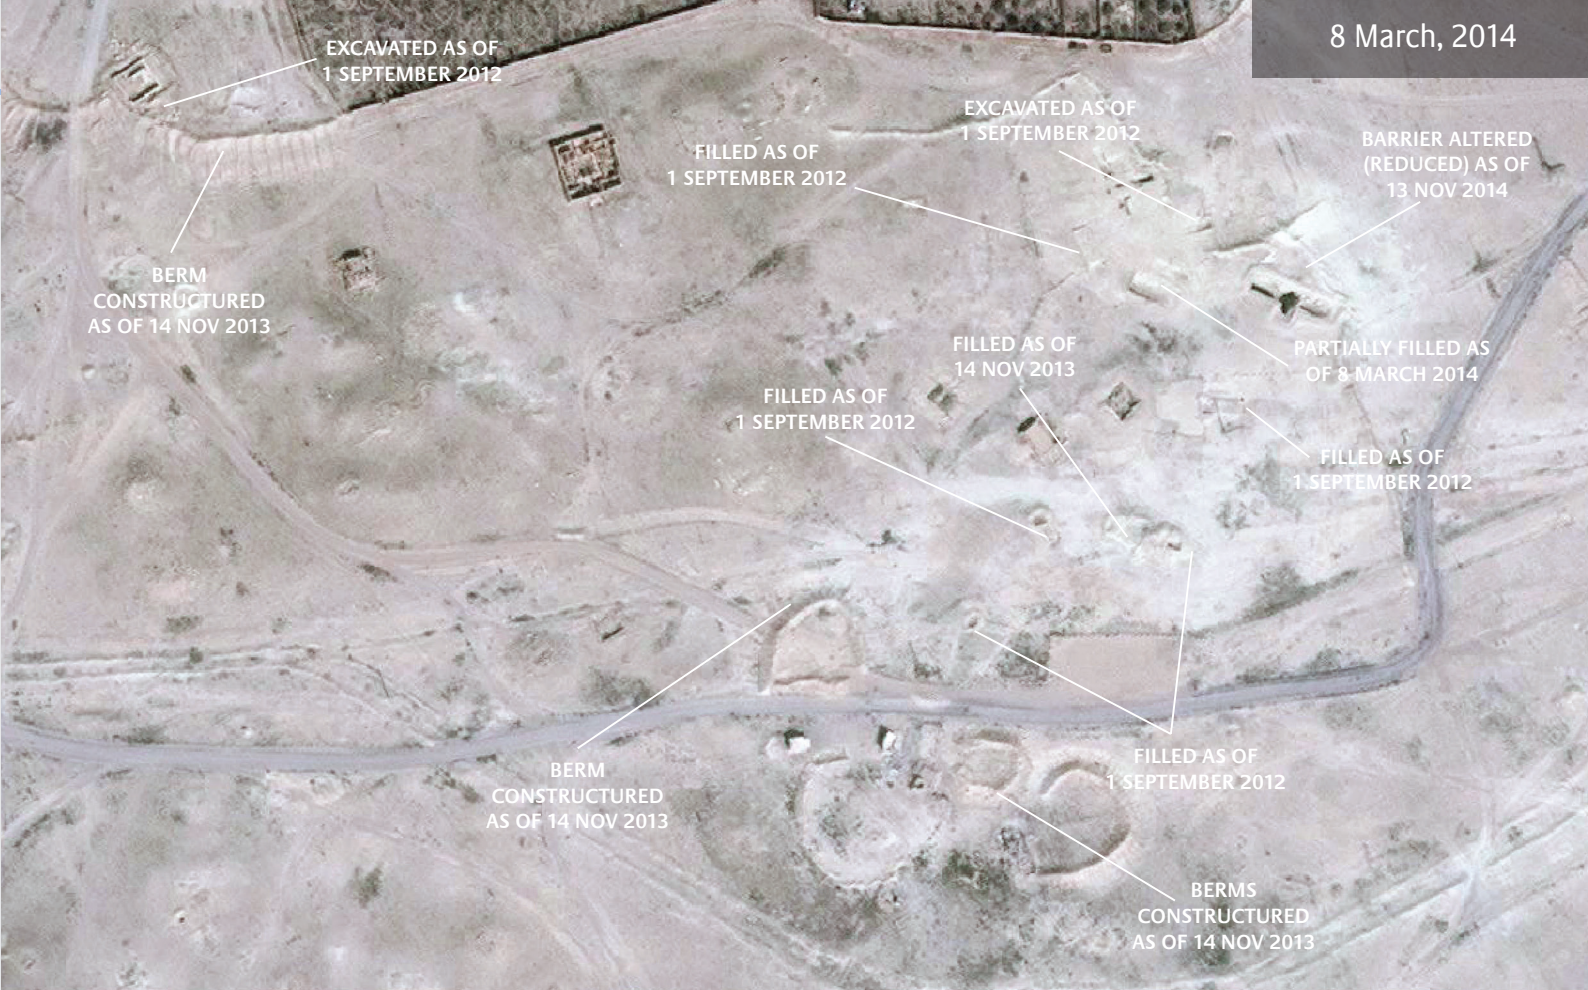
FIGURE 74. Tombs that were filled in as of 2012.

A comparison of the imagery from 2009 and 2012 shows the entrances to most of the main underground tombs in this area were filled in, presumably when the Syrian DGAM attempted to bury the entrances to the tombs in some of the cemeteries (including this one) in order to protect them.<sup>(xiii)</sup> Unfortunately, analysis of the imagery also shows that at least three of those filled in—including the Tomb of Bolha<sup>(xiv)</sup> and the Tomb of Bariki—were reopened between 2012 and 2013, as small holes become visible in the filling. The Tomb of Artaban was completely filled in during the period between 2012 and 2013 (see figures 74 and 75). However, soil heaps are visible around the tomb in 2012, suggesting it was possibly looted and then recovered more thoroughly later. A fourth tomb, tomb C, was filled in by March 2014 and at that point the holes into the tombs were no longer visible, supporting the hypothesis that the tombs were reburied, again in an attempt to protect them. There is also evidence of earth being moved in this area throughout the period under examination. Funerary temple S103 was excavated in the northeast area of the site at some point between October 2010 and September 2012. Though the clarity of the excavation suggests it is legitimate, given the timing,<sup>(xv)</sup> illicit excavation cannot be ruled out.

As in other areas, an earth barrier was created during 2012 - 2013, between the palm groves across the road leading from the site. An additional barrier was created heading south from the eastern road that borders the necropolis down to the northern edge of the palm groves surrounding the site. It dates back to the same period as the other barriers. Lastly, and also during this period, several embankments, usually associated with tanks or military emplacements, were created to the south of this area—one just to the north of the southern road and three to the south.

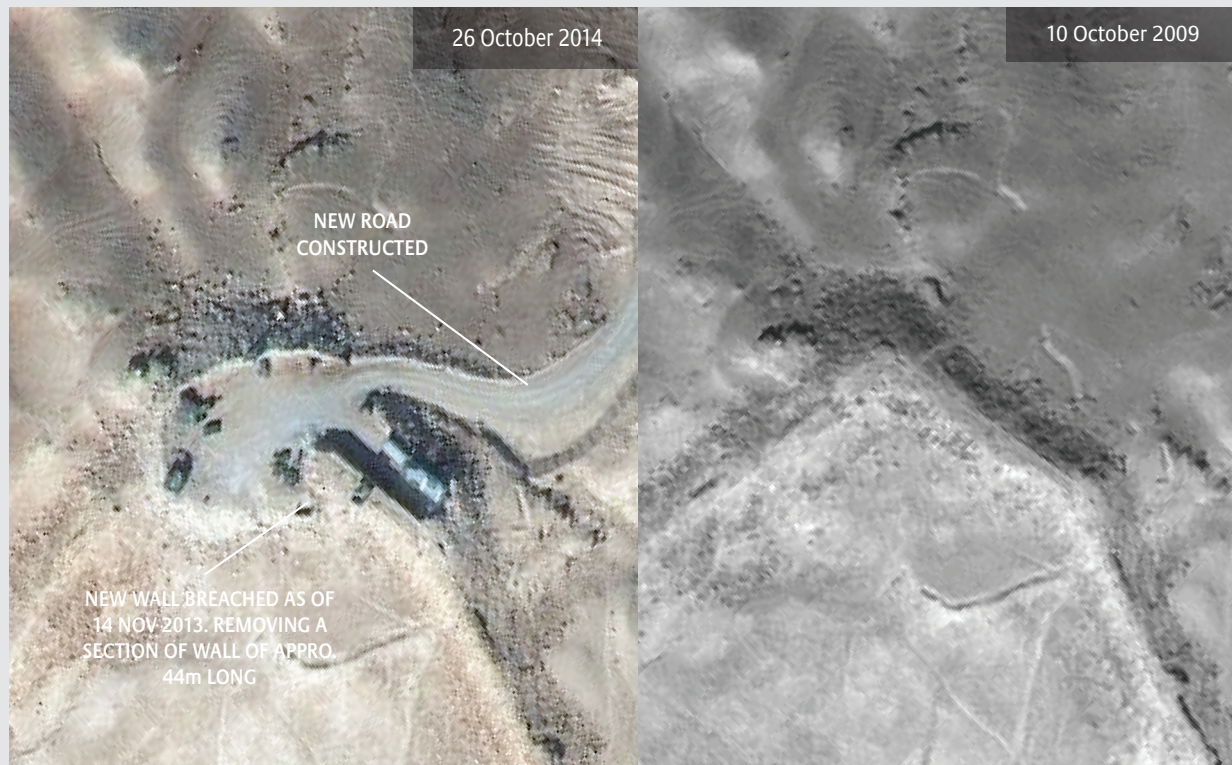
FIGURE 76 and 77. Old city walls and new road leading to 44-meter-wall breach caused by emplacement.

With the exception of the small removed area (see figures 76 and 77 – New Road), the walls are remarkably intact. Two of the funerary temples on the north wall were excavated between 2009 and 2012, and two towers appear to have been rebuilt. However, the rebuilding work is the result of legitimate restoration work conducted between 2009 - 2010 by the DGAM.<sup>(xxiv)</sup> It is probable the excavations are likewise legitimate.
