# Qanawat قنوات

*As Suwayda Governorate*

*This report provides a detailed analysis of significant changes to the cultural heritage of this site resulting from the ongoing conflict in Syria. World View 1 and 2 satellite imagery acquired on 23 November 2010 and 03 June 2014 was used for this report.*

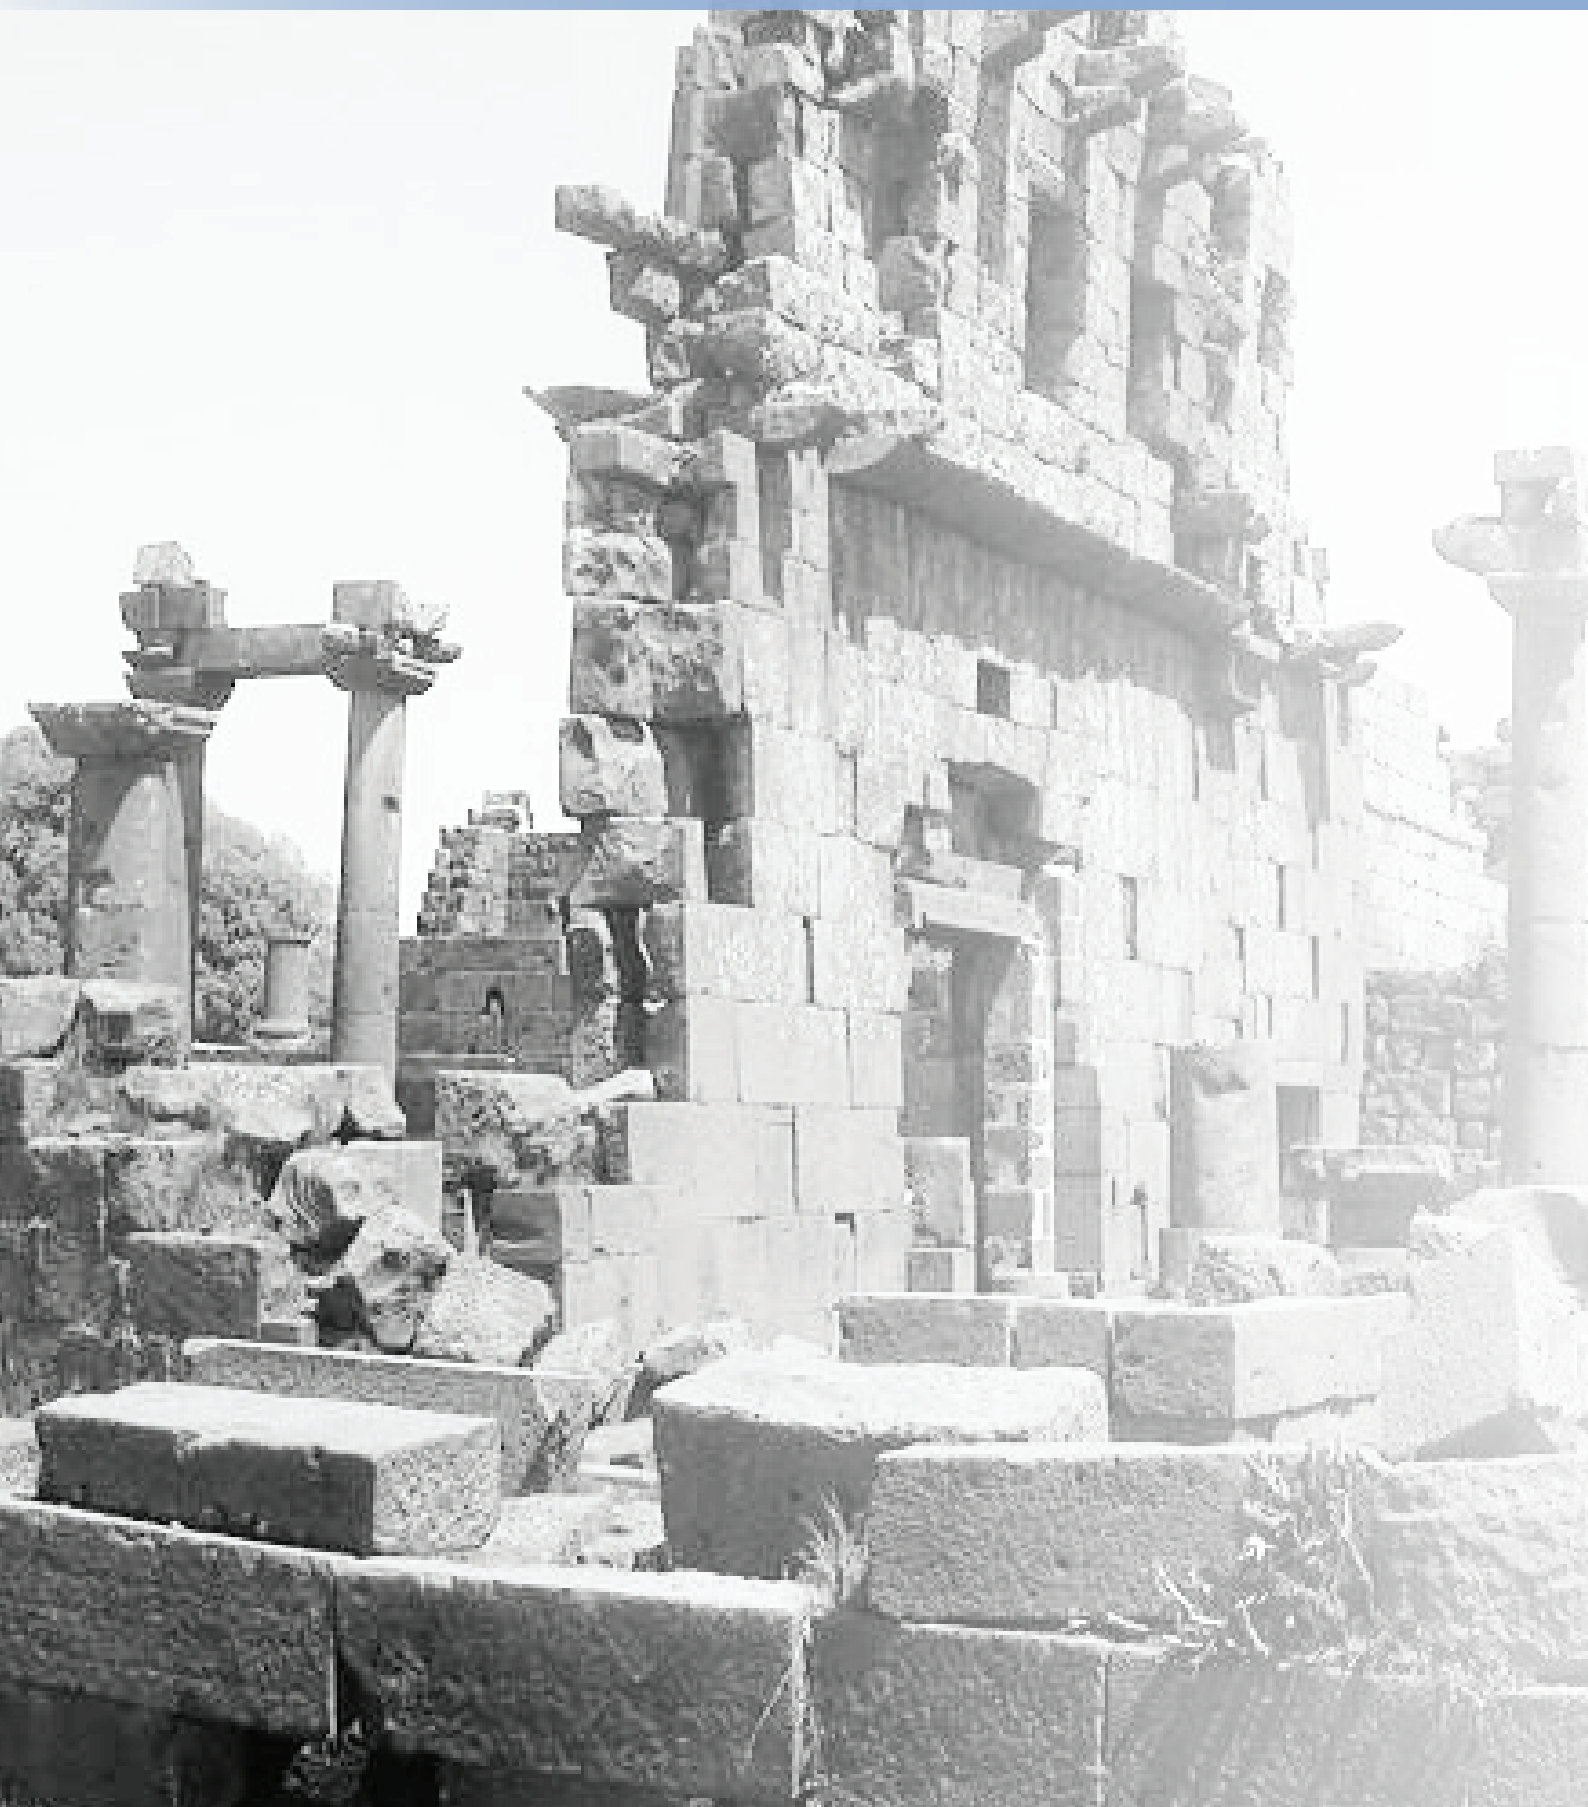
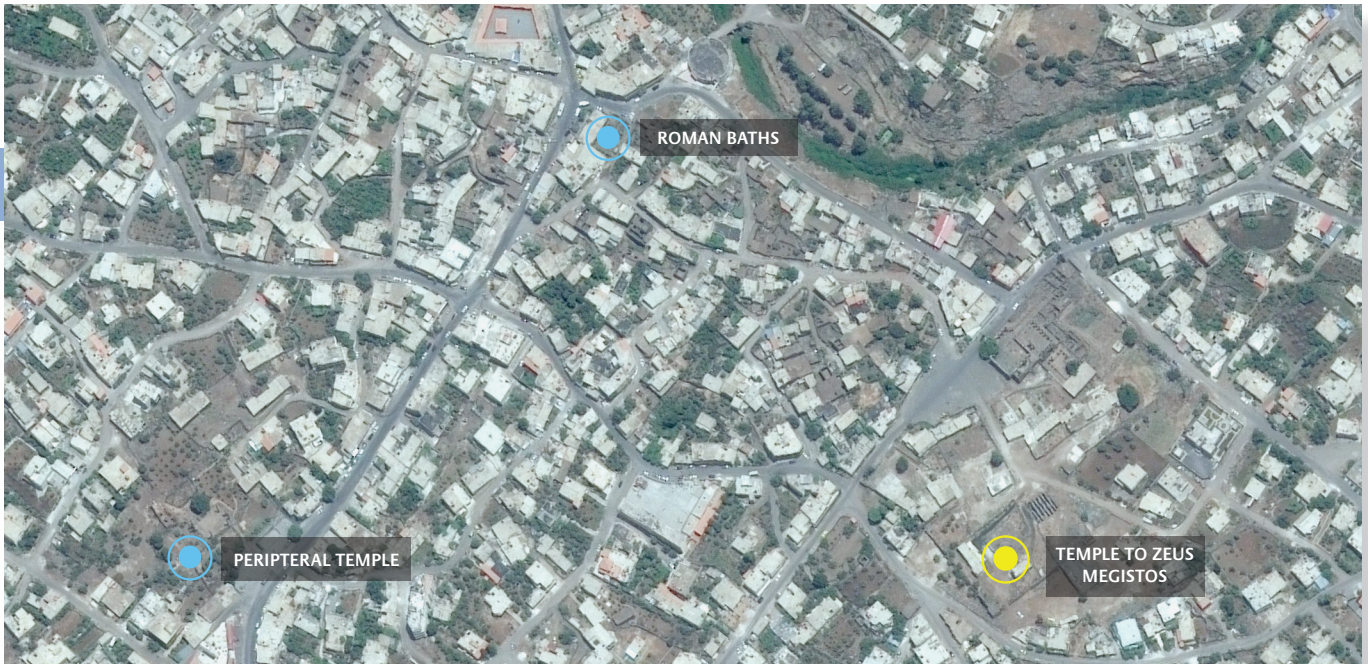
FIGURE 80. Overview of Qanawat and locations where damage has occurred and is visible.

The following features of the site were reviewed: the nymphaeum, the Peripteral Temple to Rabbos, the Roman baths, the Roman theatre, the Seraya palace complex, and the Temple to Zeus. Most structures showed no visible damage, with the exception of the Temple of Zeus Megistos. One of the cistern arches is now shorter, suggesting it has partially collapsed. In addition, many of the buildings which covered the site have been cleared. Whether this is a result of the conflict or site management is unknown. The Roman baths are also possibly damaged; the distinctness of the walls has noticeably lessened, however damage cannot be confirmed (see figure 80).

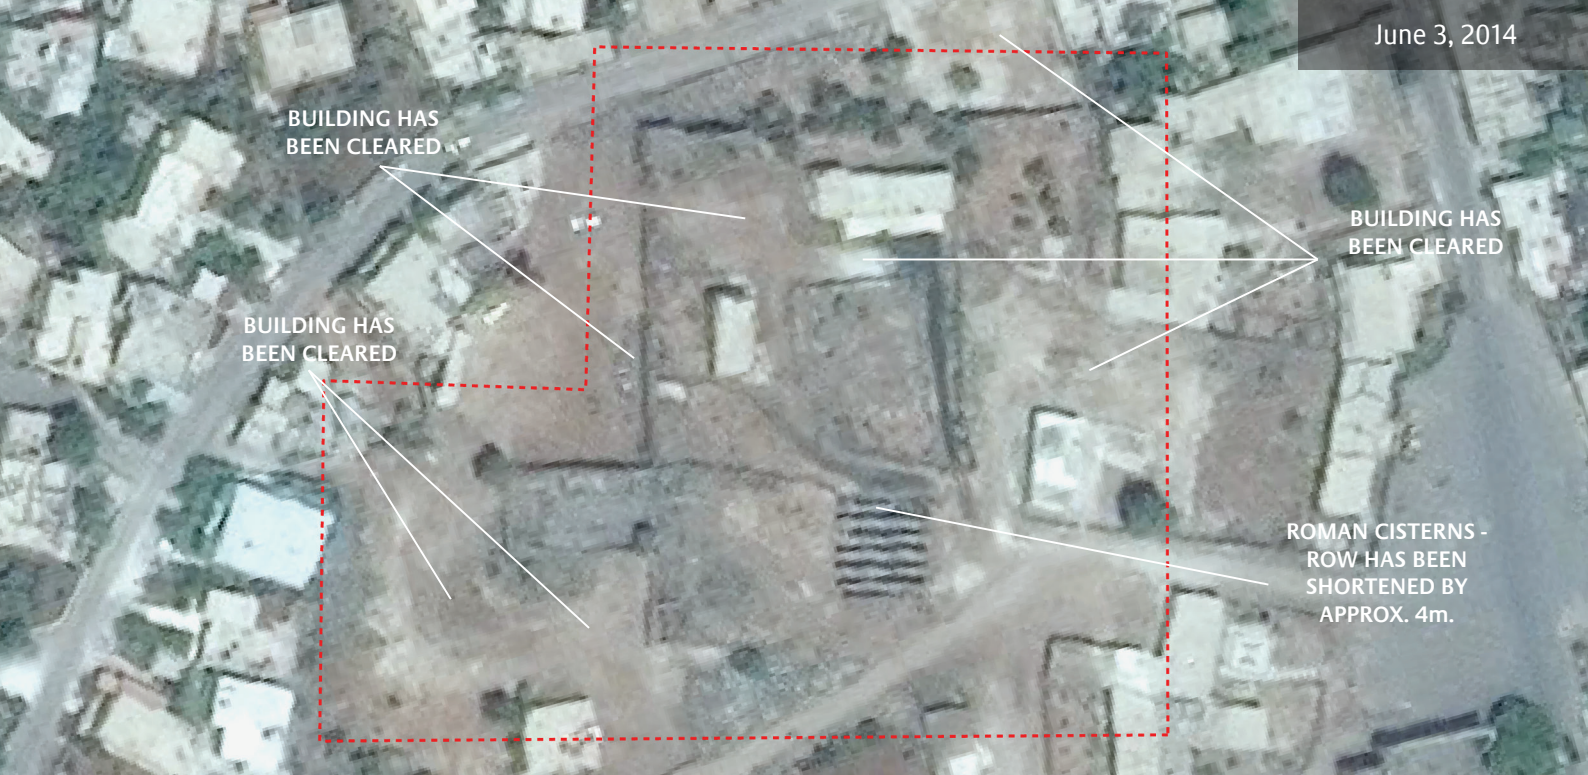
FIGURE 81. Damage to the Temple. Outer red line indicates the approximate extent of the temple.

The eastern-most part of the cistern's arches have collapsed and were shortened by 4 m (originally 17 m in length). A number of buildings have also been cleared from the site. It is unknown why they were removed, so it cannot be said how this has affected the site. It may have been to protect the temple, or it could have damaged the ruins (see figures 81 and 82).

Moderate Damage

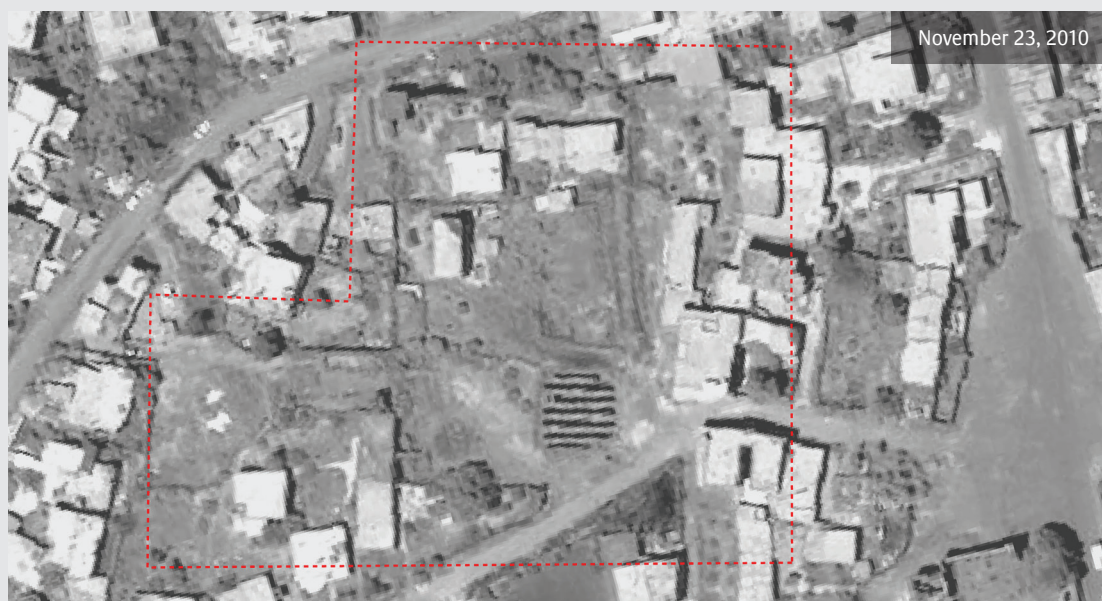
FIGURE 82. Damage to the Temple. Outer red line indicates the approximate extent of the temple.

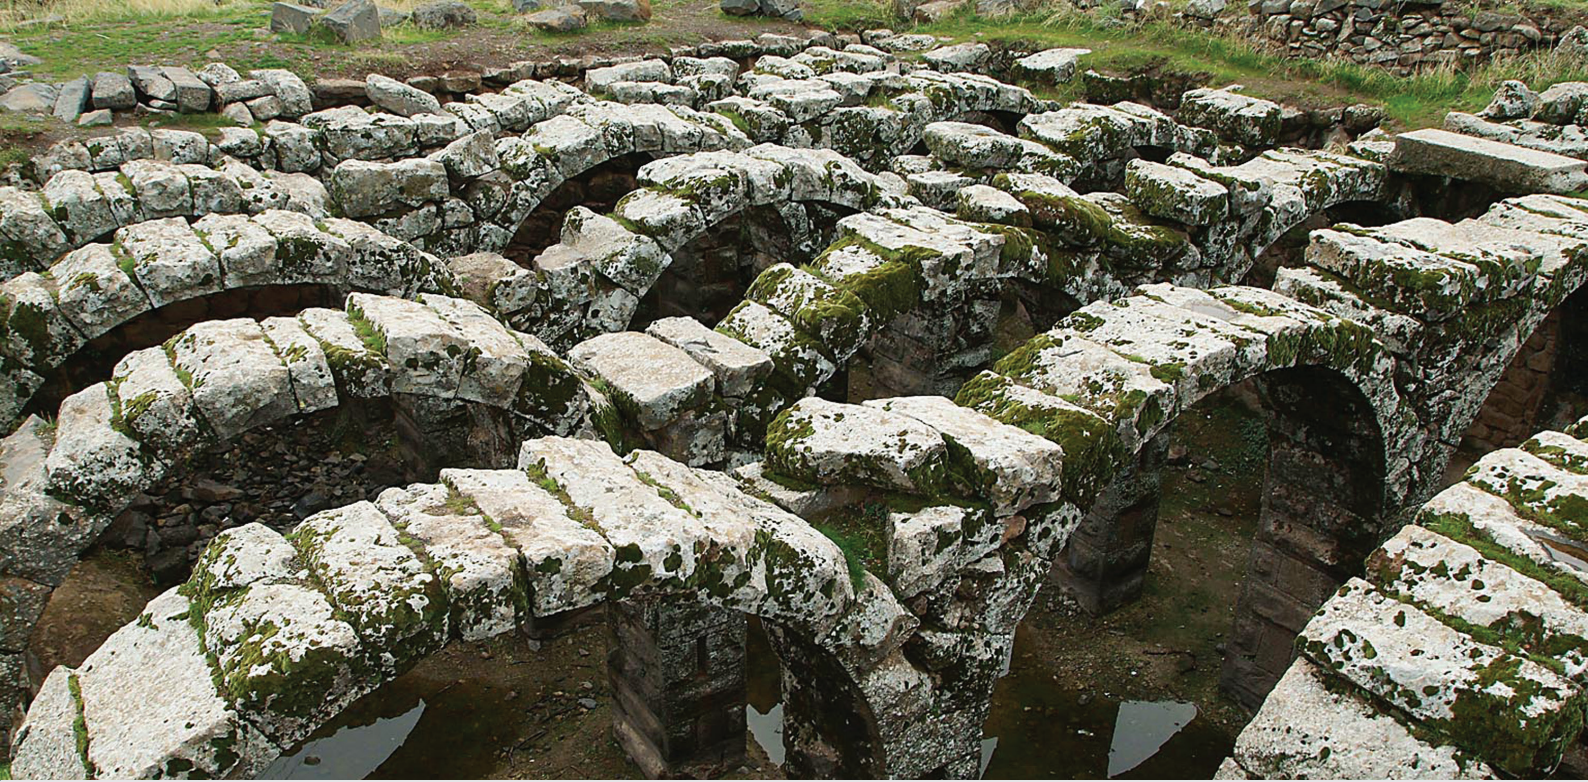
Roman cisterns in Qanawat as seen in the 03 June 2014 satellite image/Photo: Wikimedia Commons.

The clarity of the ruins has visibly lessened according to the two satellite images examined. This could indicate stone robbing or disturbances of the earth—a sign of looting. However, it could also be a result of the atmospheric conditions at the time the later image was acquired (see figure 80).

Possible Damage
