Raqqa (ar-Raqqah) الرقّة

ar-Raqqah Governorate

Status Overview

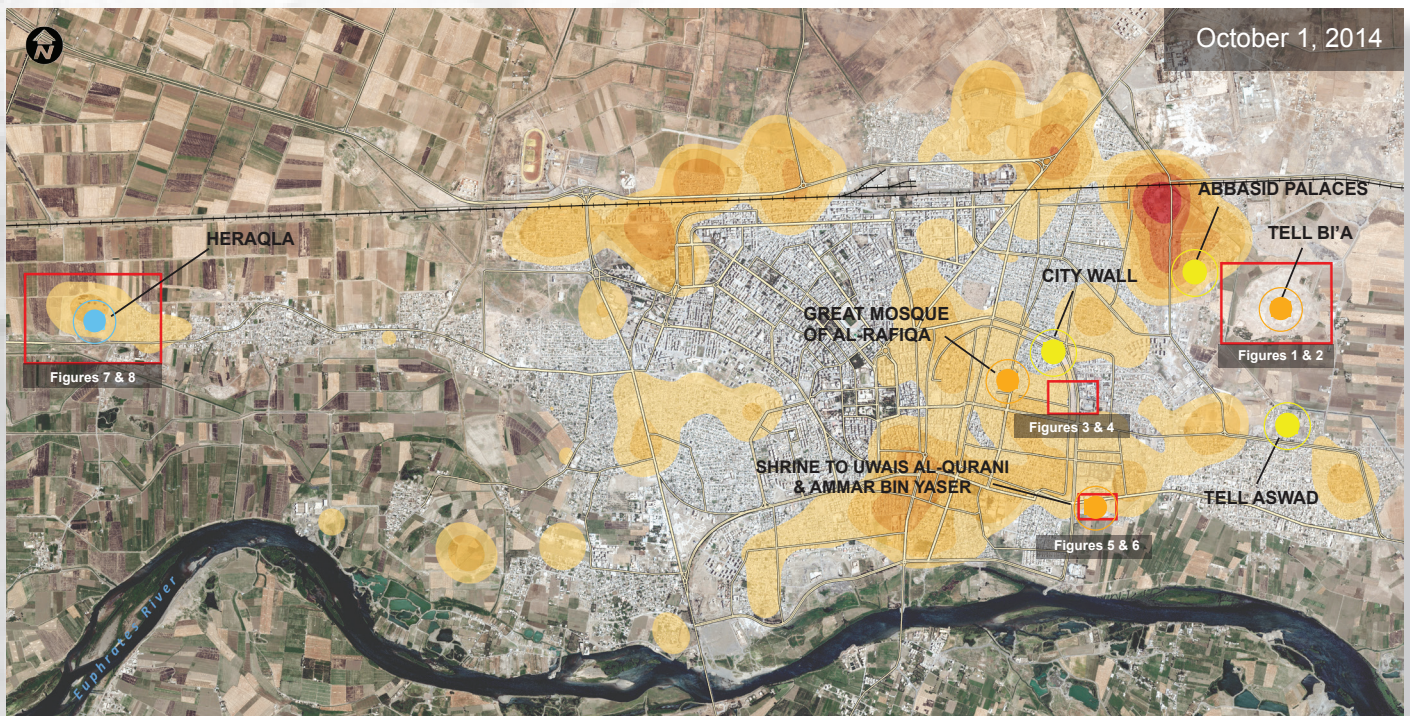
FIGURE 83. Density of detected damage in Raqqa. Damage increases from yellow to red.

The map is a density illustration of satellite-detected areas of damage and destruction in the Syrian cities of Ar Raqqa, Syria. Using satellite imagery from 2014, 2013, 2011 and 2010, UNITAR/UNOSAT created a damage site density index for affected areas in the city. Citywide analysis revealed a total of 467 affected structures in Ar-Raqqa. Most of the highest density of damage was found around the Abbasid Palaces and the Old City (see figure 82).

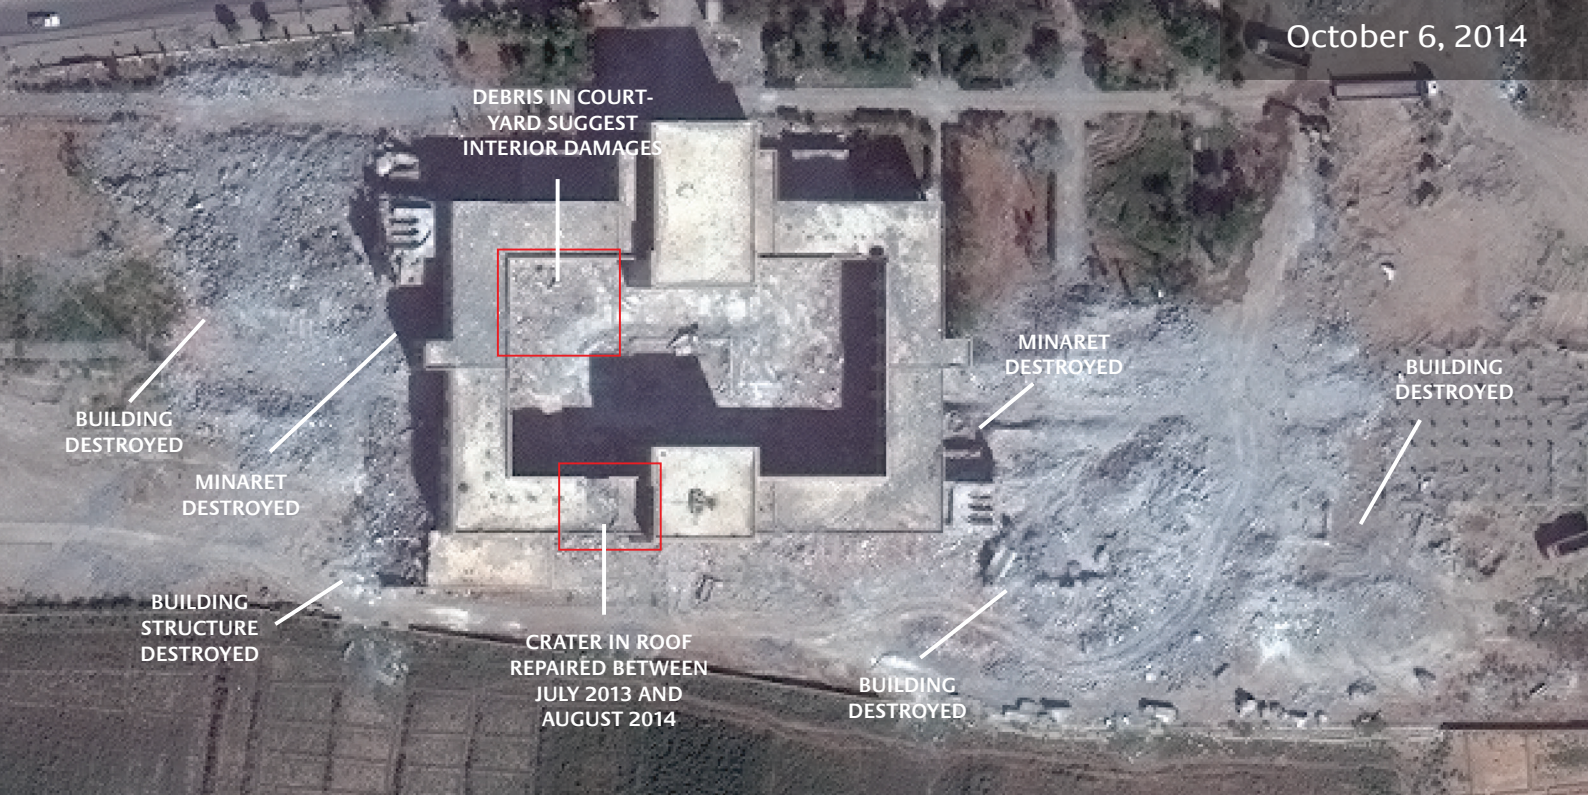
FIGURE 84. Shrine to Uwais al-Qarani and Ammar Bin Yasser.
Extensive damage to shrine buildings and structures.

The shrine has been severely damaged. Satellite imagery shows that all three tombs, their minarets, and a section of the linking arcaded precinct have been destroyed. Remnants of a few walls of the eastern tomb and some of the central precinct are still standing, though they were likely damaged by the explosions. The demolition (using explosives) dates to May 2014.⁽ⁱⁱⁱ⁾ The central precinct roof (southwest side) was also punctured by a shell in June 2013.^(iv) This appears to have been patched as only minor scarring is visible on the imagery (see figures 84 and 85).

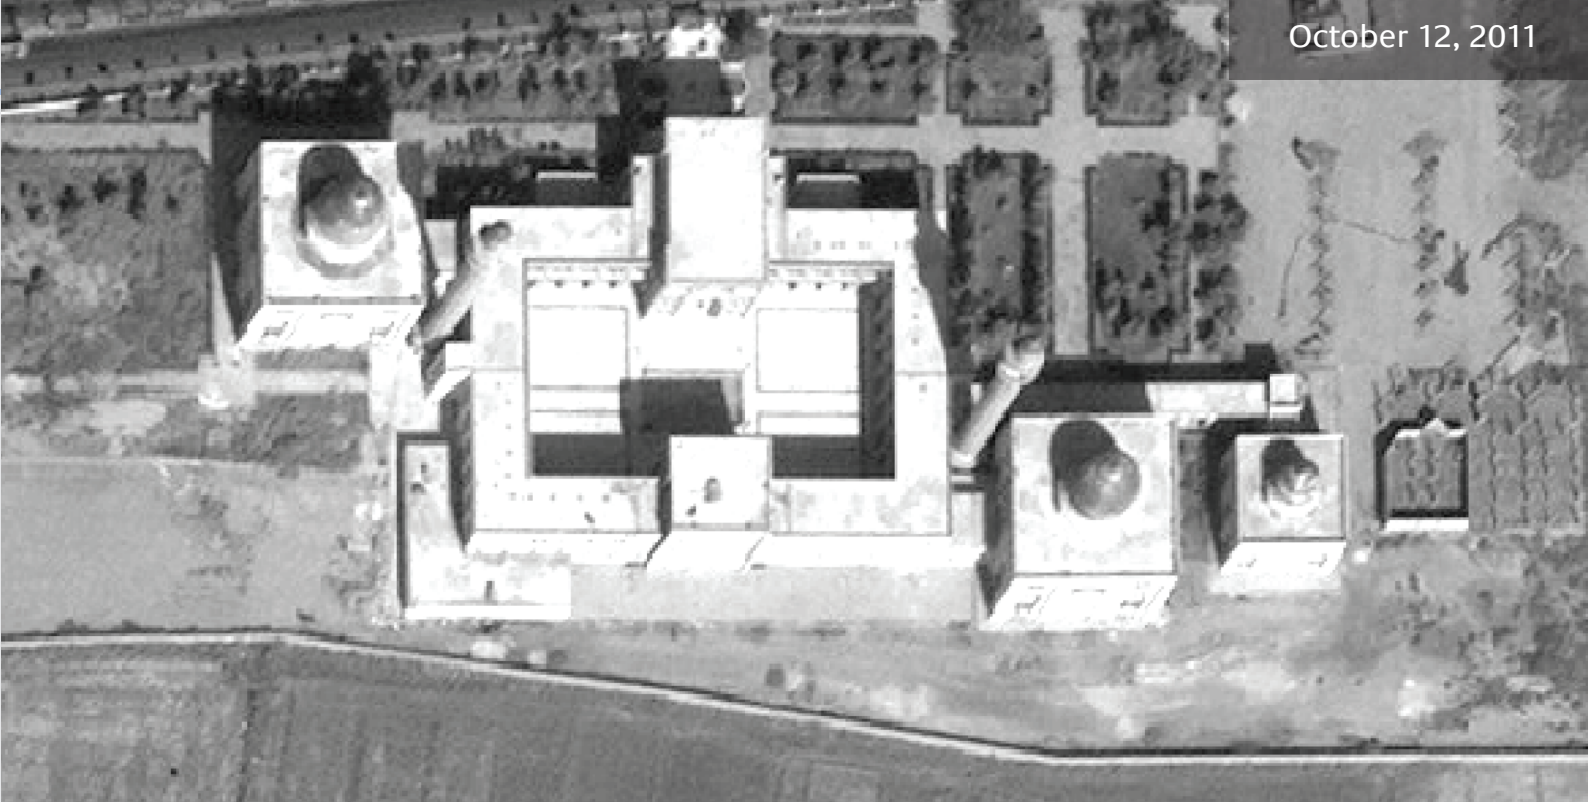
FIGURE 85. Shrine to Uwais al-Qarani and Ammar Bin Yasser.
Shrine buildings and structures before damage.

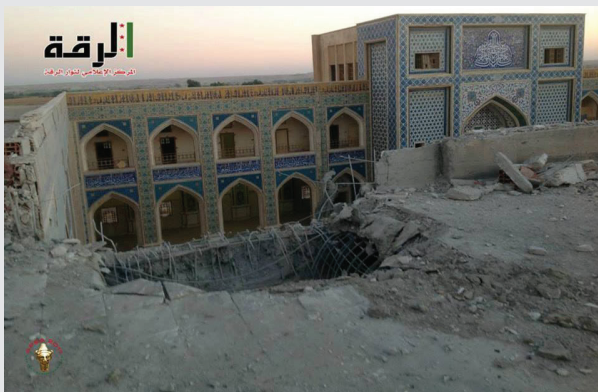
Shrine to Uwais Al-Qarani & Ammar Bin Yasser. Crater on the roof of the mosque caused by alleged bombing/Photo: APSA (The Association for the Protection of Syrian Archaeology), MCR/ar-Raqqa, 30 July, 2014.

The [Uwais al-Qarani] shrine has been severely damaged. Satellite imagery shows that all three tombs, their minarets and a section of the linking arcaded precinct have been destroyed. Remnants of a few walls of the eastern tomb and some of the central precinct are still standing, though they were likely damaged by the explosions.

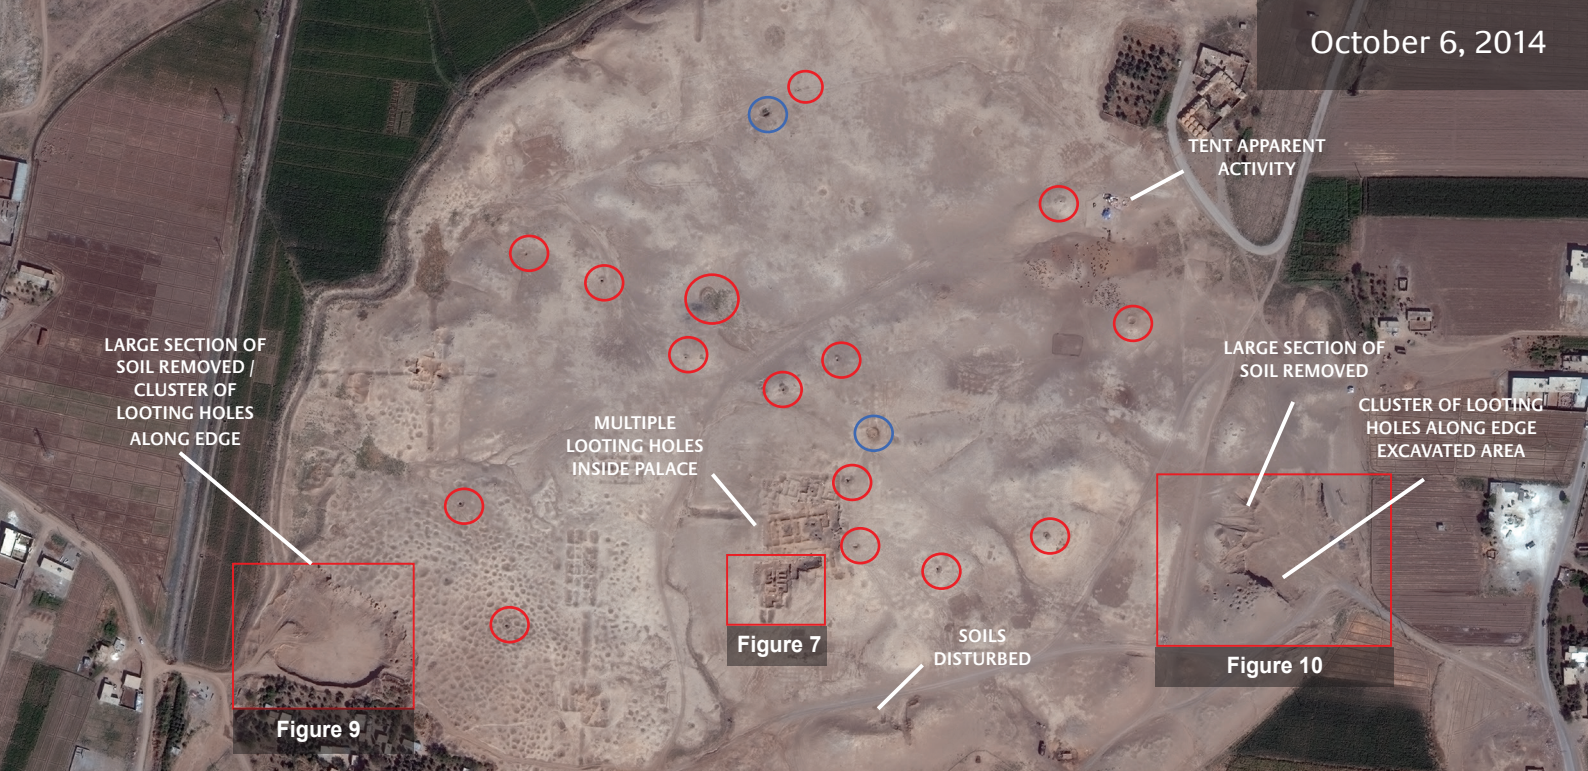
FIGURE 86. Tell Bi'a. Extensive looting and excavated areas at Tell Bi'a. Looting occurred between 19 June and 9 October, 2014.

Looting holes

A review of imagery shows intensive looting concentrated on the Hellenistic, Roman and Byzantine settlement in the southwest part of the site covering approximately 10 ha. Minor looting was present in 2011 (see figure 86) and has dramatically increased between June and October 2014 (see figure 86 and 87). There are multiple, small new holes in the excavated palace (Bronze Age). A few of the holes from previous looting in 2011 are distinctively darker and larger, suggesting they have been reopened. Numerous additional looting holes have appeared throughout the site, mostly isolated holes, with clusters of holes concentrated within the palace and along excavated areas (see figures 88 and 89). There are two areas which have been completely excavated with earth moving machinery. One area, approximately 7,000 m², has been removed from the Hellenistic, Roman and Byzantine area that was previously looted in 2011. The other area is on the far right of the site where an area of approximately 9,000 m² has been removed. The reason is unknown; if it was to obtain earth, no spoil heaps or signs of construction are evident.

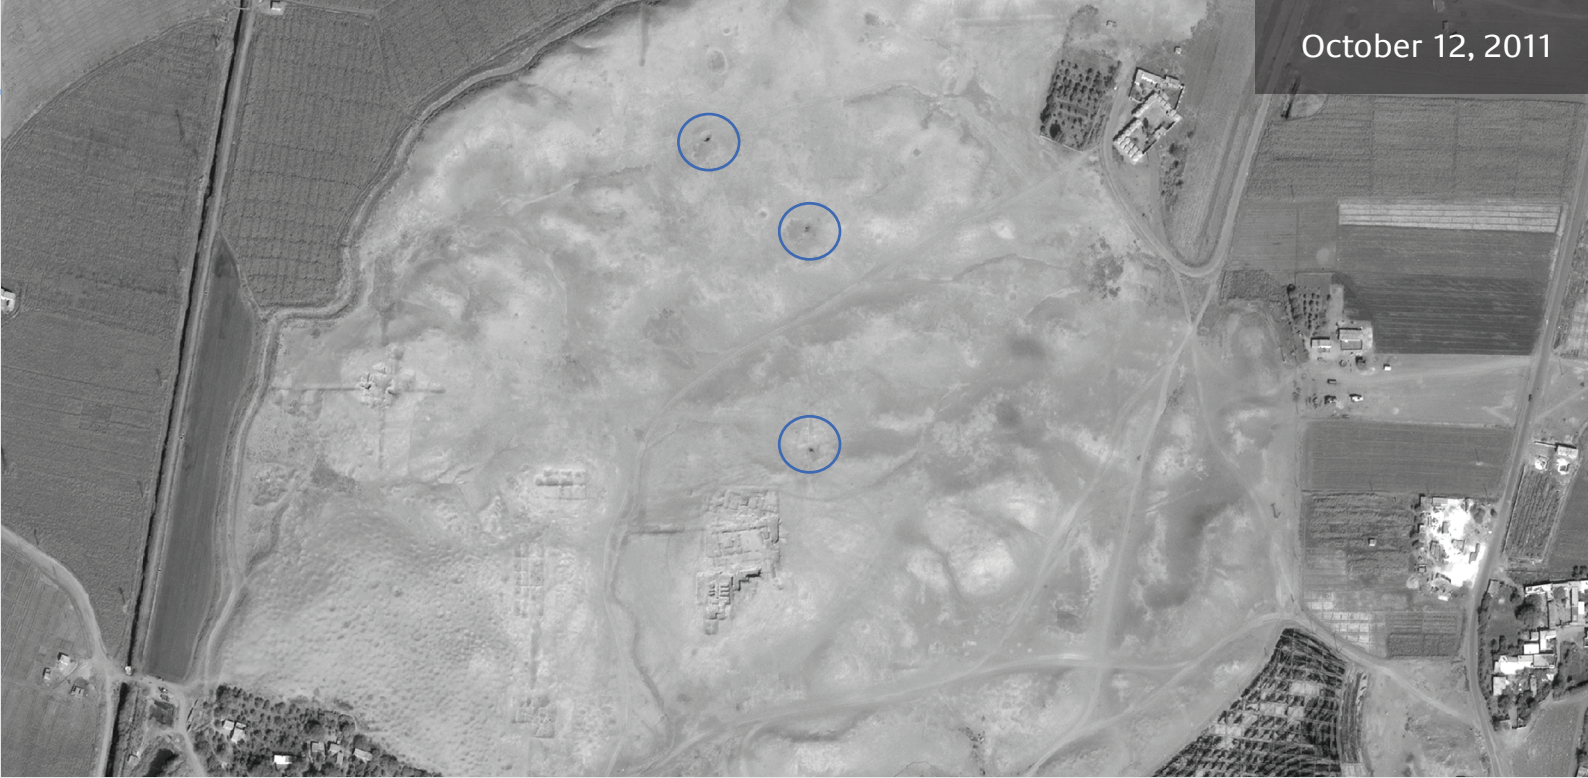
There are two areas which have been completely excavated with earth-moving machinery. One area approximately 7,000 m², has been removed from the Hellenistic, Roman and Byzantine area.

FIGURE 87. Tell Bi'a. Excavated areas and old looting holes at Tell Bi'a.

Visibly old looting holes and excavated areas

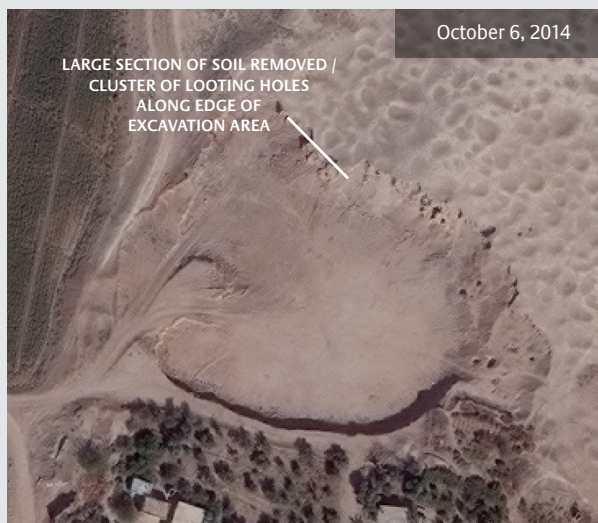
FIGURE 88. Excavation #1 At Tell Bi'a Tutul. Large section of soil removed and cluster of looting holes along edge of excavation area.

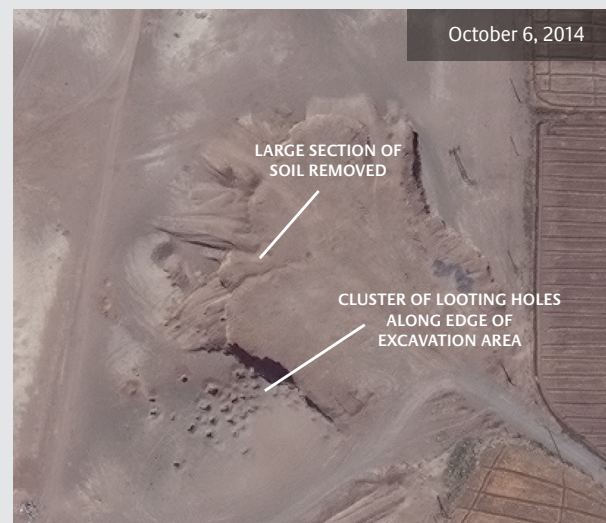
FIGURE 89. Excavation #2 At Tell Bi'a Tutul. Large section of soil removed and cluster of looting holes along edge of excavation area.

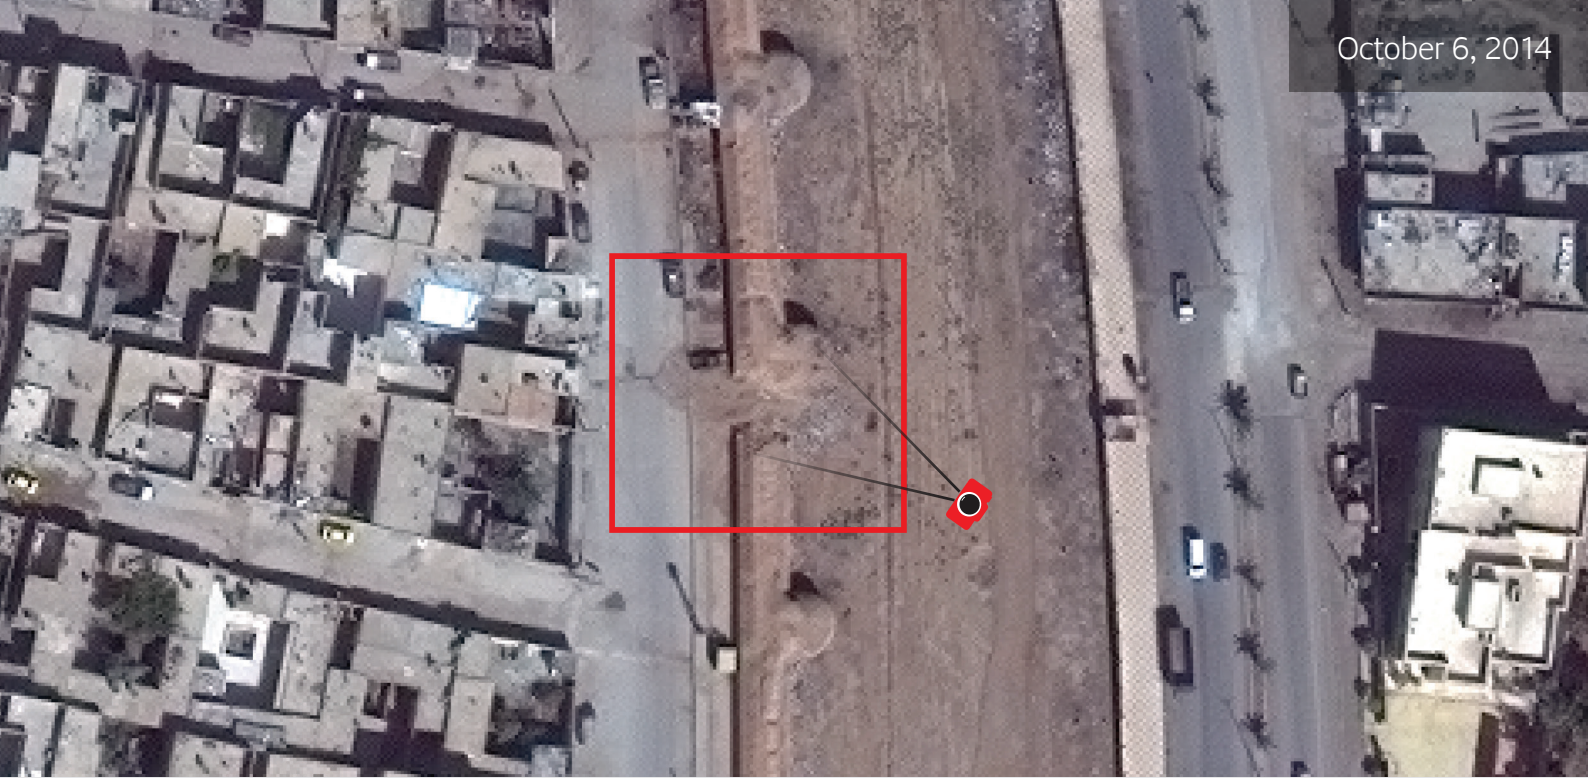
FIGURE 90. Archaeological walls. Destroyed section of tower and wall.

Imagery clearly shows damage to a small section, approximately 8 m, has been largely removed—only rubble remains. This damage is thought to have occurred at the beginning of May 2013^(v) (see figures 90 and 91). Imagery analysis also suggests that some of the turrets farther north on the wall have also been damaged, but this could not be verified.

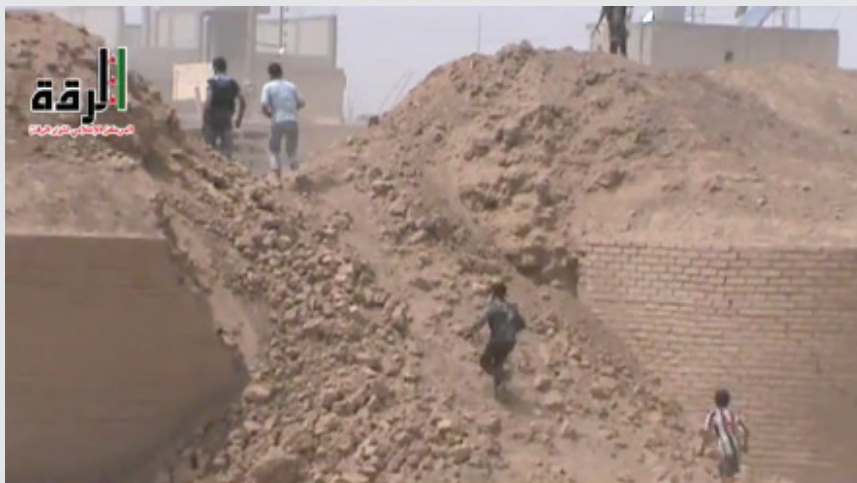
Destroyed section of Archaeological Walls/Photo: YouTube, Ar-Raqqa Media Centre, May 2013.
Video available at: <https://www.youtube.com/watch?v=OpDacVUXEzw>

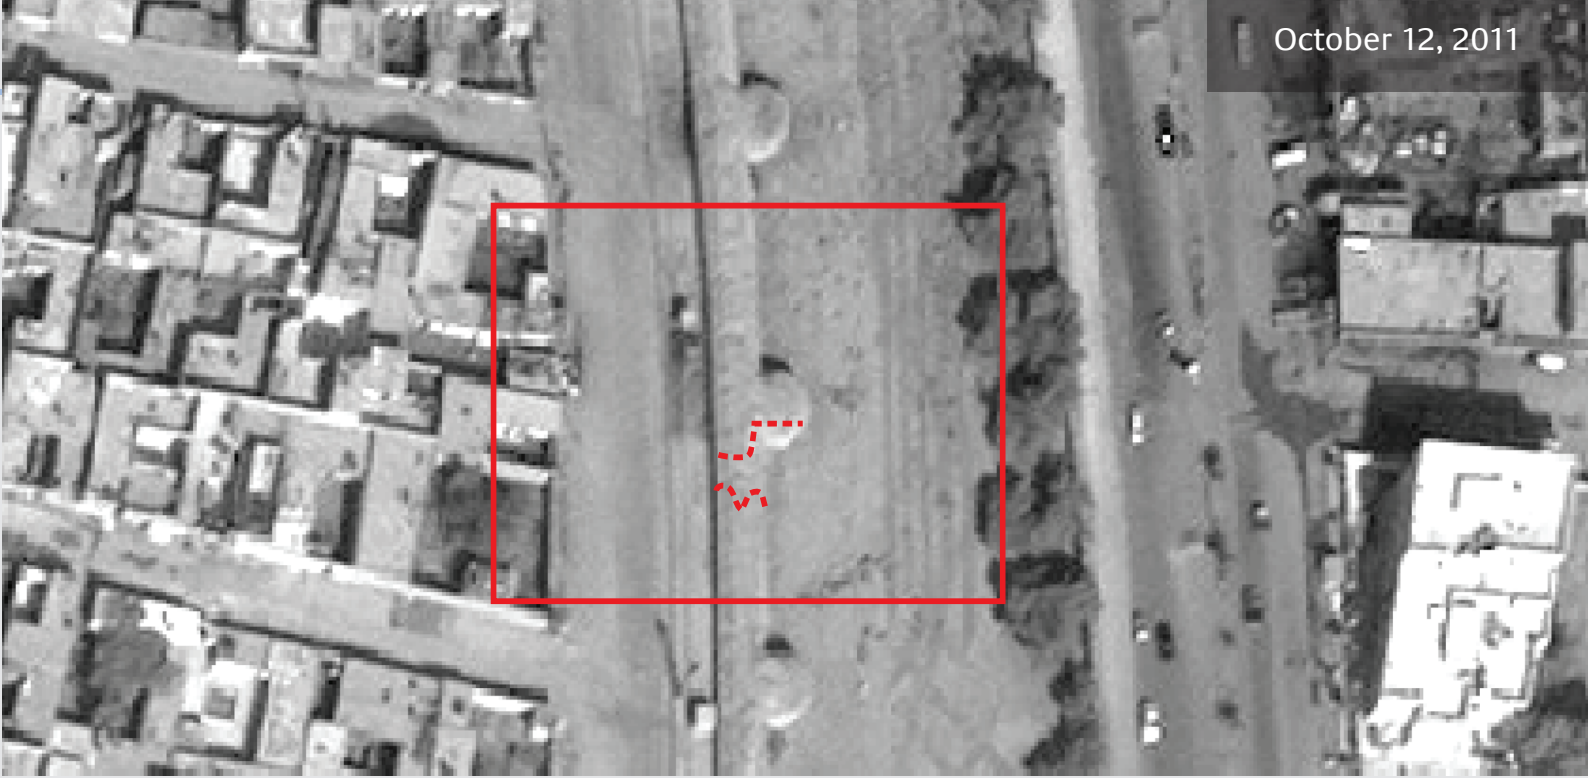
FIGURE 91. Tower and part of the wall before damage occurred.

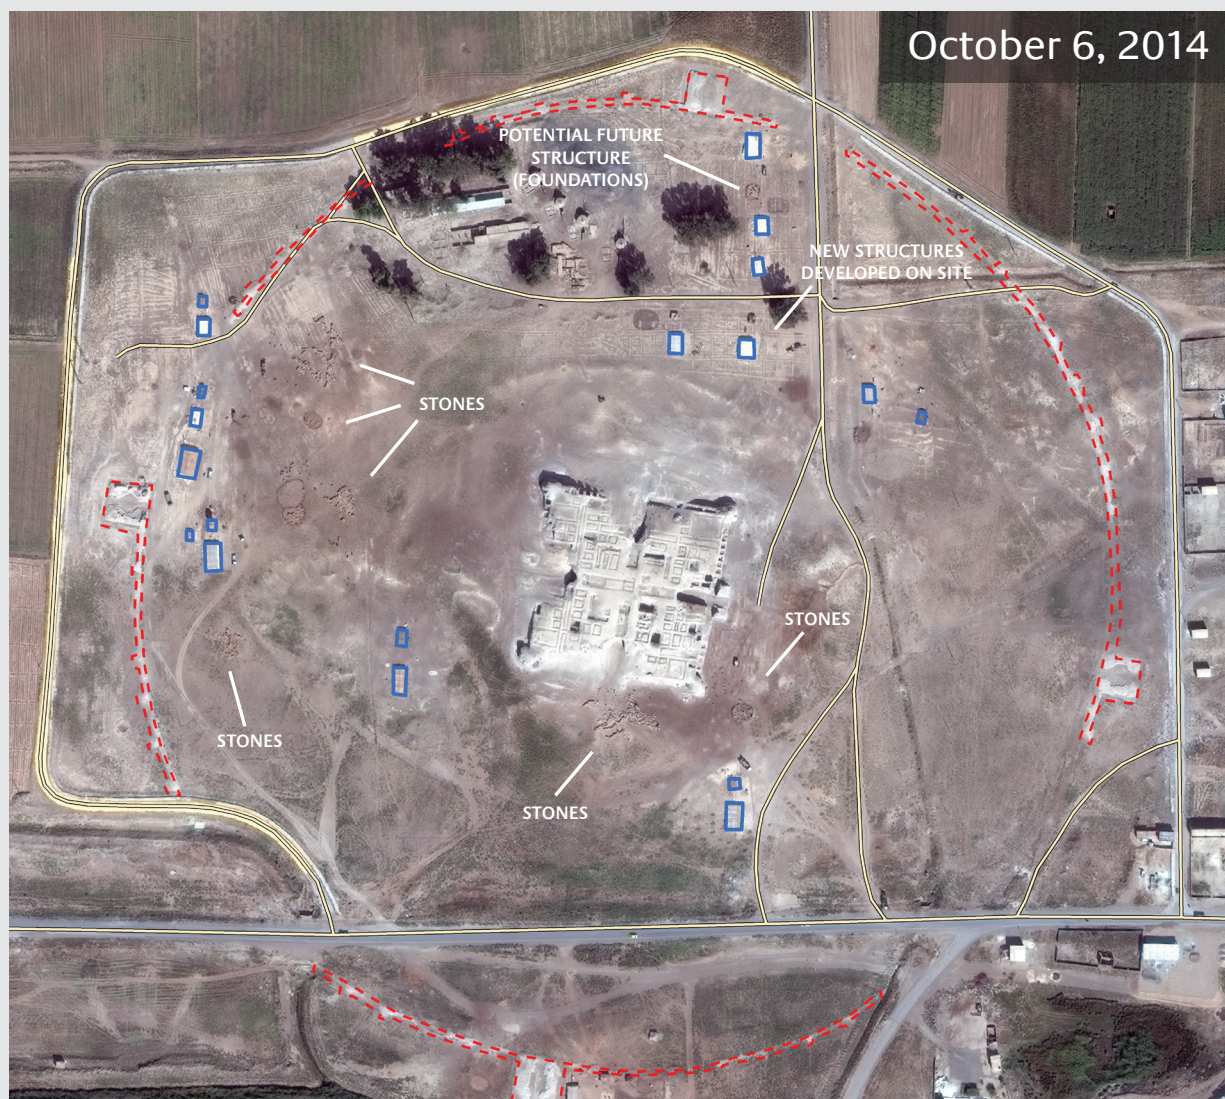
FIGURE 92. Imagery from 6 October 2014 shows new structures and collection of stones scattered throughout the Harqaleh site.

While the monument appears to be undisturbed, the area surrounding the monument has seen significant building development. Approximately 19 new structures have been built on the site between June and October 2014. Multiple collections of stones are visible to the east and immediately south of the monument indicating potential looting or the use of archaeological stones as building materials. New paths are also visible linking to main roads surrounding the perimeter of the site, potentially disturbing archaeological soils in addition to development activities (see figures 92 and 93).

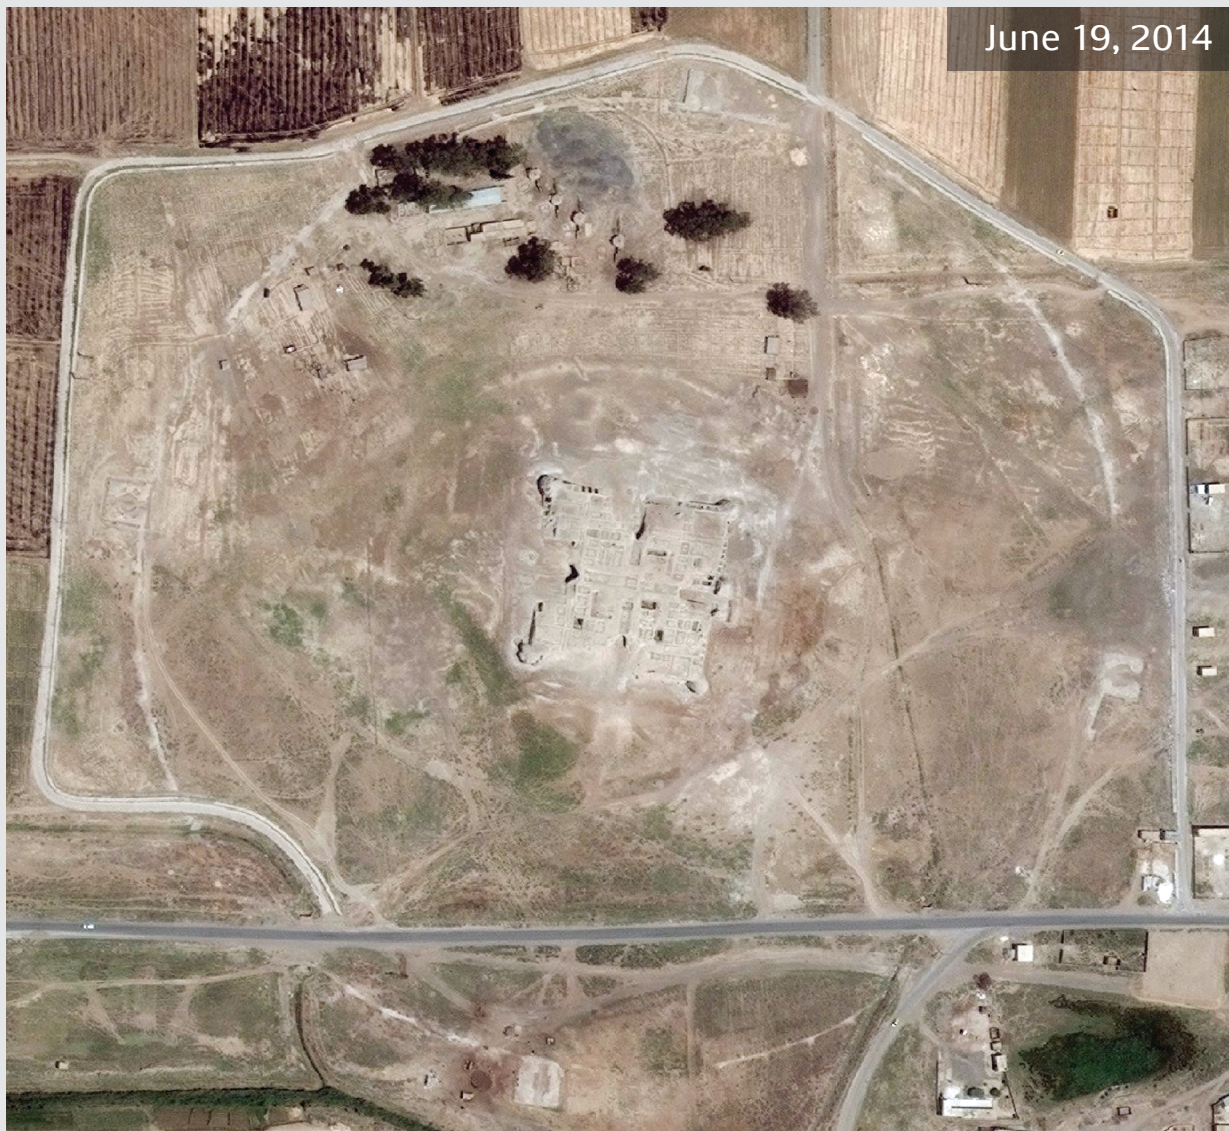
FIGURE 93. Imagery from 19 June 2014 before damage occurred at the Harqaleh site.
