✿ DAMASCUS

Damascus Damage Level (Number of Heritage Locations)

DAMASCUS DAMAGE ASSESSMENT SUMMARY

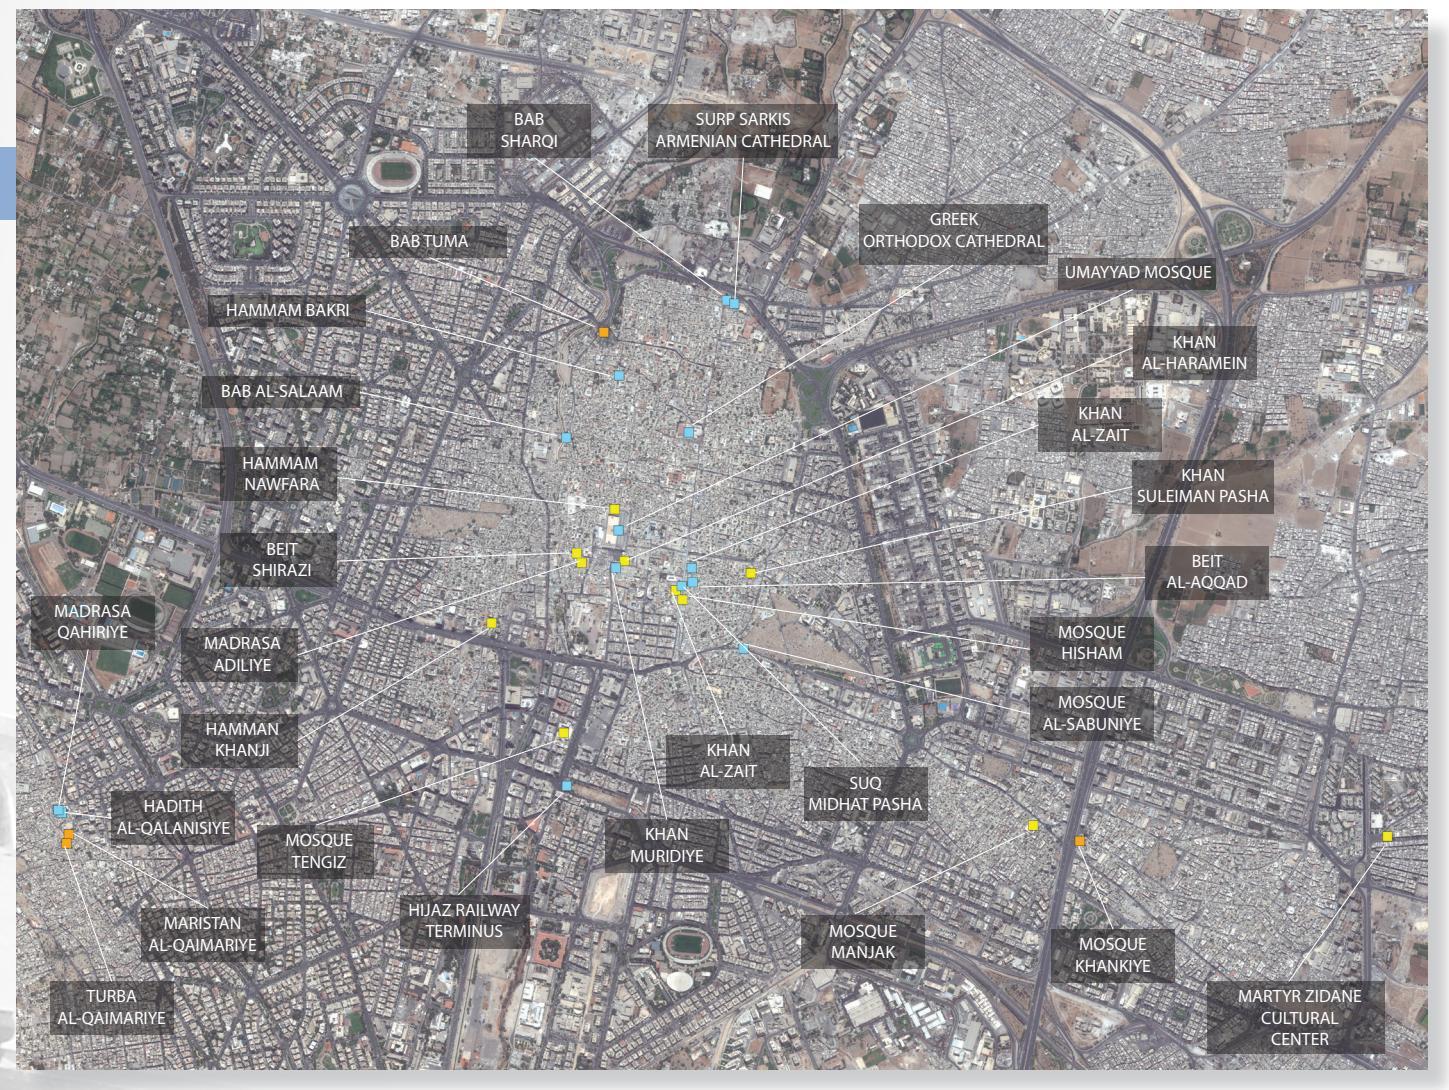
FIGURE 36. Overview of Damascus and locations where damage has ocurred and is visible

Of these locations, 15 have sustained damage, a majority with moderate damage, and some severe, however none are completely destroyed. An additional 12 are reported as damaged or potentially damaged, but cannot be confirmed via satellite imagery.⁽ⁱⁱ⁾ For example, the mosaic façade of the Umayyad Mosque was struck by a shell, but this cannot be visually verified with satellite imagery.⁽ⁱⁱⁱ⁾ Three quarters of damaged or potentially damaged sites are located in or near the Old City. Due to the large number of sites observed as damaged (see figure 36), only a selection of key damaged sites will be discussed in this section. It should be noted that due to the limitations of the imagery available for Damascus, minor damage was difficult to identify in some cases. However, the damage assessment conducted here matches the levels of damage reported in other sources.^(iv)

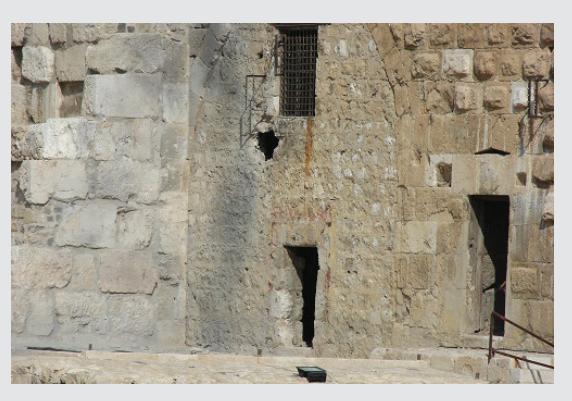
Imagery analysis detected minor impact damage in the centre of the courtyard and to the north-facing side of the south wall. Minor damage has also been reported to the western façade of the eastern gate and the northern wall of the Royal Hall,^(ix) however, no damage was observable in the imagery, so may likely be isolated to the façade and interior of the structure.

Damage to Damascus Citadel/Photo: Directorate General of Antiquities and Museums DGAM, 2013.

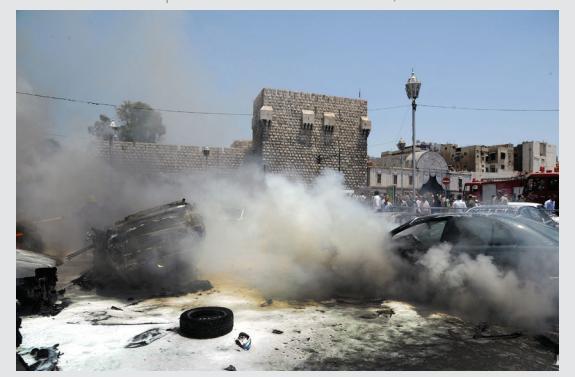
Car bombing at the entrance of the Damascus Citadel/ Photo: European Press Photo Agency; Syrian Arab News Agency.
